The Consolidation of a Zinc-Damaged Contemporary Oil Painting: Methods and Ethics

Rachel Stark

Master of Art Conservation, Department of Art History and Art Conservation, Queen’s University 2022

Case study: *Nu Féminin*

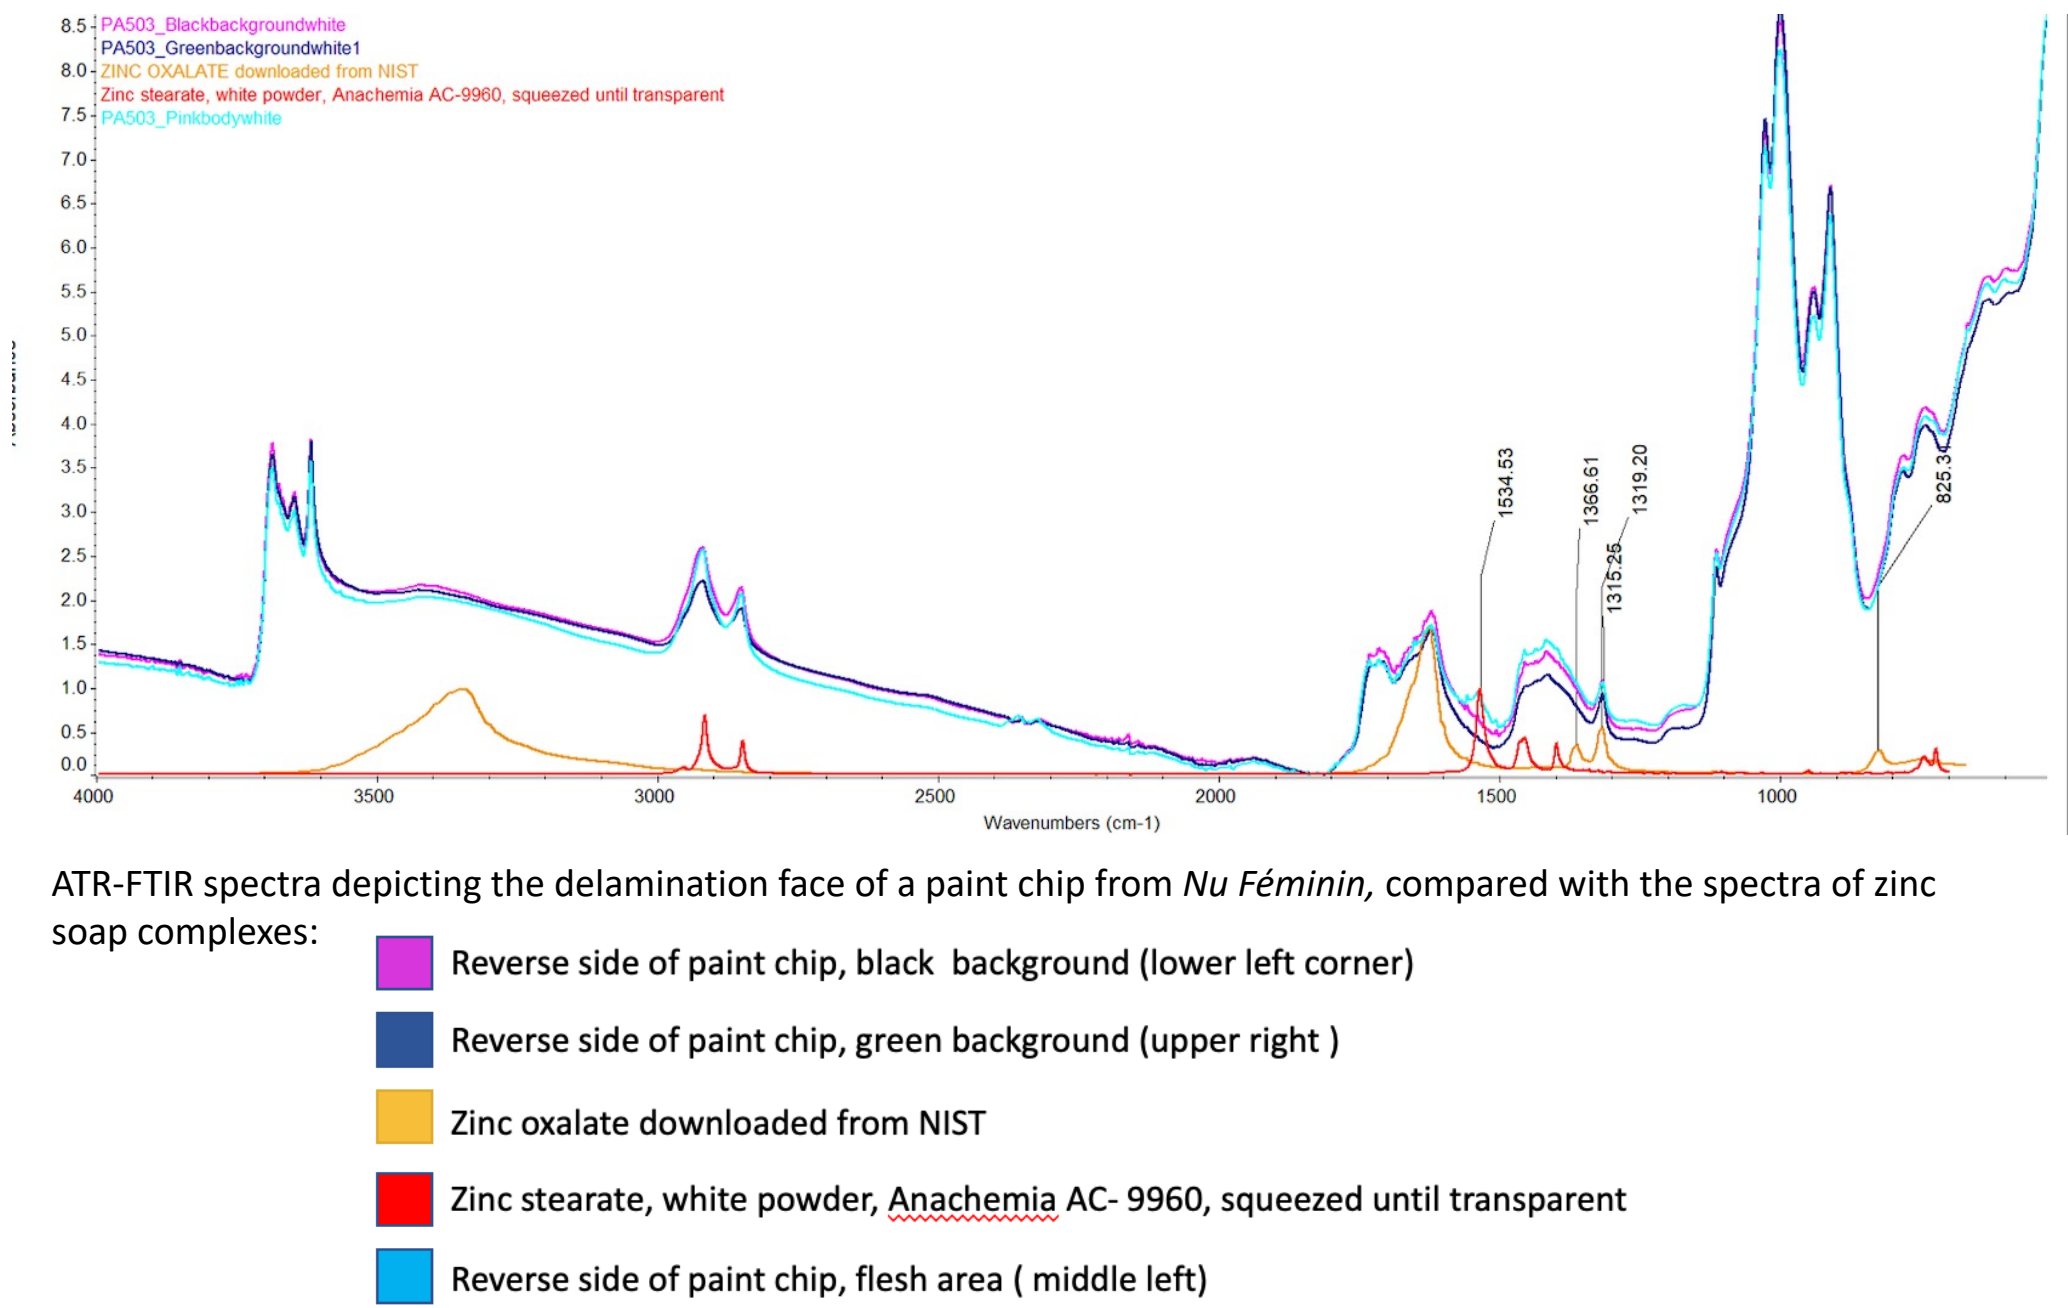
ATR-FTIR spectra depicting the delamination face of a paint chip from *Nu Féminin*, compared with the spectra of zinc soap complexes:

- Reverse side of paint chip, black background (lower left corner)
- Reverse side of paint chip, green background (upper right)
- Zinc oxalate downloaded from NIST
- Zinc stearate, white powder, *Anachemia* AC- 9960, squeezed until transparent
- Reverse side of paint chip, flesh area (middle left)

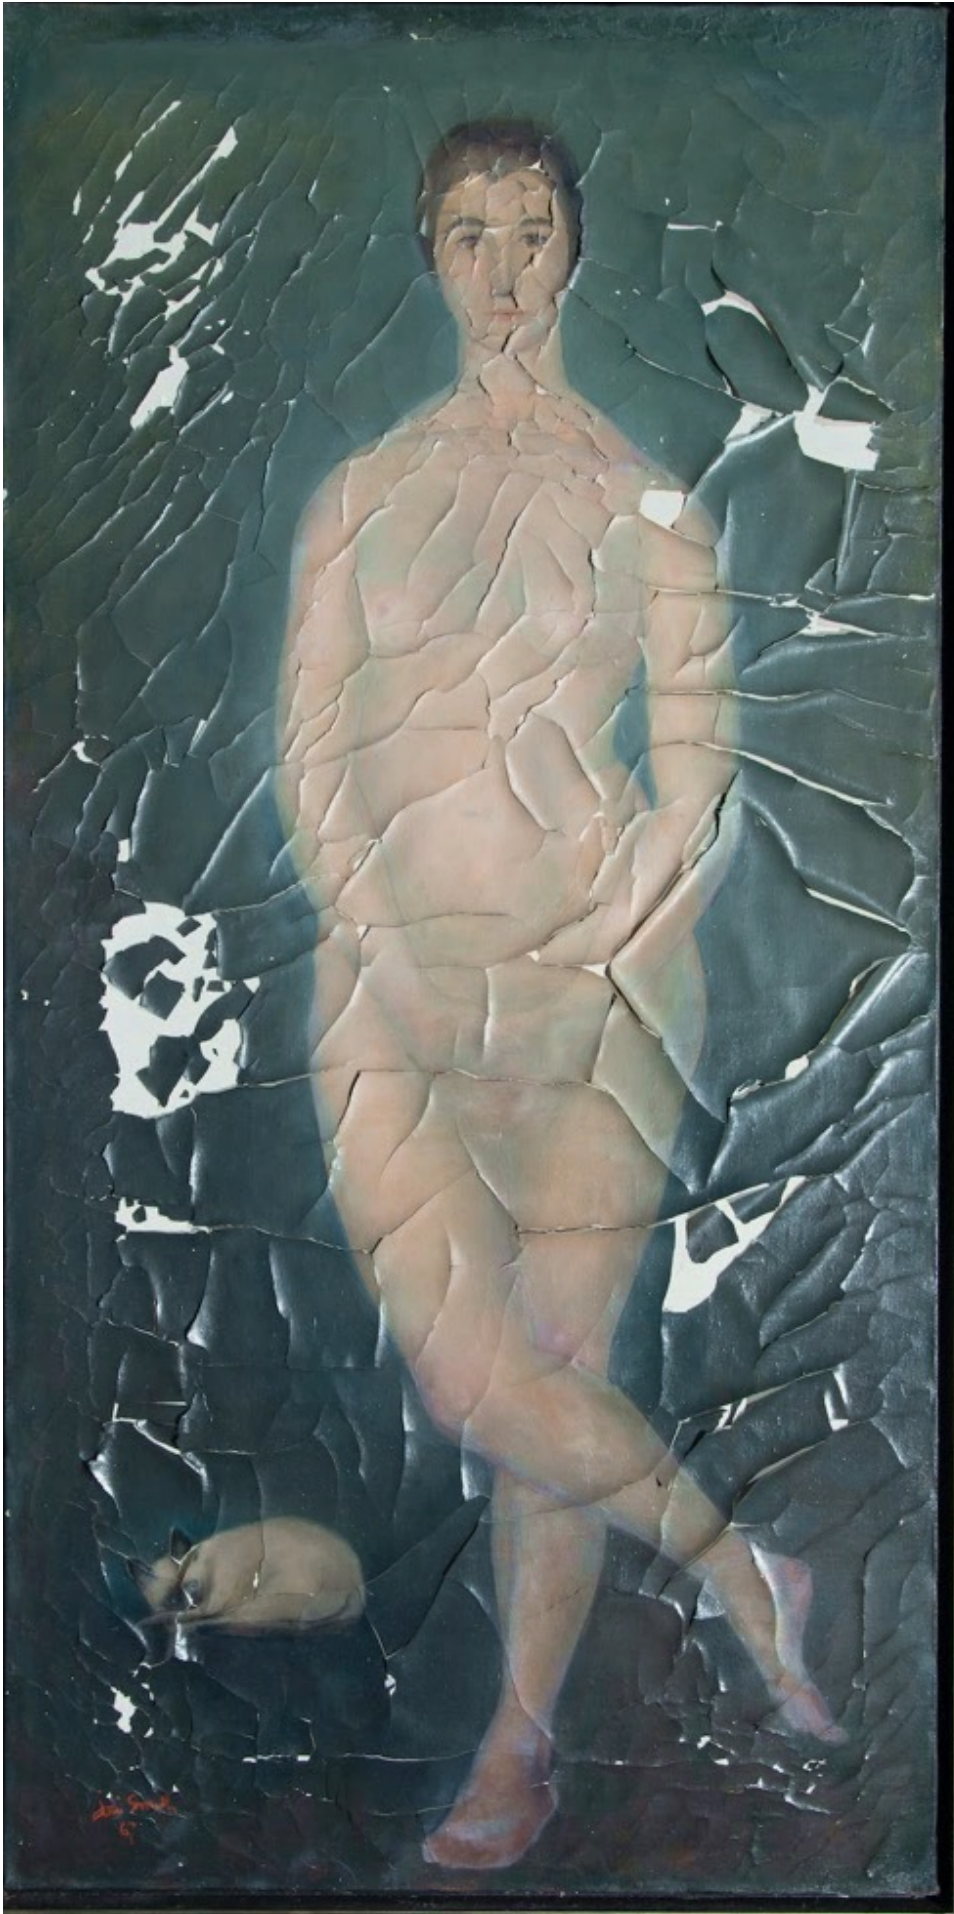
- Analysis and research completed on case study painting *Nu Féminin* (Barnes, 2014)
- Results hypothesized that the extensive delamination and cracking of the paint layer was the result of the zinc oxide content in the oil paint film
- Observation and characterization of the direction and form of the cracking and delamination

Case study: *Nu Féminin* (1967) oil painting on canvas with probable zinc embrittlement of paint film (BT, normal light)

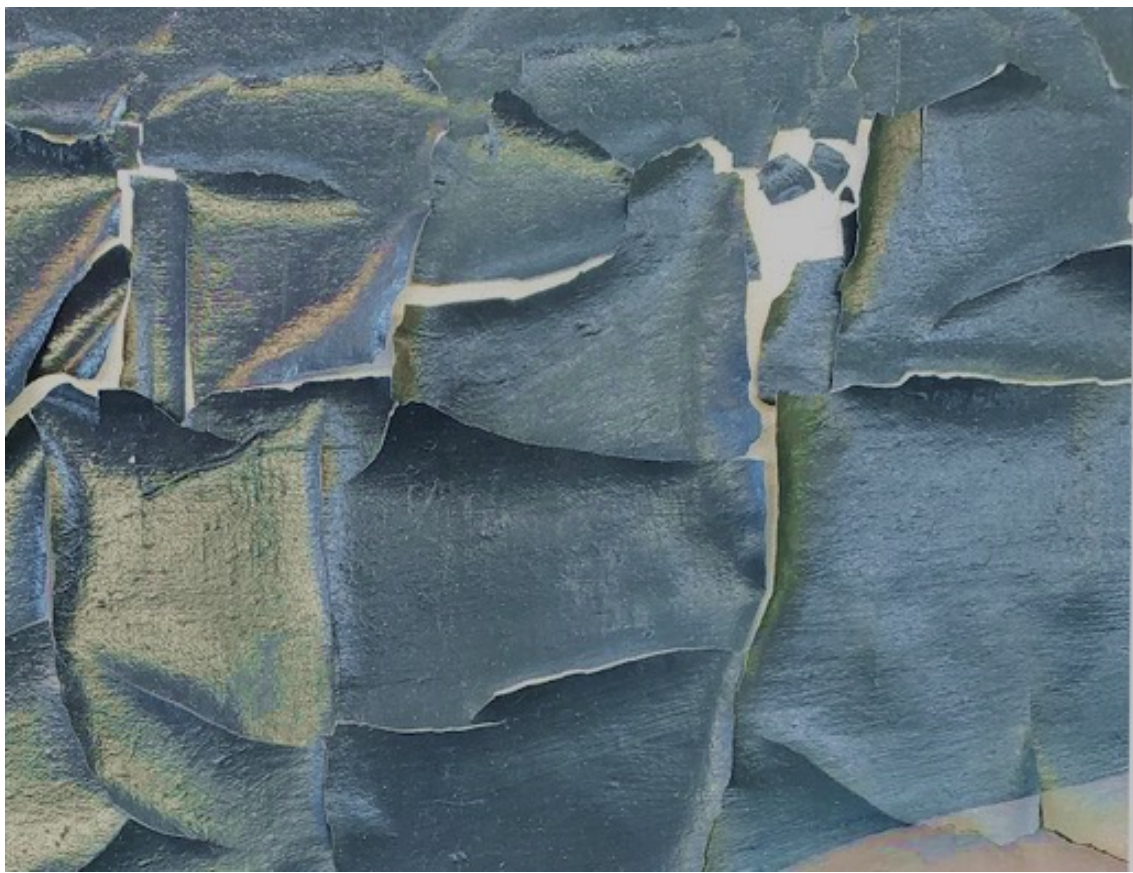
Crack pattern suggesting RH cycling resulting in expansion and contraction of canvas (BT, normal light)

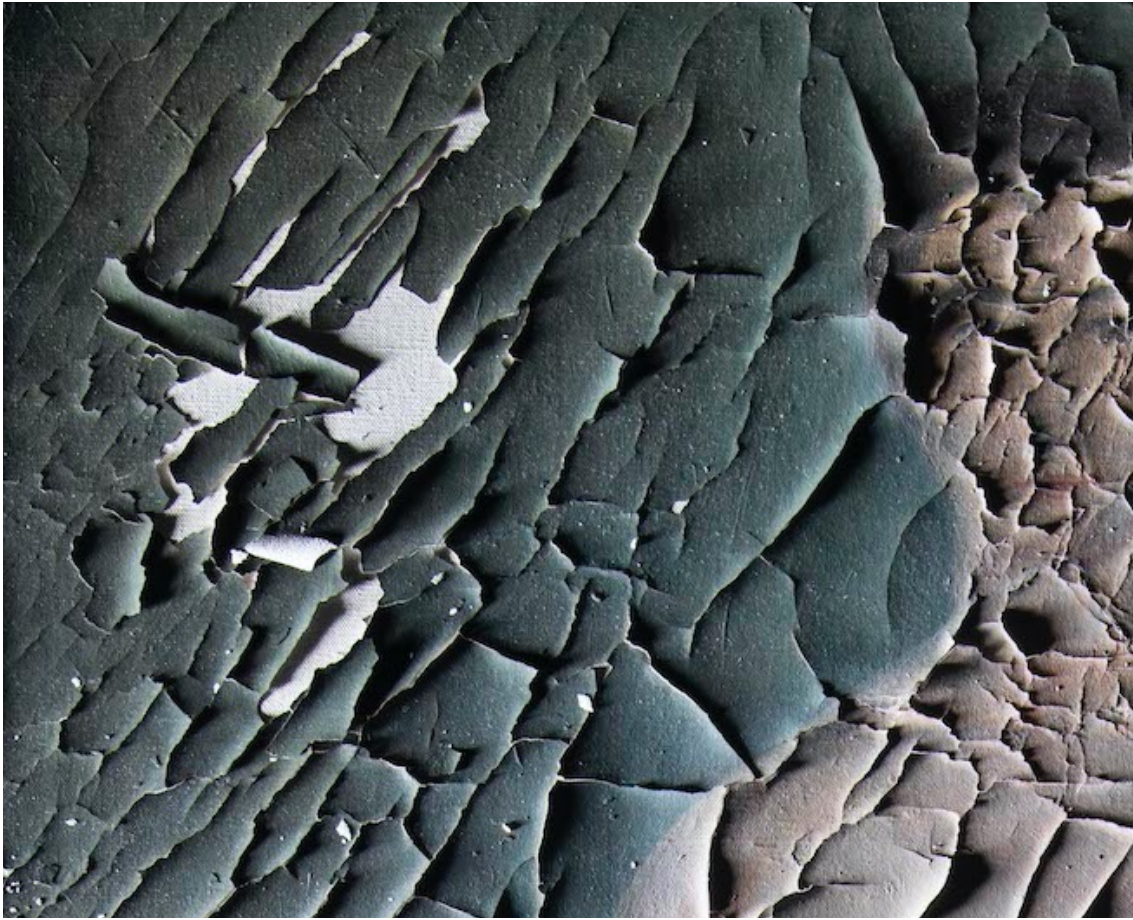
Crack pattern suggesting shrinkage of canvas, resulting in local separation of ground and paint from canvas layer (BT, raking light left)

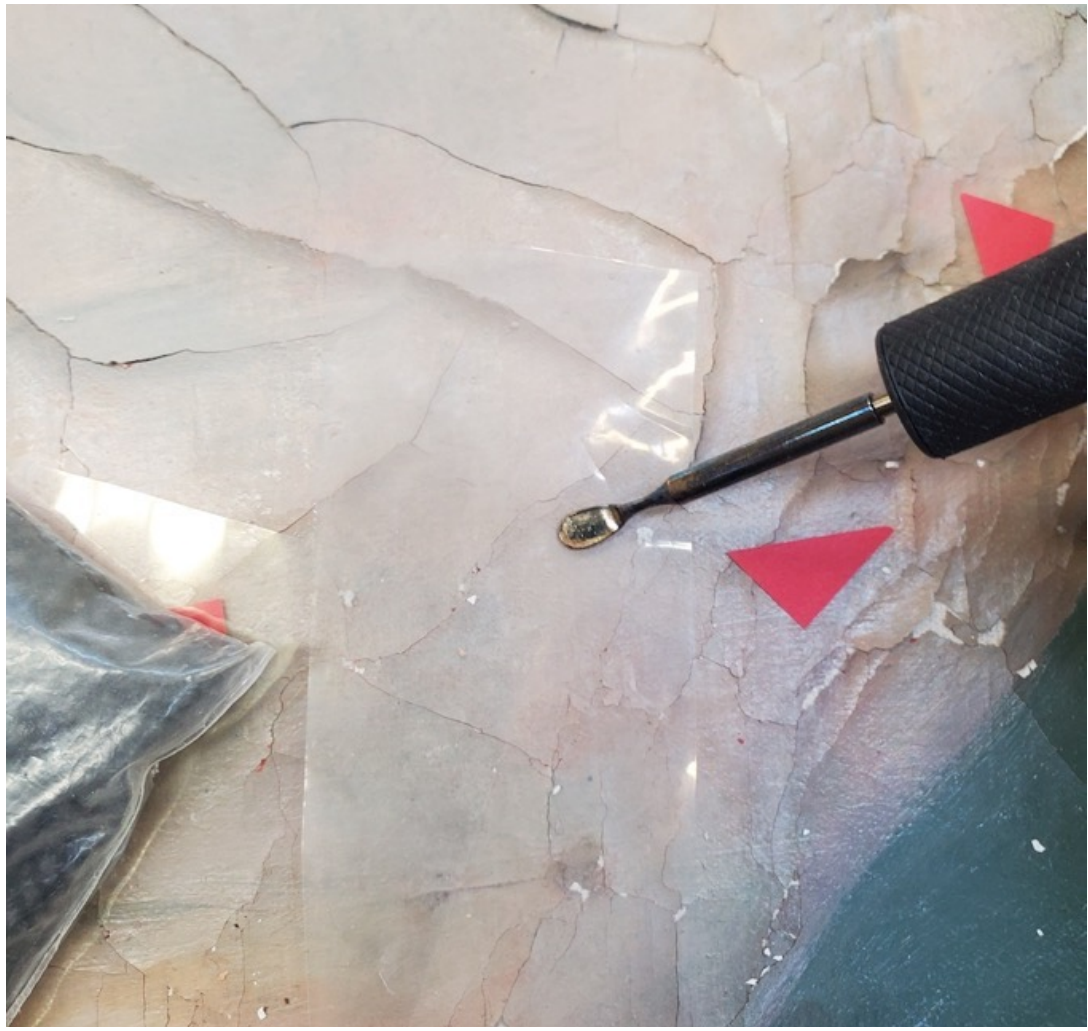
Flattening of cupping paint using wax carving tool and silicon-coated mylar (DT, normal light)

- To reactivate adhesive and soften paint film: Heat from below at 75°C
- Slow massaging of the cupping flake with a small curved wax carving tool, also at 75°C, through silicon Mylar film; Movement from the base of the cup flattening towards tip
- Small weight applied to Mylar film while adhesive cools and sets

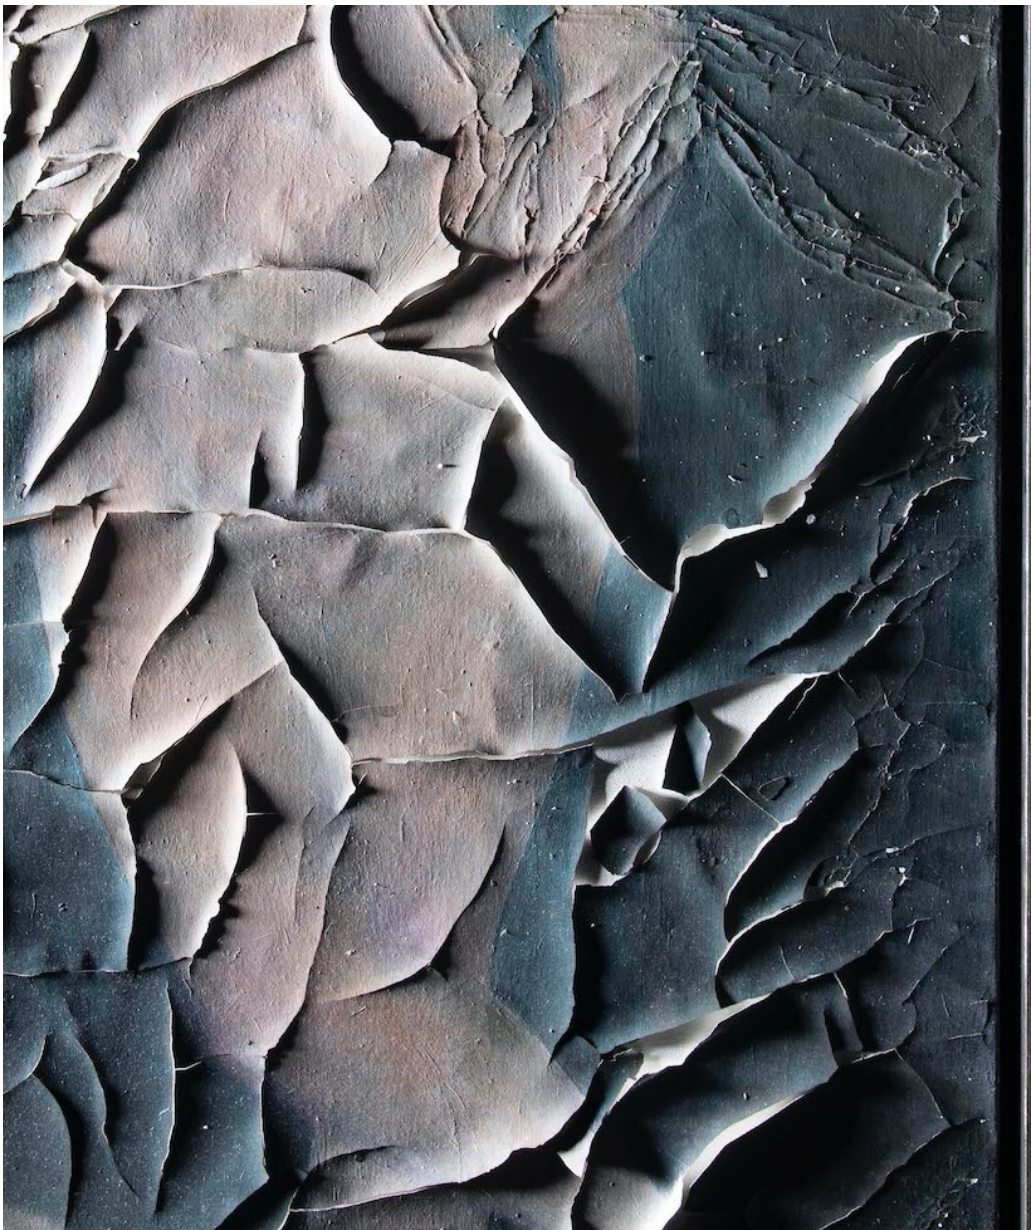
Crack pattern (BT, raking light left)

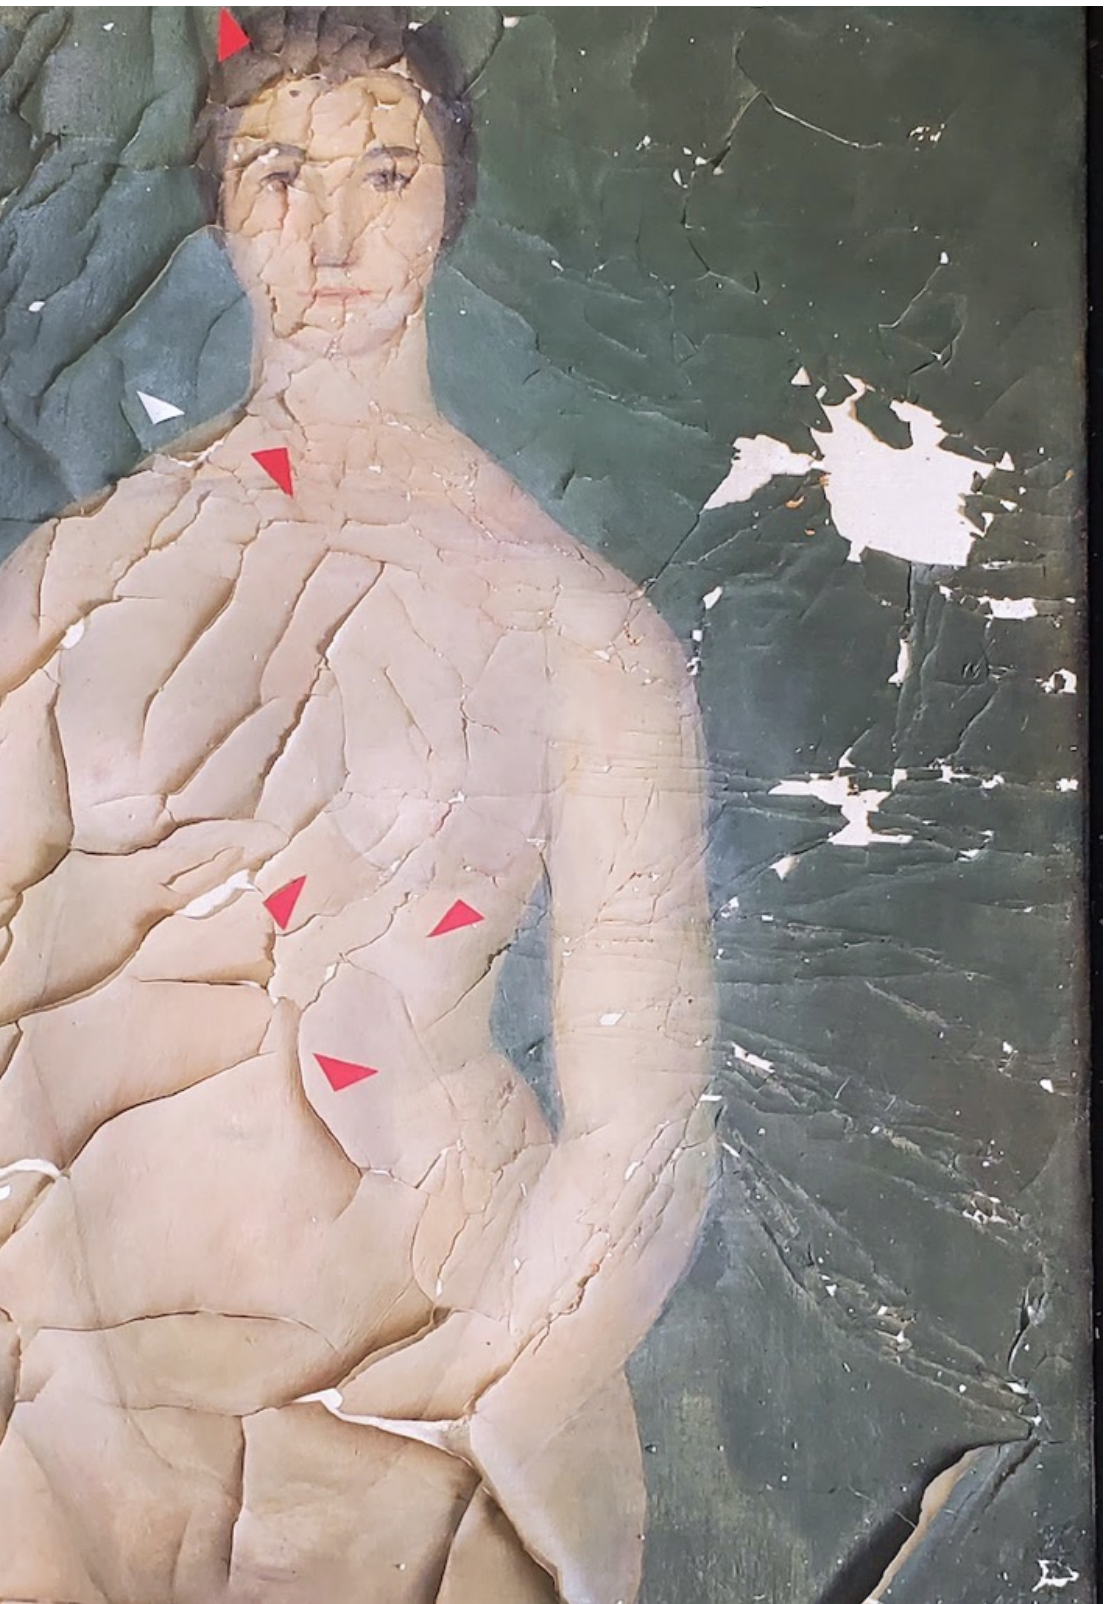
Section of consolidated paint layer (DT, normal light)

- BEVA- 371 (1:1 v/v with xylenes) applied warm using a syringe
- Adhesive directed under the delaminated paint flake and onto the areas of bare canvas
- Small brush also used to distribute the adhesive evenly
- Adhesive dried for 24 hours
