Investigation of Materials and Deterioration of Michael Snow's *Flight Stop*

Katharyn Hernández

Art Conservation Program | Department of Art History and Art Conservation | Queen's University | April 2023

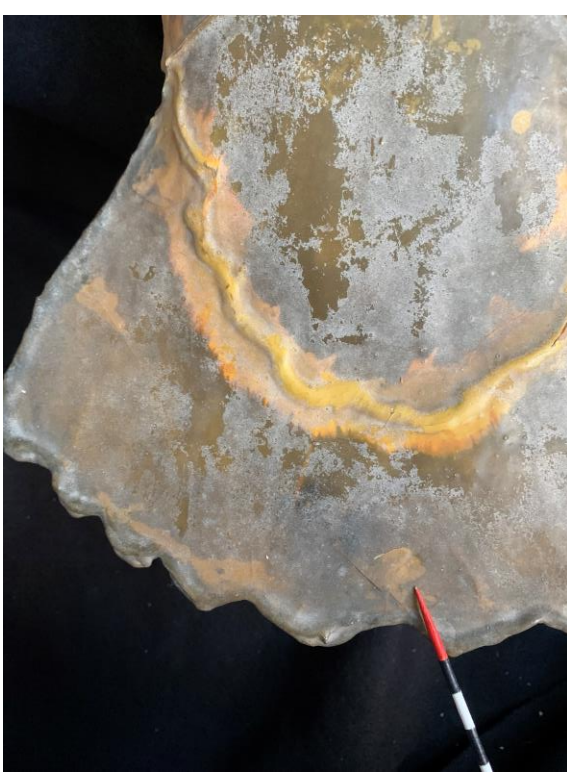
Figure 3. Image showing the chalking present on goose 26B. Courtesy of TARI.

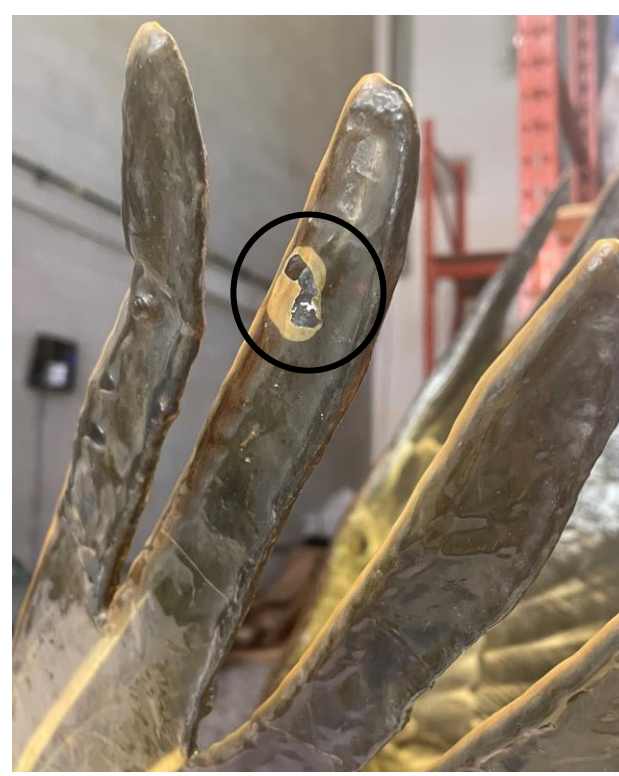
Figure 4. Image of the delamination present on goose 6A.

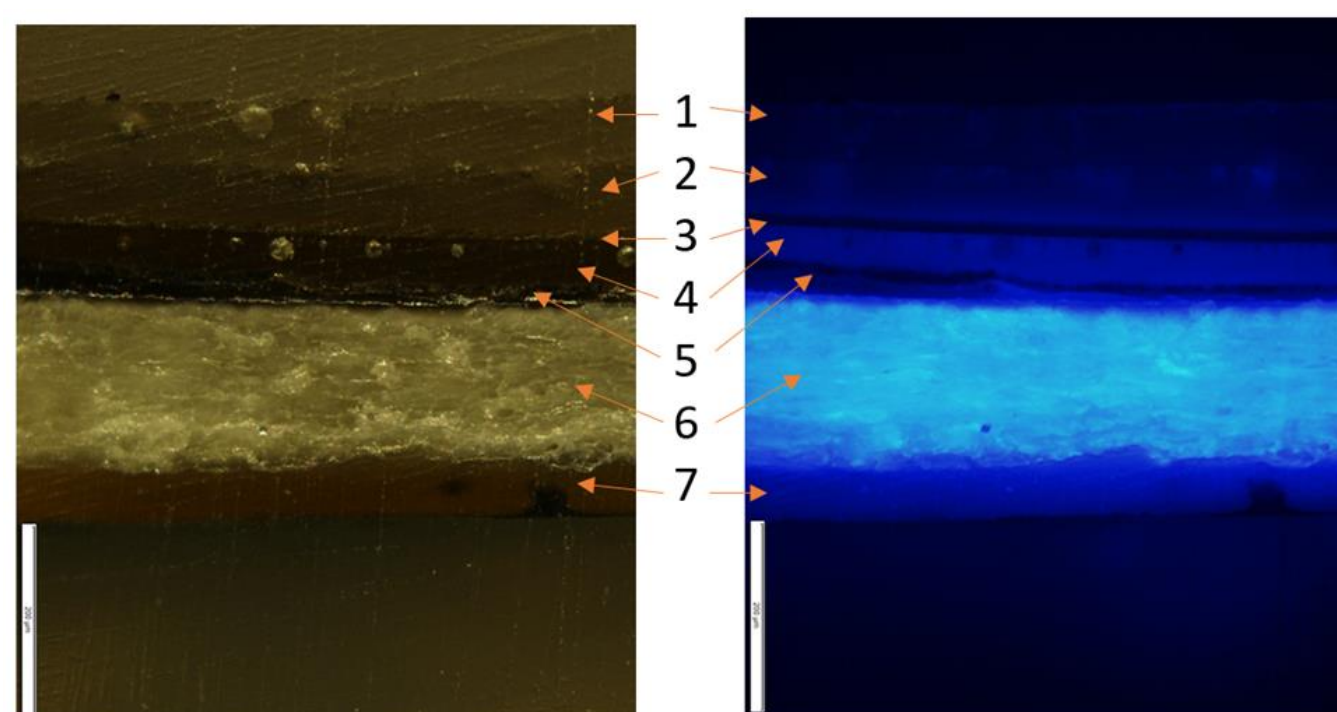
Figure 5. Cross section of Sample 1 viewed with reflected light (left) and wide UV excitation (right) under 20x magnification with layers labeled.

- 1 & 2. Two layers of clear, non-fluorescent material
3. Non-fluorescent layer
4. Slightly fluorescent clear layer
5. Non-fluorescent layer, likely the image layer
6. Fluorescent layer, contains optical brighteners
7. Clear layer adhered to the fiberglass resin shell

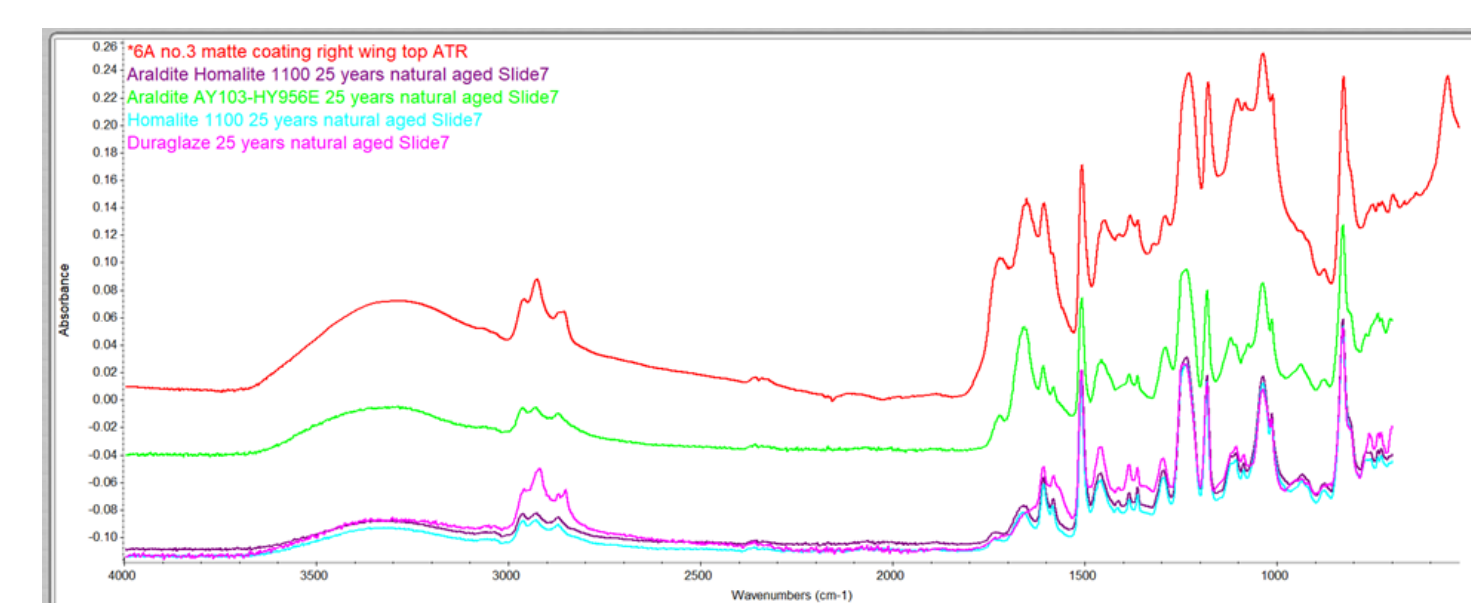
Figure 6. FTIR spectrum of Sample 2 (red line) compared to spectra of various epoxy resins. Courtesy of Scott Williams.

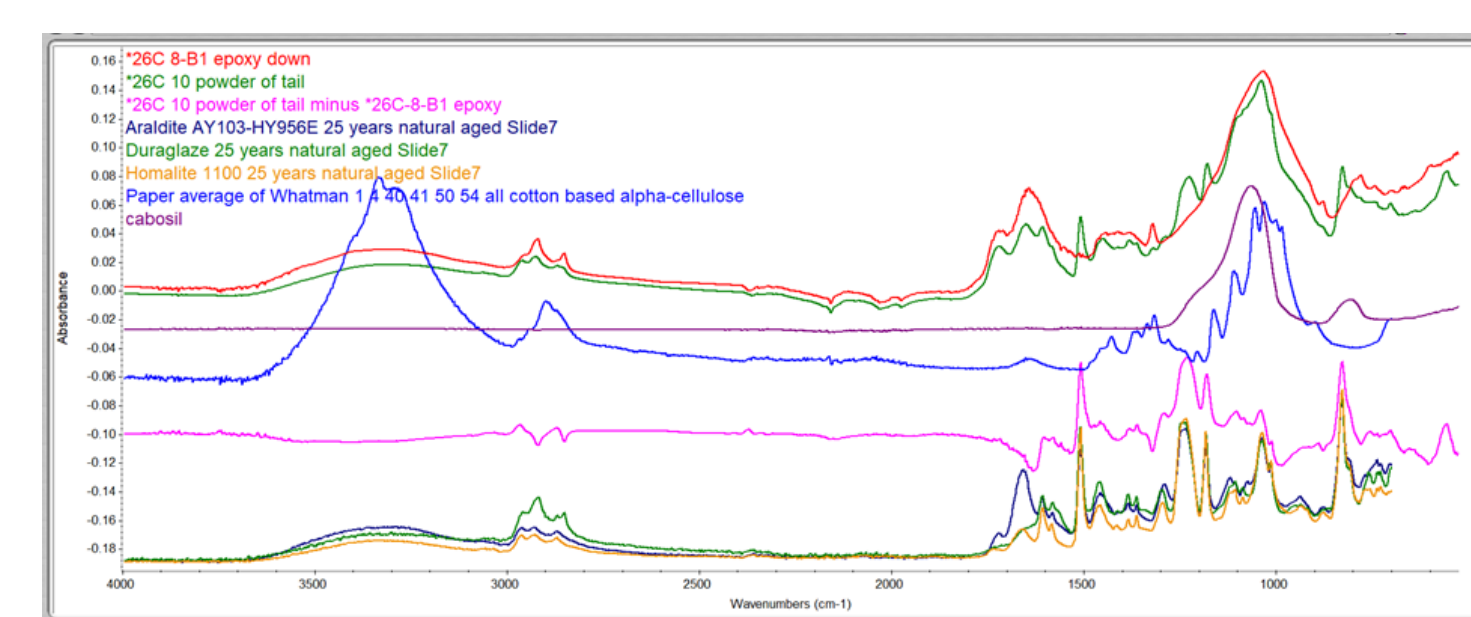
Figure 7. FTIR spectra of Samples 8 (red line) and 9 (green line) compared to spectra of various epoxy resins as well as silica gel. Courtesy of Scott Williams.
