The Rupture of *Mont St. Hilaire*: Instrumental Analysis to Discover the Causes of Deterioration

Tasia M. Bulger – Art Conservation Program, Queen’s University, 2011

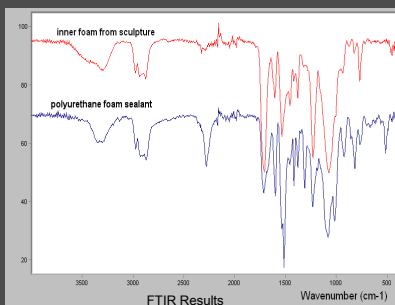
Fig 3. Foam from sculpture compared to a polyurethane foam.

Visual examination and FTIR analysis concluded that absorption of water by the foam core had not caused the deterioration because the sculpture was composed of non-absorbent polyurethane foam. The cause of deterioration is likely the tendency for thinly-applied polyester resins to become brittle and form small cracks which allow moisture to penetrate and weaken the surface. It is recommended that the Agnes Etherington Art Centre monitor the deterioration of the sculpture as it is stable in its current environment, and that the sculpture not be returned to its previous outdoor environment. Should the sculpture undergo conservation treatment the area of loss and flaking paint should be stabilized. Possible materials which could be investigated further for eventual treatment are: polyester resin fixed over an inlay material, hide glue in Plextol D 540 in a 4:1 mixture with calcium carbonate, heating resin to reshape, and polyethylene ethafoam to replace missing polyurethane foam.

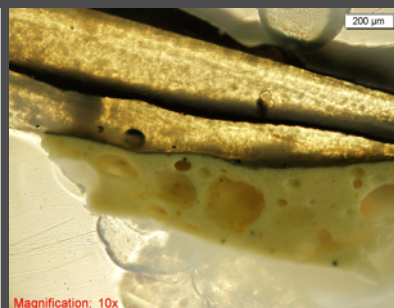
Fig 4. Cross-section of paint layers and foam under reflected light microscopy revealing layers consisting of paint, resin, paint, resin, paint, and foam.

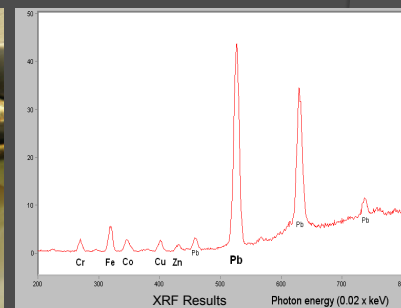
Fig 5. Paint layer contains high amounts of lead and trace amounts of chromium, iron, cobalt, copper, and zinc.
