Queen's University
Heritage Study

RESIDENTIAL BUILDINGS

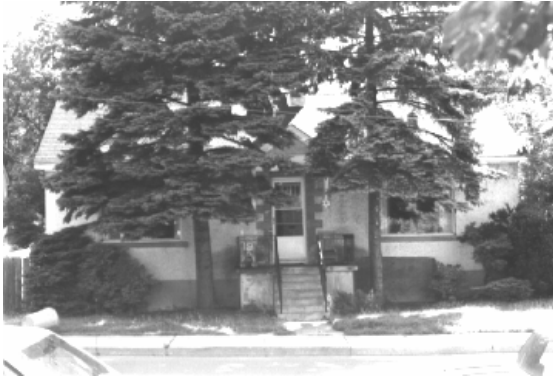
11 ALBERT ST.

This house is a good example of the early twentieth century Cottage Style, especially in its use of materials and the shape of its roof and porch. It is also an integral part of an important streetscape, anchoring the corner at Queen's Crescent, and the structure and mature landscape are largely unaltered.

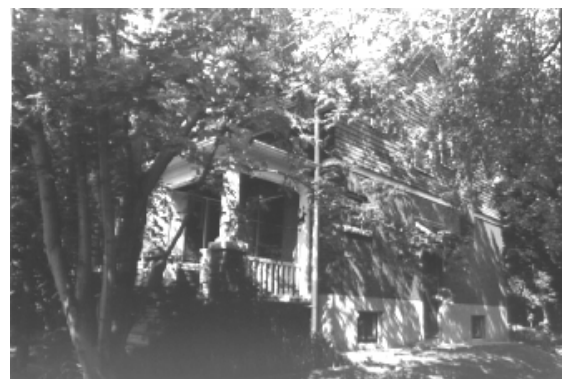
23 Albert Street is a 1 1/2 storey brick clad early twentieth century house with a full width enclosed porch and a hip gabled roof and dormers. It exhibits Arts and Crafts influences such as battered columns on brick piers and shallow arched openings with stone sills. The shingled side walls of the gable roof flair just below a raised plate to meet the brick clad first storey. The full width front

porch is partially enclosed and is simply detailed. No interior features were noted.

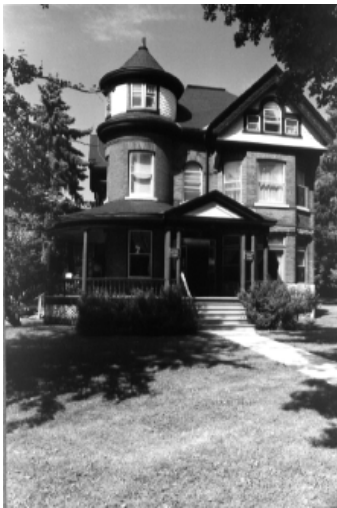
96 ALBERT ST.

This house is a good example of a late Victorian architectural style, with good proportions, balanced composition and good use of material, well suited to its prominent corner site and situated in a mature landscape, in almost unaltered condition.

96 Albert Street is a 2 1/2 storey, detached dwelling in the Queen Anne style. It has a random ashlar limestone base and is clad with brick, shingle and clapboard. It has a two-storey bay window projection to the north topped with a gable roof, and a Palladian window with painted shingles. A projecting turret on the southeast corner is topped by a conical roof. A pedimented entry faces Albert Street. Facade details include decorative bargeboards and sandstone flat arches. No interior features were noted.

The house has excellent proportions and suits its corner site well, especially with the tower and curved verandah. Broad lawns, perennial beds, foundation plantings and mature trees also contribute to the setting.

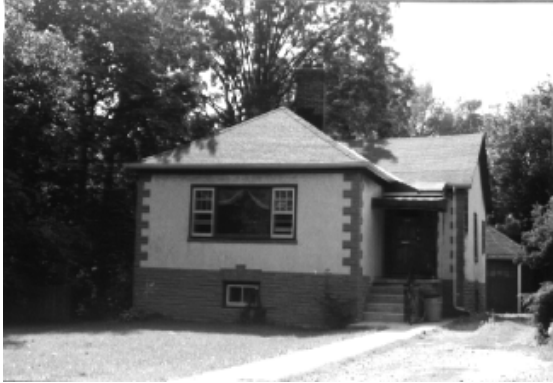
120 ALBERT ST. - THE TRAVERS HOUSE

This is a one-storey stuccoed bungalow with a concrete base which is formed and tinted to resemble a sandstone foundation and quoins at the corners. A gabled wing towards the rear of the house projects from the left side of the main block and creates a recessed entry, now covered with an aluminum awning. Roy and Helen Travers, the original owners, lived here until the 1960s.

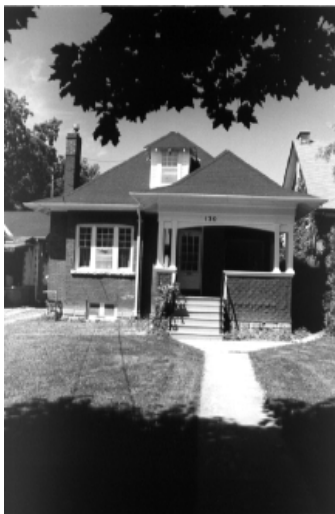
130 ALBERT ST. - THE TIROL HOUSE

130 Albert is a one-and-a-half storey brick-clad bungalow with a flared hip roof and a small hipped roof dormer. From the right side of the front facade projects a porch with a similarly styled roof. In a much simplified way, Arts and Crafts elements emerge on this building, with square columns, shallow arched openings and exposed rafter tips. The porch has a solid balustrade clad in tin with a scalloped shingle pattern.

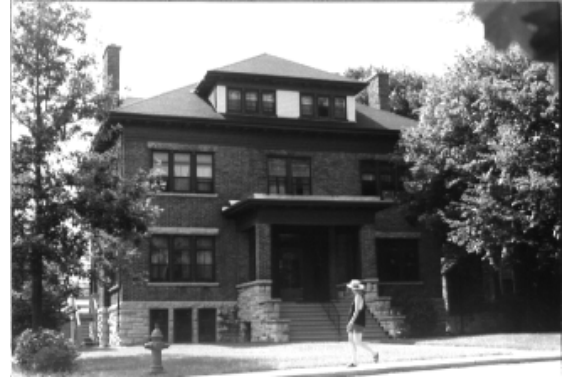
144 ALBERT ST. - DICK HOUSE

144 Albert is a 2 1/2 storey, detached dwelling in the Queen Anne style. Its interesting composition consists of a truncated hip gable roof over a large two storey bay window and an elongated conical roof over a turret in the south corner of the front facade. A small shed roofed entry porch is situated in the recess between the turret and the bay window. Cladding is brick, with wood details. No interior features were noted.

The house has a mature landscape of trees, lawn and foundation plantings. Alterations include aluminum storm windows, and removal of a verandah from around the south turret.

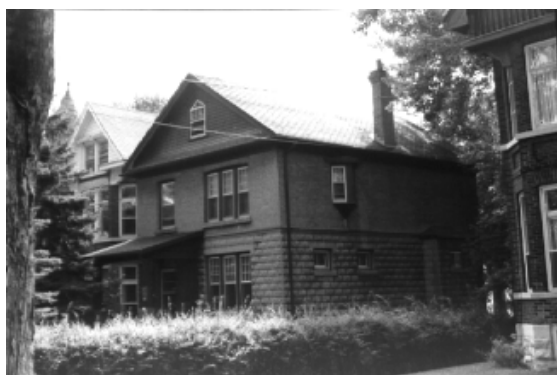
148 ALBERT ST. - COGWELL HOUSE

This is a large two-and-a-half storey, detached, red-brick house with a mixture of Regency Revival style. It has three bays with a central unprotected entrance and no surround, and has little ornamentation except the stone window sills. A shed-roofed dormer centred over the centre bay rises from the front roof plane of the side gable roof. The original windows are intact with some storm windows in front. The property is well maintained, with a lush almost overpowering landscape of mature spruce and perennial beds which obscures the house. Frederick Pound and his wife lived here from 1931 into the 1940s and may have been the original owners.

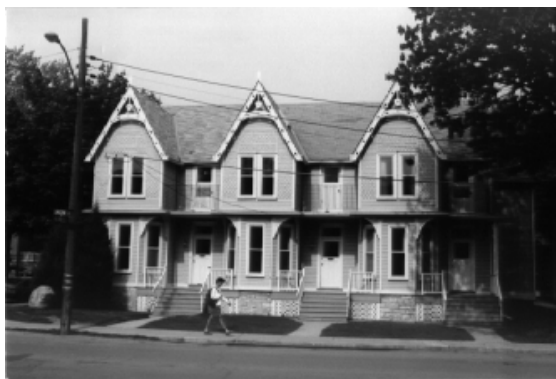
135-139 ALFRED ST

135-139 Alfred Street were restored in the past fifteen years and, in 1992, were moved from their original site at the corner of Union and Alfred Streets. The houses are 2 1/2 storeys in height wood frame, with 6 bays, each alternating bay having steeply peaked gabled dormers atop 3-sided bay windows on the left side of each unit. The facades have good wooden detailing in the bargeboards, wall shingling and brackets over the window bays. No interior features were noted.

The building renovations following the move included new porches which copy those formerly existing, but the iron railings on the flat overhangs above the door suggest that there was once a more ornate two-storey porch on the buildings. The houses have been raised onto a new foundation which has been faced in salvaged local limestone. Other recent additions include aluminum storm windows, skylights, rear additions, as well as entrance steps and the foundation.

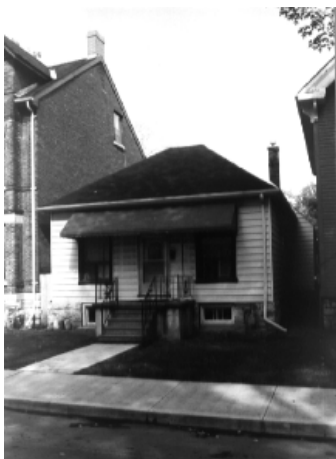
159 ALFRED ST. - SMALLBRIDGE HOUSE

This is a small one-storey bungalow with a hipped roof. The limestone foundation, Victorian entry door and offset kitchen addition to the rear suggest, however, that this is the truncated incarnation of a much larger and better designed building. Now a heavy aluminum awning stretches the width of the three bays and a precast concrete step and stoop unit gives access to the front door. George Smallbridge is described in the Kingston Directory as residing in the house in 1889.

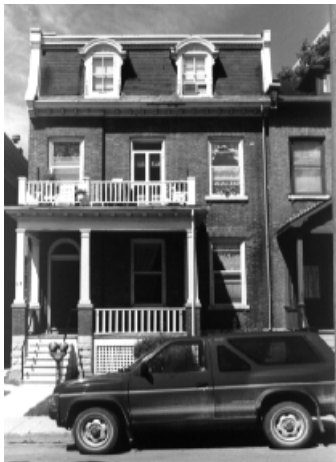
64 BARRIE ST. - DORAN HOUSE

This is an elegant Second Empire two-and-a-half storey house which may have been intended to form part of a row. Three bays wide with a left side entry, the left bay projects one brick width from the building edge. A later flat-roofed porch now spans the left two bays and the balcony above has a centre bay walkout. A pair of ornately hooded units in the mansard roof sit above a simple cornice.

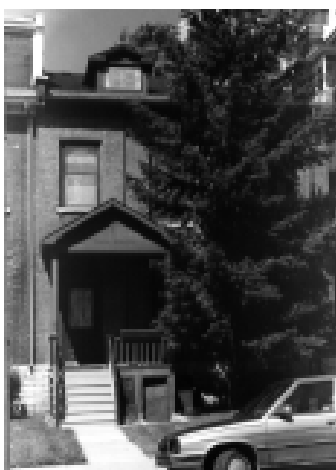
66 BARRIE ST.

This house is identical to 64 Barrie St. but it has a shallow gable roof with two small dormers in it. The original porch has also been replaced but this time with a small gabled entry porch, which is not related to the second storey walkout.

In 1881 Ben Robinson, a labourer, was living at 66 Barrie St. Whether he was in this house or not is uncertain. In 1902 the house was vacant. It is possible that this was due to a fire, and that the roof is a replacement of the original mansard.

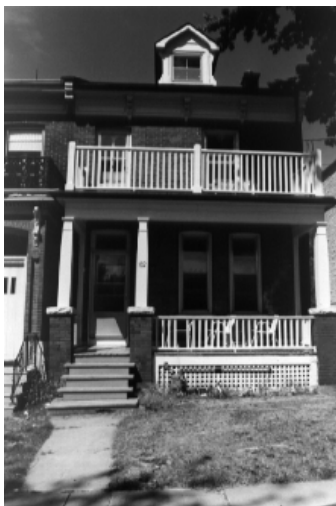
102 BARRIE ST. - THE HISCOCK HOUSE

102 Barrie St. is a two-and-a-half storey red brick residence which is attached to 100 Barrie and copies its form and design. While many of the details have been replicated, their arrangement differs slightly. The roof dormer has been centred in the roof, and the ornate brackets in the eaves which match those on #100 have been spaced differently. 102 also has a full width porch that appears to date from the early 20th century.

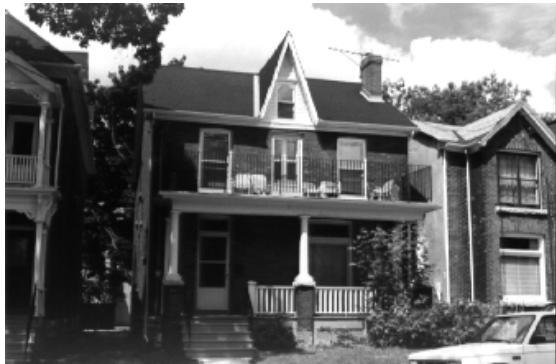
180 BARRIE ST. - MOREHAM HOUSE

This is a two-and-a-half storey, red brick Victorian house with a steeply-pitched central gable. A full-width porch with a simple railing and Tuscan columns on brick piers rises to a balcony with modern railings. Note the arched window and decorative shingles in the centre gable.

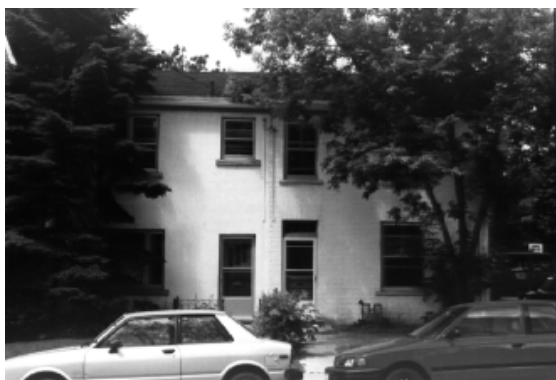
188-190 BARRIE ST. - CHADWICK/McGROGAN BUILDING

This is a simple, rectangular, two-storey, brick-sided building with a central entrance and balanced window placement.

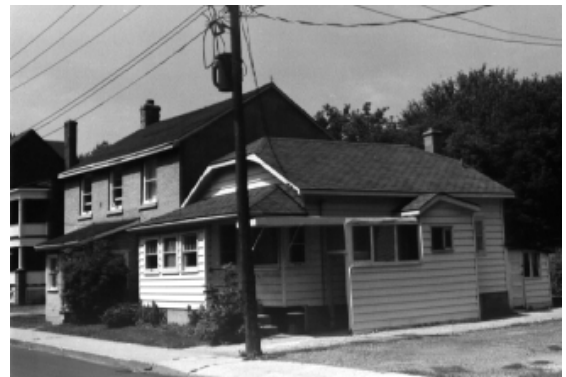
17 CLERGY ST. W. - ROURKE HOUSE

17 Clergy Street is a 2 storey brick (and, possibly, stone) house with a side gable roof and plain features. The facade is a three bay centre entry with windows in each bay but none on the end gables. There is little detailing aside from shallow arches and lintels on the ground floor windows. No interior features were noted.

Alterations include a rear extension and an enclosed single storey entrance vestibule, as well as paint applied over the brick and replacement of the original windows.

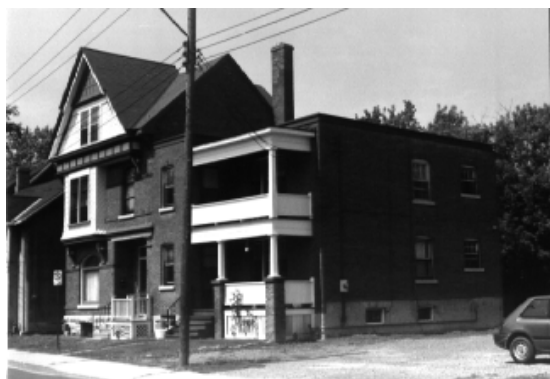
25 CLERGY ST. W. - O'DONNELL HOUSE

Date: c. 1920s

Evaluation: Good

This is a square brick two-storey duplex building. It has a flat roof and full width porches on each storey across the facade. The porches have solid railings and are supported by tapered square columns.

Erected after the 1908-1911 Insurance Plan.

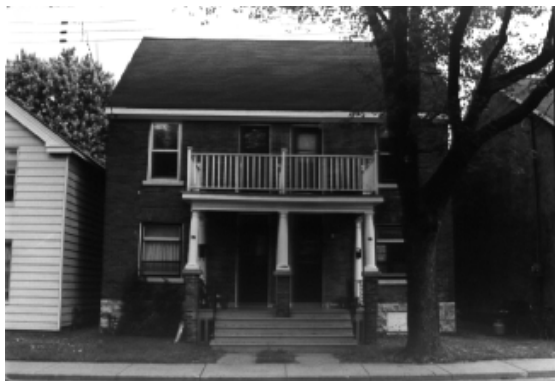
35-37 CLERGY ST. W. - WATTS/DOYLE HOUSE

The four-bay semi-detached units mirror each other in this two-storey brick structure. Although forming only two units, the building could easily be part of a block of Victorian row-housing. There is a flat-roofed porch on top of which is a top verandah with a high square balustered railing. The porch structure has Tuscan columns on brick piers. Note the window sills and shallow arches at the openings.

The building was likely constructed after 1850, but helps sustain the character of Stuartsville, even if it is a brick building in an area of predominantly wooden construction. In 1881, William Watts, a painter, and Miss J. Doyle, a dressmaker, were residing in the units.

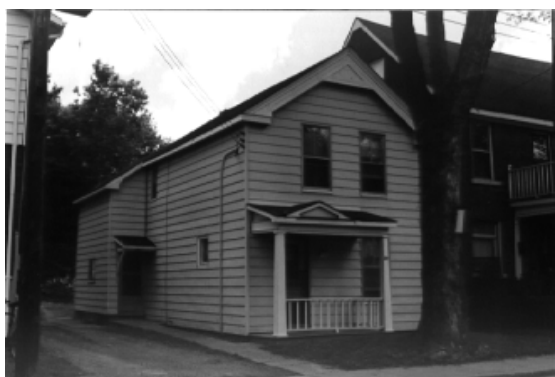
39 CLERGY ST. W. - DEAN HOUSE

This simple vernacular two-storey frame building has vinyl cladding but retains a distinctive gable return and bargeboard. The small porch on the front gable portion echoes the character of the bargeboard.

Although the building could date from an earlier era, the first reference in a Kingston Directory was in the 1881-89 edition, noting William Dean, a printer, as the resident.

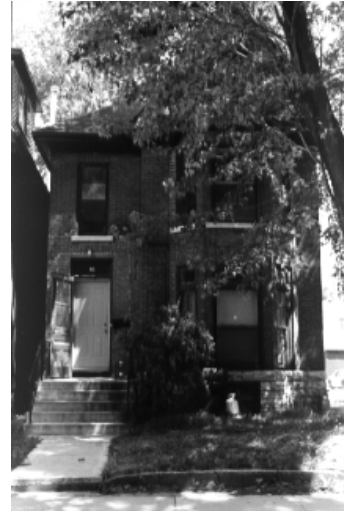
95 CLERGY ST. W. - HORNE HOUSE

This is a two-and-a-half storey hipped roofed brick building with a two-storey projecting gabled pavilion. The projected gable has decorative brackets, decorative shingles and bargeboards. The right bay has a shed roof entrance supported by battered columns and there is a small pediment over the steps.

The first resident or owner was Alex Horne, a merchant, whose middle class position reinforced the contemporary development of the area.

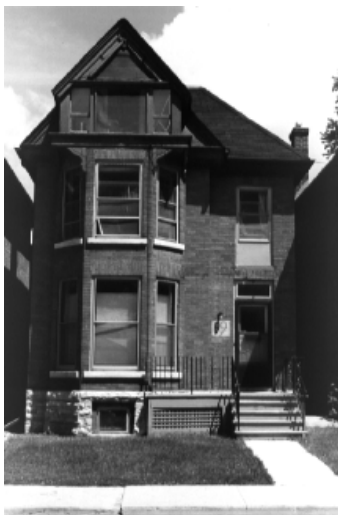
99 CLERGY ST. W. - BAILEY HOUSE

This is a two-and-a-half storey hipped roofed brick building with a shallow projecting pavilion containing deep 3 sided, 2 storey bay windows. In the pavilion gable there is decorative woodwork and bargeboard. A small screened porch is carried by cantilevered corners. The right bay entrance has a door above suggesting an original two-storey porch, and the uncovered front stoop has a modern wrought iron railing.

S. Bailey, a broom manufacturer, first occupied this building.

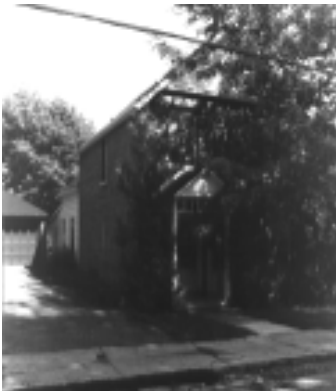
137 COLLINGWOOD ST. - ROE HOUSE

Evaluation: Good

A two storey, red-brick, end-gabled house with a small gabled entry porch. The porch has turned columns and spindlework ornamentation. There is a square bay window at the front, and an unusual pent roof above the eaves line.

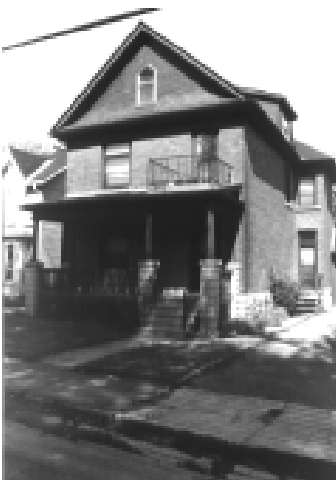
141 COLLINGWOOD ST. - BUNT HOUSE

This is a two-and-a-half storey, end-gabled, red-brick house with a full-width front porch. The porch has turned columns on concrete block piers. The pedimented front gable has a pent roof and is decorated by shingle work and a peaked window. There are shallow arches over the window and door openings. The house also has a brick rear addition in a similar design to the main structure.

The first resident in 1902 is listed as Charles A. Bunt, a post office clerk.

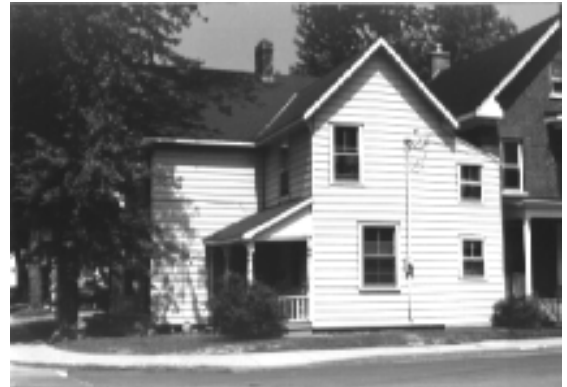
47 DIVISION ST.

The building is in fair condition. Alterations include vinyl siding and trim storm windows and a new chimney. There are no landscape features, but the building maintains the residential setback on this street.

The building appears to have been substantially altered. Character defining features of the current building include the door hood and the form and location of the ground floor window openings. Removing alterations would improve the building's appearance.

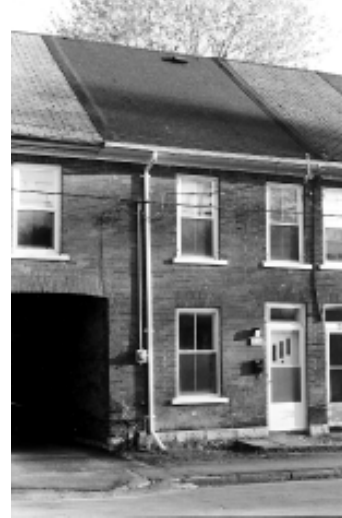
246 EARL STREET - O'DONNELL HOUSE

246 Earl Street is a 1 1/2 storey frame house with a side gable roof which appears to have been converted from a semi-detached dwelling. It has a 3 bay facade with an offset entry covered by a simple gabled hood supported by brackets (the other entry is blocked). The entry is flanked by paired windows. A large shed roof dormer, which also appears to be a later addition, is centred on the facade and is inset slightly as it rises from the eaves line. No interior features were noted.

The house was built prior to 1880 and possibly dates from the Stuartville era of 1840-50. The 1881 Kingston Directory lists the occupant as Brian O'Donnell, gardener.

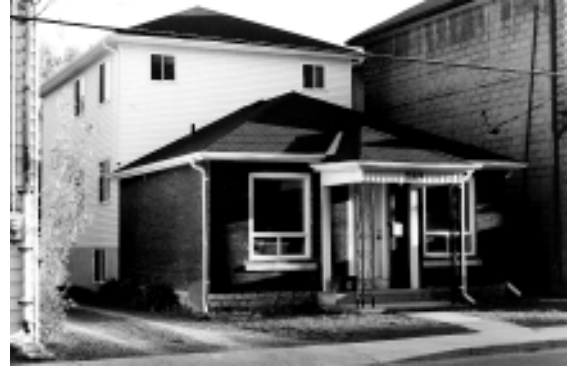
302 EARL ST.

This is a good example of a detached Victorian urban house, with attractive details. It is a 2 1/2 storey brick house with a hipped roof. The foundation is coursed, rough faced stone. A 2 storey, 3 sided bay window occupies the entire first bay of the house and is capped with a decorated wooden gable end. The main entrance is in the second bay under a covered porch supported by brick plinths with stone caps under round wooden posts. The door has a transom over and with a window in the second storey. The bay has full height paired windows with stone sills. A gabled dormer projects from the west side of the hip roof. A kitchen ell projects to the rear. Details include decorative bargeboard and ornate brackets supporting the gable end. No interior features were noted.

Alterations include aluminum storm windows and a new porch. There are no landscape features. The house is built to the streetline and reinforces the streetscape in this area as part of the group of houses Nos. 304-306.

The house appears to have been constructed in 1891; the Kingston Directory of that year lists S.W.Hobart, druggist, as the first resident. The house is within a subdivision in the late nineteenth century which was part of the westward expansion of the middle class in that period. The area has since become dominated by student housing, the function this house now serves.

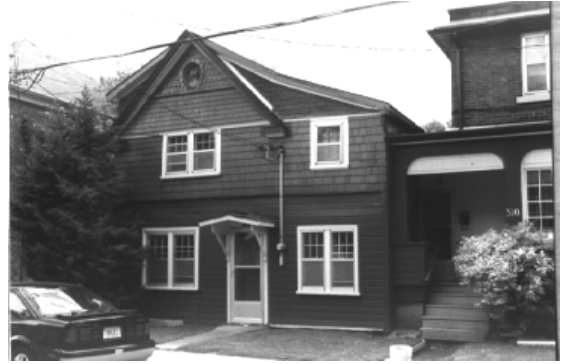
310 EARL ST. - RIGLEY HOUSE

The two-storey brick building is part of the rear ell of 195 University Ave. (corner house). A left-side entry shed-roofed porch with fixed glazing dominates the left-side ground floor, while a bay window occupies the right side.

This building is probably that which is registered in the 1889 Kingston Directory as the home of James Rigley, labourer.

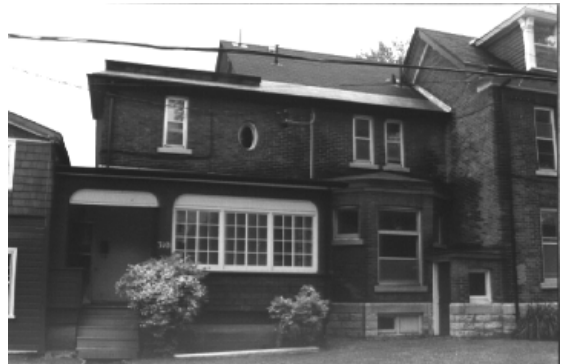
314 EARL ST.

Evaluation: Fair/Poor

This extension of an existing wing has a poor composition and use of materials. The structure is a 2 storey frame structure with vinyl cladding. It matches the form and massing of the wing of No. 194 University Avenue, and has a 2 bay facade with an entrance in the first bay. A large plate glass window flanks the entrance; above is an asymmetrically placed smaller window in the second storey. The gable end on the side elevation contains two single windows, the rear one having a metal fire escape leading from it. The rear elevation has three asymmetrically placed windows of various sizes, two in the second storey and one below. No interior features were noted.

The extent of alterations depends upon the date of construction but may include the cladding, windows, door and fire escape. The house, as part of the wing on Earl Street, helps establish the street line in this block and mirrors the massing of the house at the other end of the block (No. 324 Earl).

The date of construction and first occupant could not be determined, but the structure does not appear on fire insurance maps of the 1890s, nor is it listed in Kingston Directories of the period, thus it was probably built in the early to mid-twentieth century.

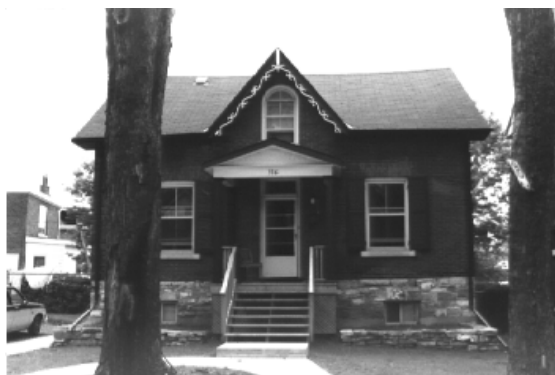
316 EARL ST.

316 Earl Street is a 1 1/2 storey brick cottage with a side gable roof and a typical Ontario Cottage style central dormer rising from the eaves line. The 3 bay facade has single windows flanking a transomed entrance protected by a low pitched gable roof which is supported by square posts linked to a simple balustrade. In the dormer above the entrance, a single round-arched window is framed by bargeboard cut in a tracery pattern. The west side of the house has two windows on each floor. No interior features were noted.

Alterations include the moving of the house from its former site at #162 University Avenue (due to the construction of the Stauffer library). The house has been raised on a new foundation. Other changes include modifications to the front porch and removal of a sun porch from the south side.

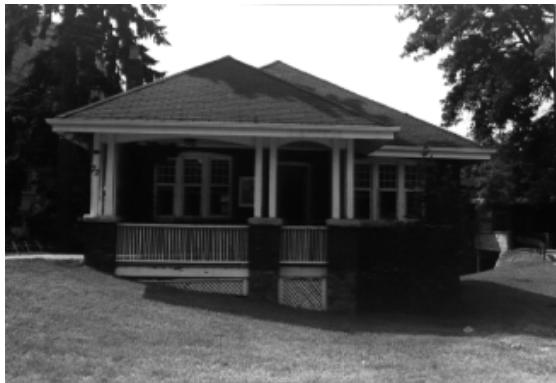
72 QUEEN'S CRES. - REID HOUSE

The three-bay brick bungalow has a central entrance and a porch across the left two bays. The porch is carried by doubled and tripled square posts on brick piers. The roof is hipped with an additional hip over the porch.

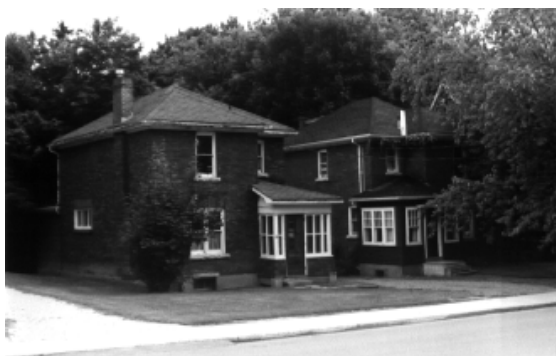
82 QUEEN'S CRES. - ALEXANDER HOUSE

This is a modest two-storey four-square brick house with a notched front entry and enclosed verandah. Note the stone sills.

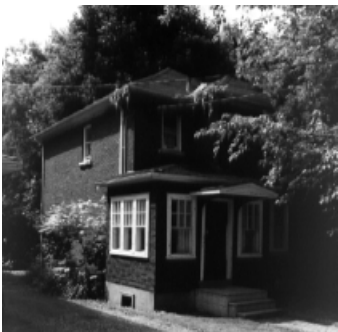
86 QUEEN'S CRES. - SMITH HOUSE

The building mirrors the house at 82 Queen's Cres. as a four-square with a notched front entry. The enclosed porch has a shallow gabled hood cantilevered on decorative ironwork brackets.

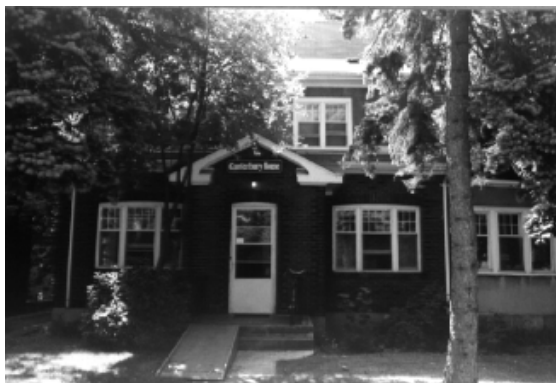
90 QUEEN'S CRES. - CANTERBURY HOUSE

This is a two bay four-square brick house with two storeys and an entry porch in the left bay. The porch has an arched fascia and is supported by triple Tuscan columns on brick piers. The hipped roof has a central dormer with arched fascia. There are bay windows in the west side. The windows have stone sills and flat arches.

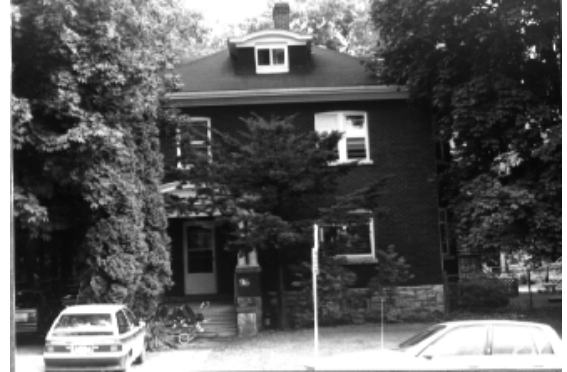
104 QUEEN'S CRES. - MACDONNELL HOUSE

This one-and-a-half storey brick house has French Colonial influences. The side-gabled house has a steep roof flaring over a full width verandah. There is a central hipped dormer and parged gables. Buildings at 104-127 Queen's Cres. are part of a similar cottage-style grouping.

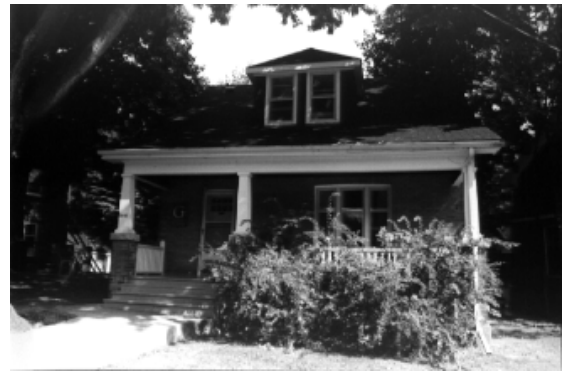
119 QUEEN'S CRES.

Evaluation: Good

This is a three-bay, one-and-a-half storey brick house with a side-gabled roof. The right bay is recessed with a terraced plate window and a reverse dormer. The central bay has a curved brick entry porch with a curved roof arched entry. The left bay has a steep gable and a roofed pavilion over a plate window. The building has a Tudor cottage style.

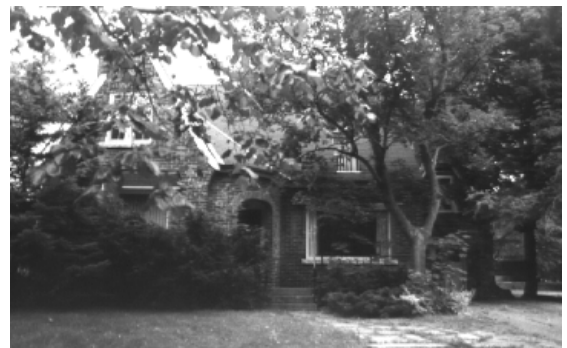
123 QUEEN'S CRES.

Evaluation: Fair/Poor

This one-and-a-half storey building has a gambrel roof and side gables. It is clad in stucco except for weatherboard on the three-bay dormer across the front of the roof. The right bay has a flat-roofed projecting block and it has an entrance with a classical revival surround. There is a flat-roofed square bay window on the left side.

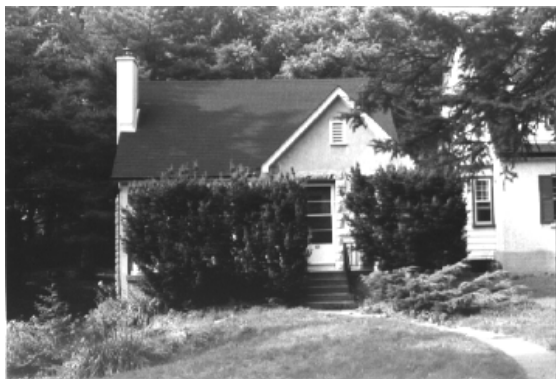
127 QUEEN'S CRES.

The one-and-a-half storey building is clad in brick, stucco, clapboards and cedar shingles. It has a full-width enclosed porch with a simple Classical entry on the left and a continuous bank of windows on the front and sides. It also has a full-width shed dormer rising from the roofline, front and rear. The area under the gables is stuccoed, as is the enclosed porch. There is a braced chimney on the right.

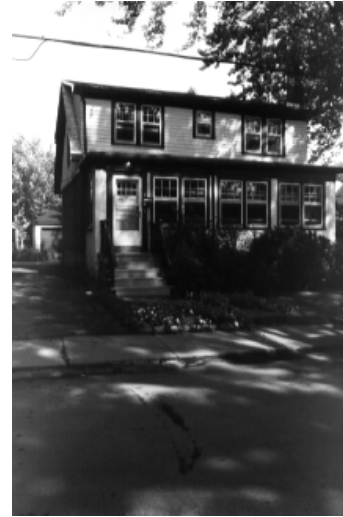
11 St. Lawrence Ave. - Kay House

This one-and-a-half storey brick house has steep side gables clad with shingles. The large framed and enclosed entrance porch has a hipped roof and sits below a large gabled roof dormer in the centre of the building.

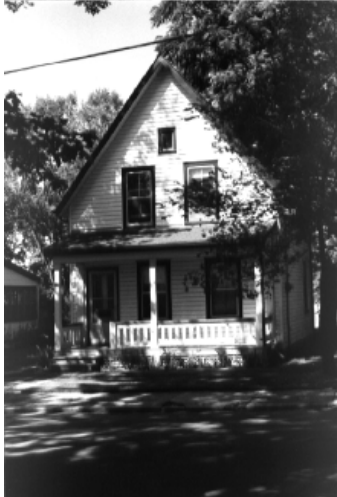
16 St. Lawrence Ave. - ALLEN HOUSE

16 St. Lawrence Avenue is a 1 1/2 storey frame building with an end gable roof. The 3 bay facade has a side hall plan and a full width, shed-roofed porch extends across the facade. The entrance is in the first bay, with windows in each of the other bays. Above this, two windows are centred in the end gable on the second storey and there is a small window below the roof peak. The gable roof of the ell is very steep and there is a small dormer in the south roof plane. A kitchen extension is located to the rear of the first bay. No interior features were noted.

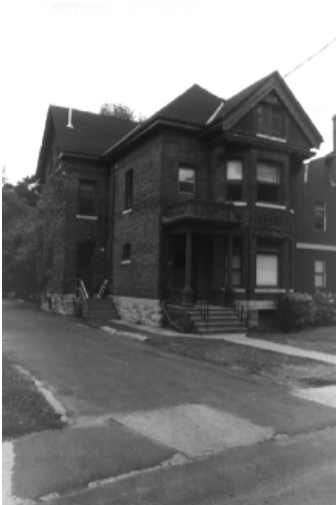
154 STUART ST. - KING HOUSE

Alterations include an addition to the west which connects #154 to #160 Stuart Street. A frame porch on the rear has been removed and a door and window opening closed. The landscape is reduced to lawn, foundation plantings and climbing vines. The building is part of a row of important, formerly residential buildings.

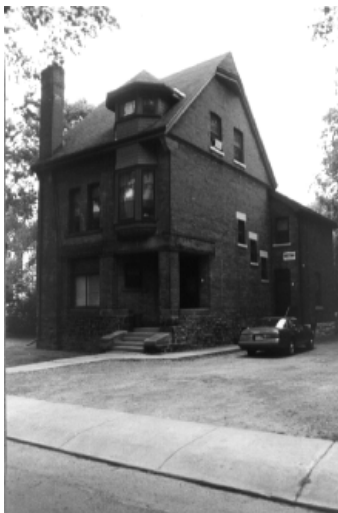
174 STUART ST. - GILL HOUSE

174 Stuart Street is a 2 1/2 storey brick and sandstone detached house on a limestone and granite foundation. It has a side gable roof with the western gable end having a stylized jerkinhead roof at the peak. The 2 bay facade has the unusual feature of an entrance in the second bay recessed within a chamfered corner which is supported by a brick column and a sandstone beam. Above this is an oriel window which pierces the eaves and forms a polygonal dormer with a conical, hipped roof. The first bay has a single window on the first floor, divided by a central muntin, with a single transom. Above this is a pair of transomed windows with a common sill. An angled chimney breast forms the corner of the building in this bay. A 2 storey bay window extends from the east elevation and has a hipped gable roof and chimney breast forming the centre of the bay. The west side has three stepped windows lighting the interior stairwell, with wide stone lintels and narrow sills. To the rear is an offset kitchen extension, the facade of which has a secondary entrance. Details include terra cotta and sandstone ornamentation, leaded glass, and round brick in the shallow arched openings. No interior features were noted.

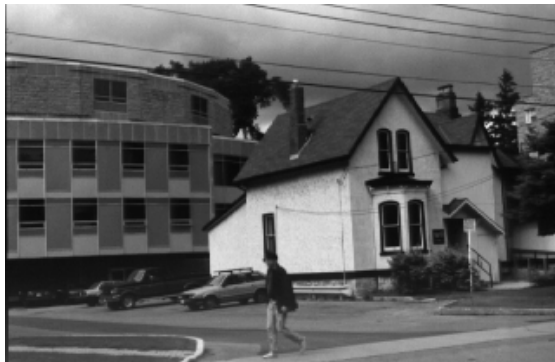
187 STUART ST. - COFFEY HOUSE

Alterations include a very awkward concrete and metal replacement of the original front porch which extends out from and obscures part of the facade and encloses the main entrance with a shallow hood. The former door on the second storey of the third bay still exists but no longer has access to a walkout.

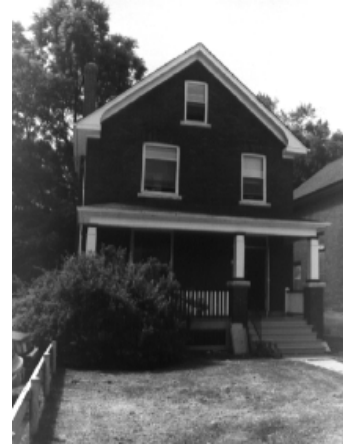
196 STUART ST. - SHORTALL HOUSE

This is a two-and-a-half storey front-gabled brick house which mirrors its neighbour at 194 Stuart St. Note the left side entrance and the single-arched window in the front gable.

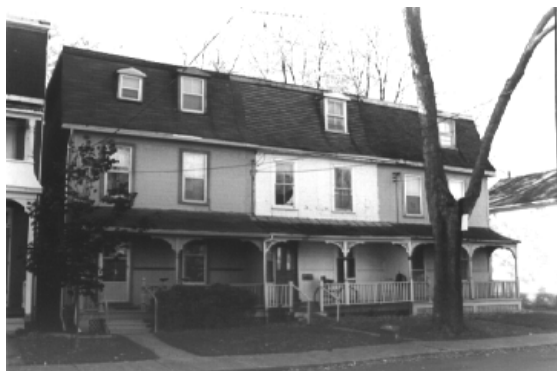
214-218 STUART ST. - MADDEN/HOWLAND/DUFFY BUILDING

Alterations include aluminum storms on #214 and #218 and concrete steps on #216. The landscape consists of mature and replacement street trees, lawn, foundation plantings and perennial beds. The houses form a good composition with the tower house on the corner (#212).

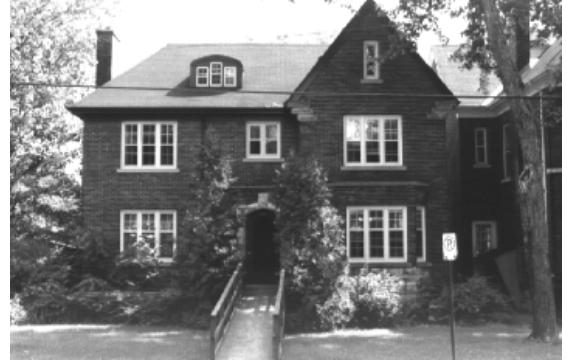
186 UNION ST

Evaluation: Good

This is a two-and-a-half storey, red brick Victorian house has an entrance in the right bay that has a neo-Georgian surround. The left bay is slightly projected with two storey bay windows and is topped with a gabled pavilion that projects slightly over the bay. There are decorative shingles in the gabled pavilion. A flat-roofed garage has been added.

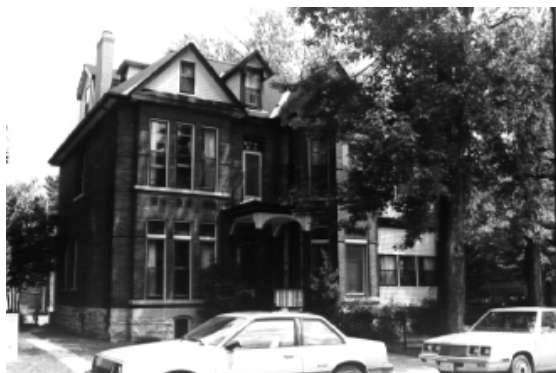
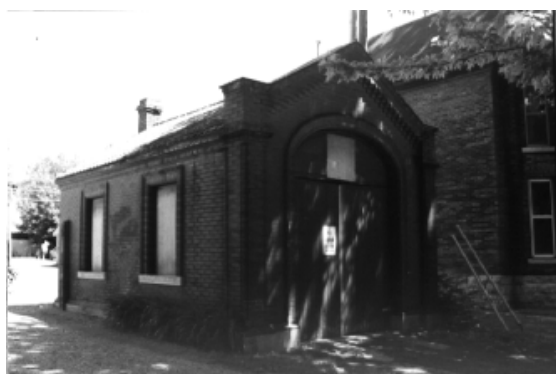
169 UNIVERSITY AVE. (105 CLERGY ST. W.) - YOUNG HOUSE

169 University Avenue is a 2 1/2 storey brick and wood frame composite house with a crossing gable roof on the main block. The University Avenue facade is brick and has 3 bays, with a centre entry supported by square columns over which is a flat roofed porch with a walkout above and a transomed window surmounted with a small gabled dormer. The first bay has a slightly protruding pavilion with three transomed windows on each floor and a dormered gable above. The third bay is a two storey bay window topped with a dormered gable supported by a dentilled cornice. Details include decorative terra cotta inserts between floors, leaded glass window transoms, and gable ends which feature shingles, spindles and bargeboards respectively.

The Clergy Street facade has 3 bays, two of which are wood frame additions. The third bay is a brick projecting bay, similar to the one on the University Avenue facade, with a gabled dormer framing an arched window. The other bays are 2 1/2 storeys high frame with three large windows per storey, infilling the corner of the building. There are pilasters dividing the bays and there is an entrance parallel to the street on the first storey of the second bay, with a gabled hood. A one storey, shed roof extension tops the second bay, flanked by a balcony in the first bay. Details include terra cotta inserts between floors and decorative bargeboard, all in the third bay. No interior features were noted.

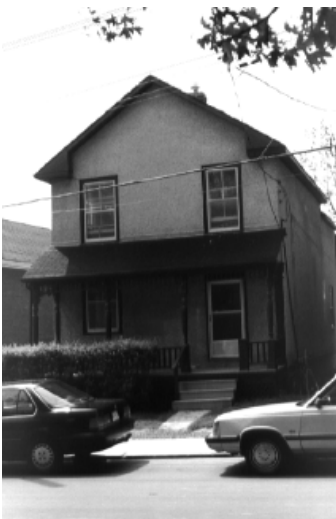
176 UNIVERSITY AVE. - BELL HOUSE

176 University Avenue is a 2 storey (probably) wood frame house with an end gable roof. The 2 bay facade has an entrance in bay 2 with a transom above, flanked by a window in bay 1. There are windows in the second storey in each bay. A full width, shed-roofed porch covers the first storey facade. Details include turned columns, brackets and spindlework on the porch. There are pairs of windows in each floor on the south facade and a 2 storey kitchen addition to the rear, with a shed added to this. No interior features were noted.

Alterations include aluminum storm windows, stucco cladding, changes to the soffits, and balusters replaced on the porch. The landscape includes lawn and a hedge across the edge of the porch. The house anchors the southern end of a significant heritage grouping and establishes the residential character and setback of the area immediately north of the Stauffer Library and the John Deutch Student Centre.

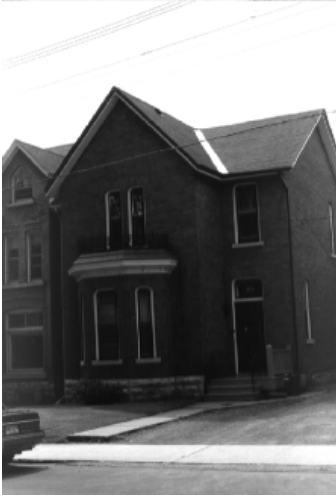
186 UNIVERSITY AVE. - BARBER HOUSE

Alterations include aluminum storm windows, and the removal of the original porch and bargeboards. Surface paint has been removed from the brick walls with abrasives. The landscape consists of lawn and one foundation planting.

Reinstatement of the bargeboarding and replacement of the porch (to match the same renovations to #186) would improve this property.

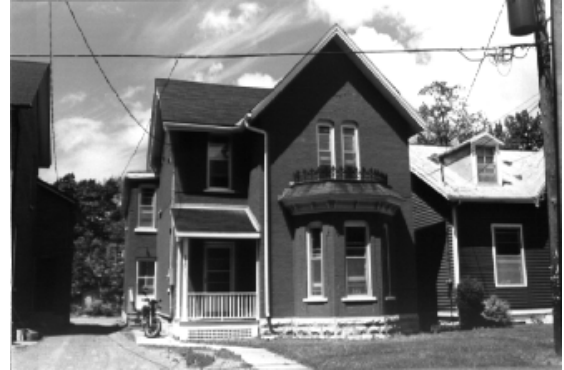
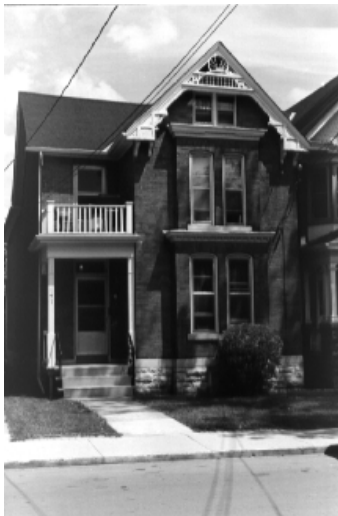
191 UNIVERSITY AVE. - GAW HOUSE

Alterations include aluminum storm windows, a basement window in the second bay filled in with a vent, and the possible replacement of the original porch. Landscape features include one foundation planting and lawn. The house is part of an important heritage grouping.

The asymmetrical composition, the projecting pavilion in the main bay, with its paired round-arched windows and bracketed cornice, the bargeboard and spindlework in the main gable, the rusticated base and stone sills are essential to the building's character.

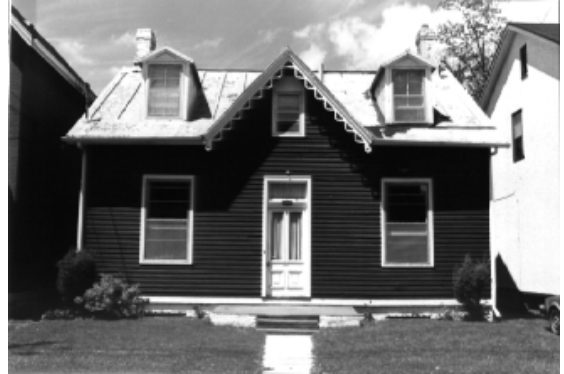
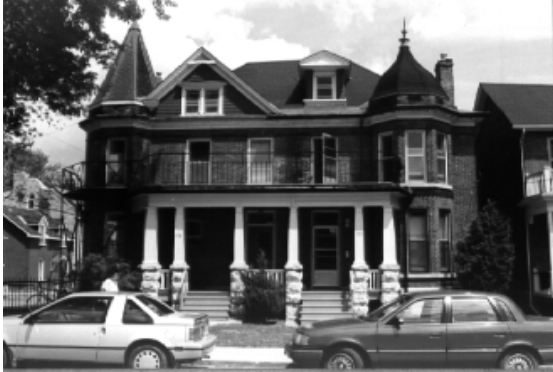
193-195 UNIVERSITY AVE. - DONNELLY HOUSE

Bay 2 of the main facade has small stained glass window high in the first storey with a standard window above and a paired window in the end gable which links bays 1 and 3. Bay 4 has a gabled dormer in the roof above and bay 5 has an angled bay which rises to a tower with three windows per storey, with common sills. This tower is set in from the corner and is capped with a bell-shaped roof and a pinnacle. The rear additions to this building are inventoried under #310 Earl Street. Details include decorative brick panels just below the roofline and windows on both towers, dentilled cornices, stone sills, pellet moulding in the wall gable and decorative side wall shingles and a sunburst design in the pediment of the roof dormer. No interior features were noted.

Alterations include aluminum storm windows and the exterior fire escape. Landscape features include mature street trees, lawn and foundation plantings. The house establishes the street setback for this block and anchors the street corner.

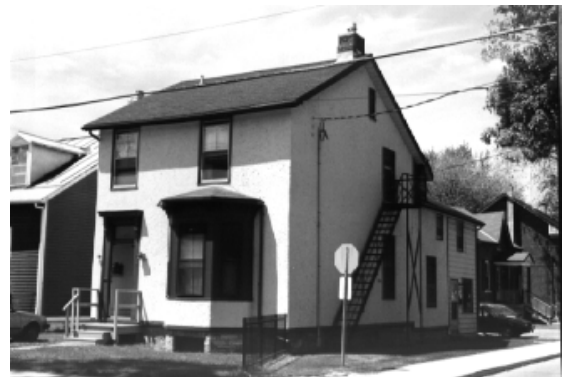
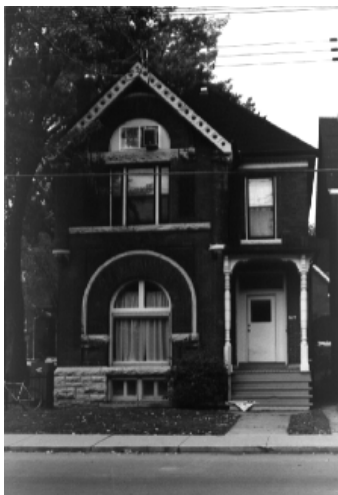
196 UNIVERSITY AVE. - JENKINS HOUSE

Details include limestone string courses separating the first and second storeys, heavy stone sills, decorative brick and stone arches around the first floor windows, terra cotta panels flanking the second storey window in bay 1, decorative barge board in the gable end, cylindrical brick and stone buttresses on the edges of the second storey, and stone brackets on the chimney breast. No interior features were noted.

Alterations include aluminum storm windows, infilling of the gable end window, and replacement windows on rear fire exits. Landscape features include mature street trees, lawn and foundation plantings. The house anchors the street corner and establishes the street setback for this block.

The late Victorian Romanesque style, asymmetrical composition, the transomed entrance with porch and turned columns, the rusticated stone base and rusticated sills, the round-arched main
