Queen's University
Heritage Study

APPENDIX A:
RESIDENTIAL BUILDINGS NOT
OWNED BY QUEEN'S UNIVERSITY

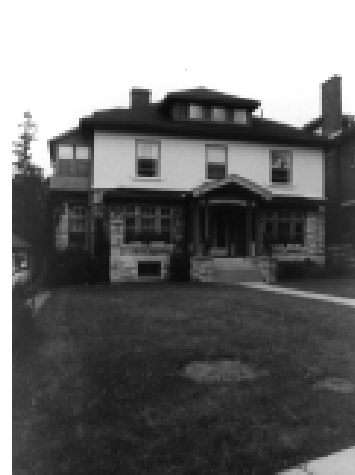
138 ALBERT ST. - SKELTON HOUSE

138 Albert is a 2 1/2 storey stone and, possibly, frame house with stone cladding on the first floor and stucco above. The house has a hip gabled roof with a gabled dormer. A two storey bay projects slightly from the south side and is clad in shingles above the stone first floor. No interior features were noted.

The house has a centre entry, foursquare plan, a well proportioned example of its type. Square bays with triple windows flank a slightly recessed double entrance with a fanlight. A gabled entrance porch shows Craftsman influences in simple square paired columns and a concrete stoop flanked by low stone walls. Later alterations include aluminum storm windows on the upper storeys.

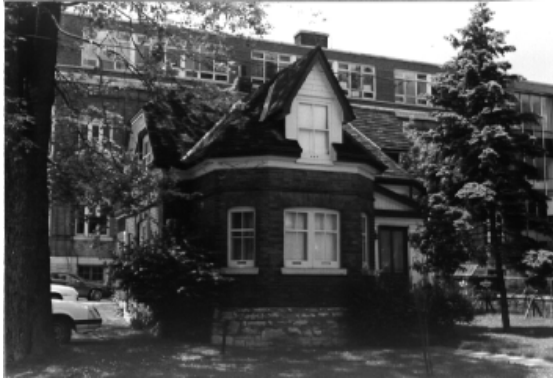
136 ALFRED ST. - MURRAY - CRUSE HOUSE

136 Alfred Street is a 1 1/2 storey brick cottage with an unusual building form similar to a gatehouse. A jerkinhead roof on the south end and five sided hip gabled roof on the north end atop a wall width polygonal bay. Projecting from the roof above this bay is a steeply gabled dormer. A wing projects towards the street. The main entrance is located in the intersection of the wing and main block and is enclosed by a shed roofed porch. The entrance door is flanked by pilasters in the gable end. The north elevation matches the pavilion on the street face. The windows are undersized but otherwise the house proportions are good. No interior features were noted.

The house has been well maintained and appears to retain most of its original features. It is the only house on this side of the street and is a landmark in this area.

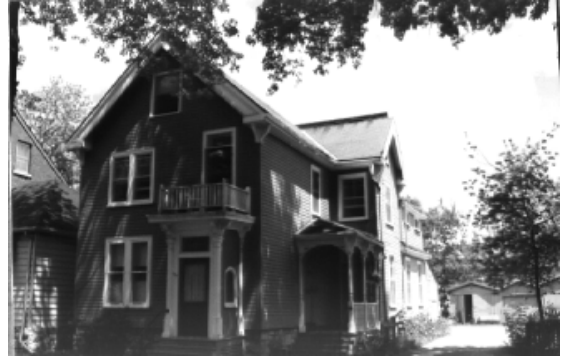
157 ALFRED ST. - MILLER HOUSE

157 Alfred Street is a 2 1/2 storey wood frame house with a gable end facade. There are two facade bays, the right hand bay containing an enclosed entrance vestibule, ornately bracketed, with a walkout balcony on the flat roof. A gable ell to the rear has a narrow porch with turned columns and brackets matching those on the front entrance. Further ornamental details include bargeboards on the gable ends and a leaded glass transom over the main entrance door. No interior features were noted.

Alterations have been made over the years, mostly in the form of extensive rear additions. Otherwise, the original millwork, siding, trim and storm windows remain. New shed dormers have been raised on rear roof planes.

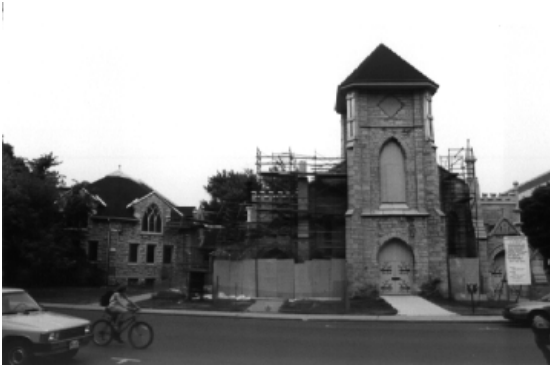
91 ARCH ST - ST JAMES ANGLICAN CHURCH

St. James' Church consists of three linked buildings: the main sanctuary, the parish hall, and the chapel. All are constructed of Kingston limestone. The main sanctuary is approximately three storeys high with a much higher tower (now capped). The main entrance on Union Street is centred in the tower base, flanked by two bays separated by full height buttresses. The main entrance contains a pair of wooden doors within a Gothic-arched opening, with a Gothic-arched window above. The flanking bays are narrow and contain Gothic-arched windows. The gabled roof slopes down on either side of the tower and become flat roofed in the two outer bays. These bays contain gabled secondary entries with Gothic-arched double doors flanked on the outside corners by small buttresses. The roofs of these one storey outer bays are crenallated. Flanking and rear walls continue the pattern of bays flanked by full height buttresses. Details include ornate metal hinges and fittings on the wooden doors, Gothic tracery in the main windows, stained glass, and decorative carving in the door surrounds, buttresses and cornices.

The sanctuary is connected to the parish hall by a small side gable passageway, with eaves and a window flanking a secondary entrance. The chapel is a polygonal structure with a hipped roof containing wall dormers in each bay, containing Gothic-arched windows with Gothic tracery. A skylight is situated at the apex of the roof.

The buildings have been progressively renovated over time, sympathetically so in each case. Major renovations currently underway (a complete replacement of the roof and tower) appear to be a restoration of the original fabric and do not detract from the heritage character.

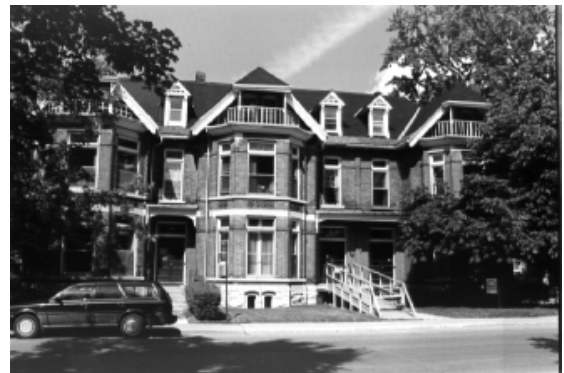
20-24 BARRIE ST. - ROBERT CRAWFORD BUILDING

20-24 Barrie Street is a three unit row of 2 1/2 storey red brick townhouses. The building is characterized by two storey bay windows with small open porches under an unusual jerkinhead gable roof in each unit. Next to these bays are double entry doors with transoms sheltered by flat roofed porches. Each unit has a single gable roof dormer above the front entry bay. Ornamentation includes terra-cotta medallions, limestone banding above the windows and stained glass transoms in the bay windows. No interior features were noted.

The building is in good condition. Alterations include an accessibility ramp that intrudes into the front garden of #22.

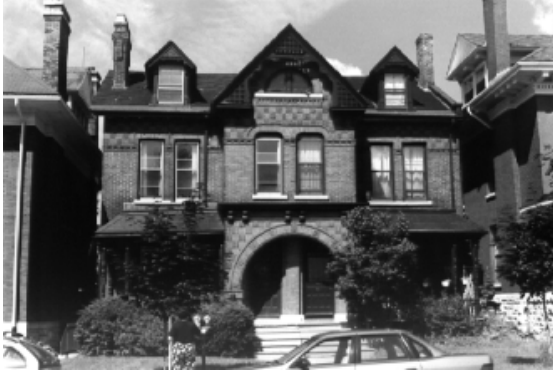
34-36 BARRIE ST. - STRANGE HOUSE

34-36 Barrie Street is a 2 1/2 storey brick semi-detached house with strongly symmetrical massing on the street facade. A central gabled pavilion is flanked by one storey porches. Within the pavilion, two entry doors are recessed behind a heavy Romanesque arch. The gable at the top of the central pavilion contains a semi-circular window. This gable is flanked by gabled roof dormers. The decorative building details include lattice work in the central gable, a variety of decorative brickwork, and wood trim and panels on the window surrounds and doors. Aside from the replacement of the left bay window with thermopane, aluminum storms on most windows and missing porch railings, the house retains its original character. No interior features were noted.

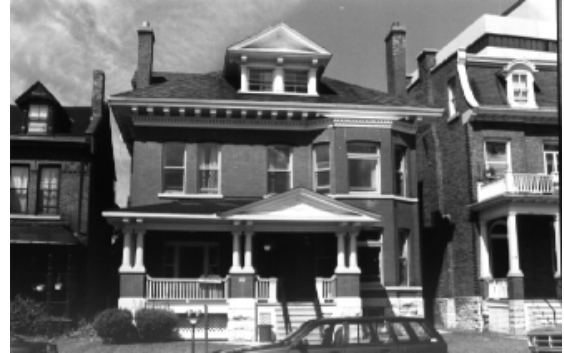
62 BARRIE ST. - CHOWN HOUSE

62 Barrie Street is a 2 1/2 storey brick house composed of balanced but asymmetrical details. A two-storey bay window to the right of the main entrance is balanced by the extension of the gabled entry porch to the left. There is some classical revival detailing in the cornice (dentils and medallions) and paired or tripled Ionic columns supporting the porch roof. In the hip roof are two pedimented dormers on the south and east elevations, each containing two pairs of casement windows. No interior features were noted.

The building retains most of its original details, aside from modern windows in some openings. The building maintains the consistent setback of other houses on the street.

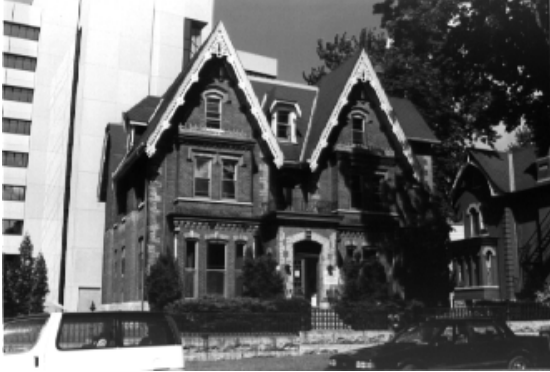
72 BARRIE ST. - WALKEM HOUSE

72 Barrie Street is a 2 1/2 storey brick structure with a three bay facade and a hipped roof. The facade is made up of a pair of steeply pitched full height gabled pavilions flanking an entrance vestibule. The steeply pitched roof is punctuated by wall and roof dormers. The central entry has a brick vestibule with a balcony above. The entry doors and walkout doors are double, the former with a transom above. In the pavilions, the window bays have iron cresting on their flat roofs. Other details include ornamental bargeboards on the gables, polychromatic brickwork and decorative ironwork on the railings and eavestroughs. No interior features were noted.

Major alterations include the removal of a full width porch from the south side and an addition to the north which detracts from the compositional symmetry.

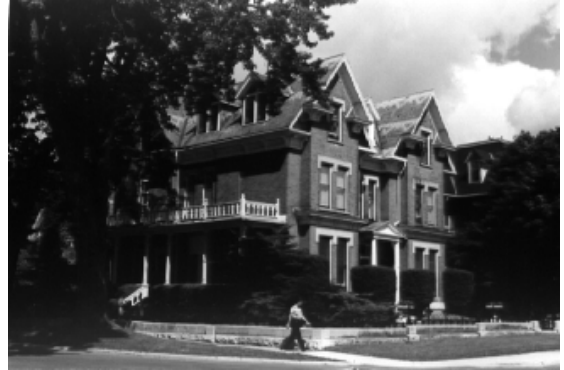
80 BARRIE ST. - WALDRON HOUSE

80 Barrie Street is a large 2 1/2 storey brick house with a hip roof and projecting full height gables and an substantial service wing extends to the rear. These projecting gables flank the main entrance on Barrie Street and contain smaller gabled pavilions within them. The original polychromatic slate roof contains wall and roof dormers on all four sides. A full width balconied porch spans the south elevation with a walkout from the left bay. No interior features were noted.

Later alterations include a Neo-Georgian front entry porch and front door and a new door on the south side.

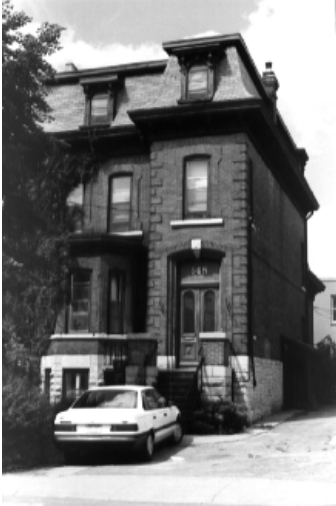
148 BARRIE ST. - THE ROGERS HOUSE

148 Barrie Street is a 2 1/2 storey red brick house upon a raised foundation of rusticated limestone. The facade has two bays with an entry in the right side within a projecting 2 1/2 storey pavilion. The double entry doors have a transom above. The main block and the projecting pavilion both have a mansard roof. Windows are located in both bays of the mansard roof and there is a projecting bay window in the first floor bay of the main block. A 2 storey kitchen wing extends to the rear. Details include ornate brackets in the cornice line. No interior features were noted.

Alterations include aluminum storm windows; otherwise the original millwork, trim and doors appear to be intact.

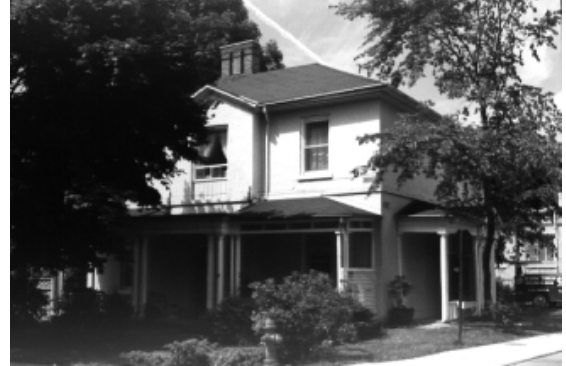
152-156 BARRIE ST. - ANGLICAN RECTORY

152-156 Barrie Street is a 2 storey brick detached house, designed in the Regency style. It has a three bay facade composed of a slightly projecting central pavilion terminating in a gable end. The hipped roof has a three flue chimney projecting above the first bay. Across the facade, a full width gabled porch rests on a concrete base and is supported by Tuscan columns. The central portion of the porch roof is flat, relating to a former balcony. A smaller porch covers a side entrance on the north elevation. Other details include ornamental trim and original window frames. No interior features were noted.

Alterations include removal of the former balcony, replacement of the walkout door in the second storey central pavilion with a plate glass window, removal of the northern three flue chimney, and replacement of the original windows with new units. The porch appears to be a later nineteenth century addition.

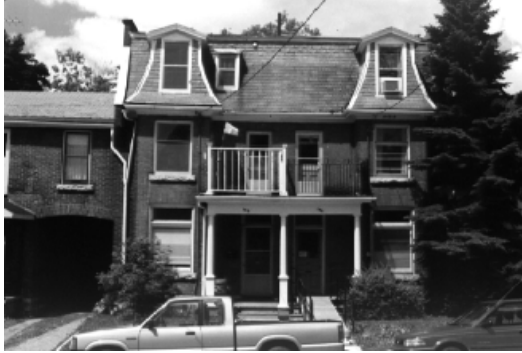
184-186 BARRIE ST. - LOYNES/DE L'ARMITAGE HOUSE

184-186 Barrie is a 2 1/2 storey, semi-detached brick house. Its facade is composed of four bays, the outermost bays projecting slightly and being topped by mansard shaped dormers with low gabled roofs. The central entrances are enclosed by a porch with a flat roof above onto which open doors from the second storey. A two storey addition extends to the rear. Details include turned columns on pedestals supporting the porch. No interior features were noted.

Alterations include aluminum windows, mismatched railings on the porch balcony, and a dormer window added to #184. The building is not in good repair.

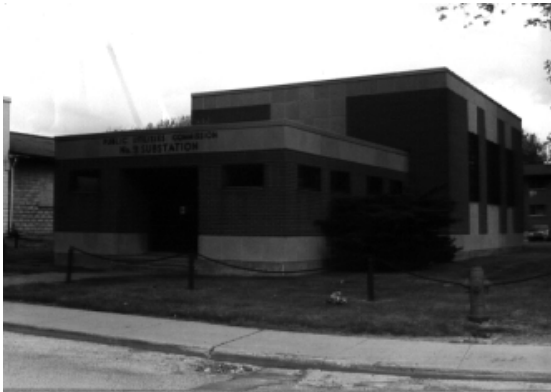
KINGSTON PUBLIC UTILITIES COMMISSION NO. 9 SUBSTATION

Substation Number 9 is a 2 storey square industrial building clad in brick and limestone, with a flat roof. This Modern building is windowless except for one-and-one-half storey high windows on the Division Street elevation. A single storey wing projects from the Clergy Street elevation. This wing contains a recessed entrance and has slit windows high on its walls, within the brick cladding. Windows are single pane glass with metal frames. Limestone panels form a continuous band at the base and cornice of both the two and one storey blocks, and form large vertical bands on the centre third of the Clergy Street elevation and containing the windows on the Division Street elevation. Details include metal lettering over the main entrance and metal flashing along the tops of the walls. No interior features were noted.

The building is unaltered except for the addition of steel grilles on the large windows.

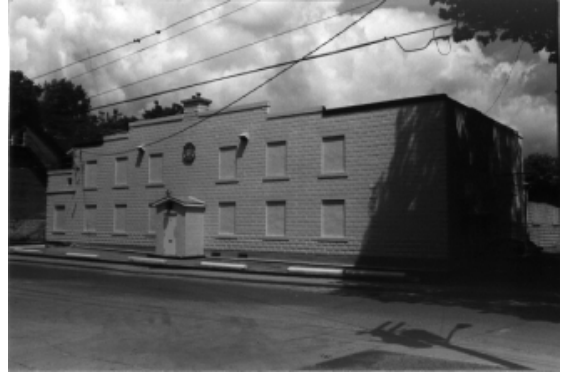
75 CLERGY STREET W. - KINGSTON CURLING CLUB

The two-storey, stepped parapet flat-roofed building is built of cinder blocks.

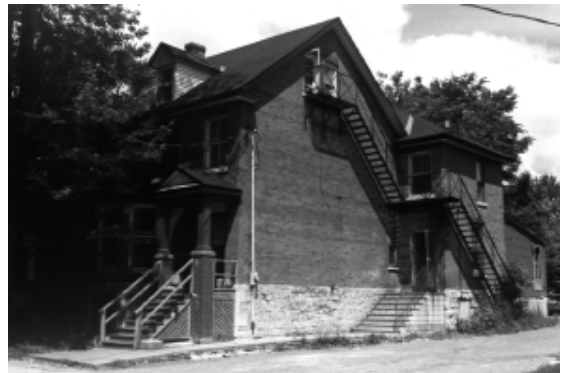
81 CLERGY ST. W. - DOWNING HOUSE

This two-and-a-half storey brick building has side gables, a dormer window, a bay window on the left side, and a porch on the right side (which is an addition).

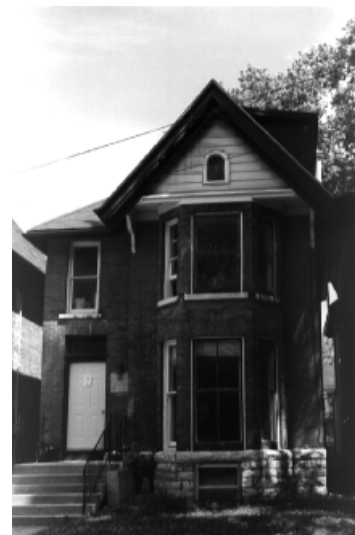
93 CLERGY ST. W. - GALLOWAY HOUSE

This is a two-and-a-half storey hipped roof brick building with a slightly projecting gabled pavilion. There is a small roundhead window in the gable, surrounded by aluminum siding and two-tiered bargeboards. The gable sits atop the pavilion and is supported by ornamental brackets.

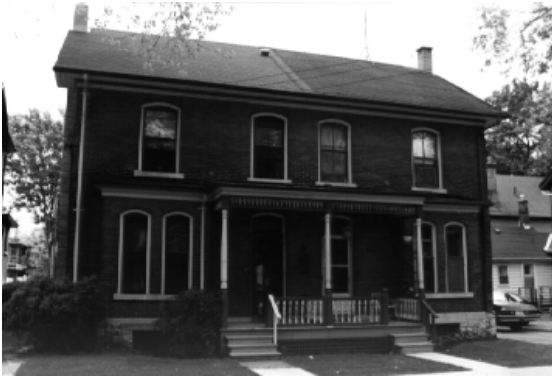
318-320 EARL ST -SMALLBRIDGE/CUNNINGHAM BUILDING

This is a two-storey side-gabled semi-detached brick structure with four bays. The middle bay entrances share a porch which has a shed roof and turned columns. Note the spindlework in the porch and also note the arched-top windows on both floors. There are bay windows in bays one and four.

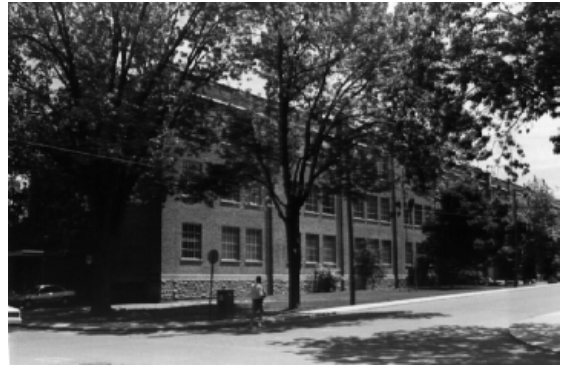
KCVI - KINGSTON COLLEGIATE & VOCATIONAL INSTITUTE

Kingston Collegiate and Vocational Institute is a much altered 3 storey brick high school. Stylistically it has elements of Collegiate Gothic. The main entrance is in the central bay of the 12 bay Frontenac Street facade, with an auxiliary entrance in the 11th bay. It is slightly recessed into a limestone surround. The building elevations are multi-bayed, with each bay defined by full height stone and brick pilasters. Each bay has three large multi-paned steel framed windows per floor. Details include four oak doors in the main entrance, with glazing under a multi-light transom containing Gothic tracery, and Gothic arch details in limestone along the parapets on each elevation. The building interior has a noteworthy central staircase.
