Queen's University  
Heritage Study

# TABLE OF CONTENTS

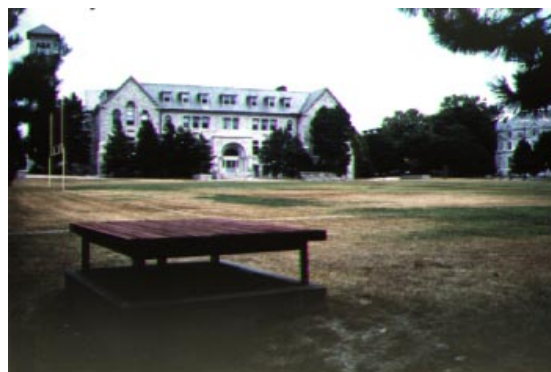
Kingston Field is a major campus open space and recreation ground stretching south in front of Kingston Hall and Theological Hall. It is bounded by these buildings to the north and by University Avenue to the west, Stuart Street to the south and Summerhill Park to the east. The main spatial groupings are a playing field to the west in front of Kingston Hall and tennis courts to the east in front of Theological Hall. The playing fields are located on top of a large underground parking garage. Access is by means of hard surface paths across the north edge, joining the access drive around Theological Hall, and by a north-south path between the field and the tennis courts. Access from the west is blocked by a chainlink fence. The landscape is characterized by the playing surfaces bordered by buildings to the north and by dense plantings of coniferous and deciduous trees and shrubs on the

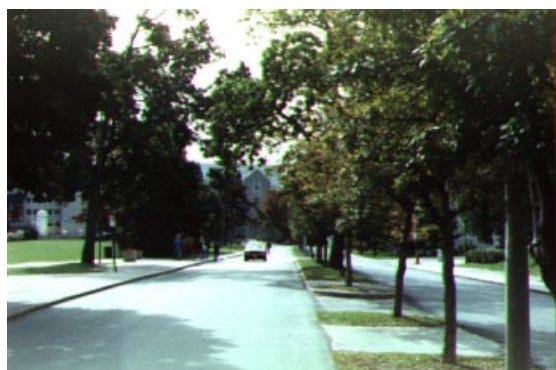
The southern part of University Avenue is a broad, boulevarded street sloping southwards from Union Street to Stuart Street and flanked with institutional buildings of fairly uniform height and setback. Queen's Crescent is the only street to intersect with University Avenue; otherwise, only the east-west pedestrian paths cross the street. There are two main landscape spatial groupings: the boulevarded street itself, and the open spaces which flank buildings on either side. The main boulevarded space is defined in the northern half by a mostly consistent building setback and height, but this consistency dissipates at the Agnes Etherington Art Centre, which reasserts the former residential setting and Kingston Field across the street removes the enclosure by buildings. The street terminates inconclusively at the angled intersection with Stuart Street and the vista to the south is only partially closed by McLaughlin Hall.

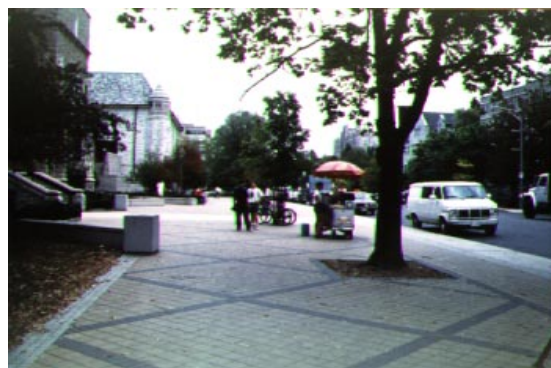
Union Street as it passes through the University campus is an approximately 1.5 km. long arterial street. It is the primary east-west vehicular corridor through the University and provides a significant image of the campus within the city. It is also a street undergoing change. As the University develops new building sites such as the Stauffer Library and upgrades its streetscapes, the overall character of the street is becoming more “urban” than it was previously.

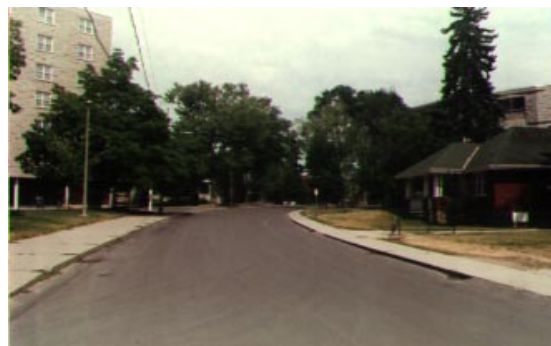
Vegetation is variable, with some mature street trees and a large amount of random tree and shrub planting. Problem areas include the combined pedestrian/vehicular access to the Agnes Etherington Art Centre and Harrison-LeCaine Hall. These spaces serve neither vehicles nor pedestrians well, with mixed and patched pavement and large granite boulders used as bollards, none of which integrate with the adjacent buildings. An opportunity exists to commemorate the former alignment of Lower Alfred Street; similarly, remnants of the original residential landscape, such as the elm next to Stirling Hall and the mature maples next to 51 Queen's Crescent, should be structuring elements for a renewal of the streetscape. The western intersection should also be improved while recognizing the curve of the Crescent.

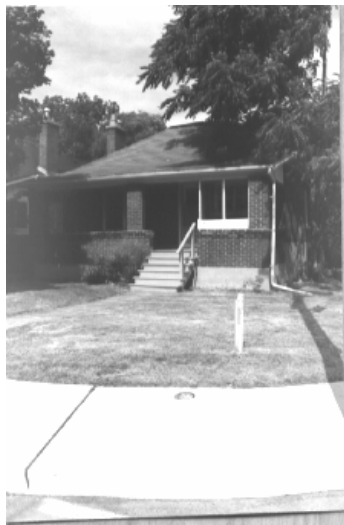
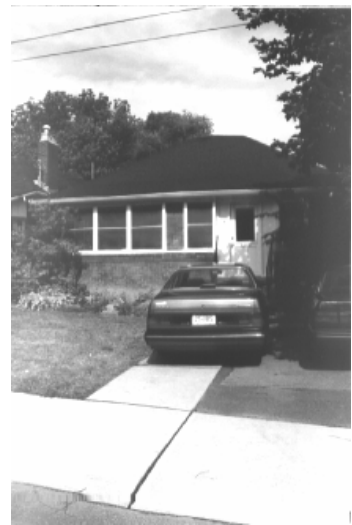
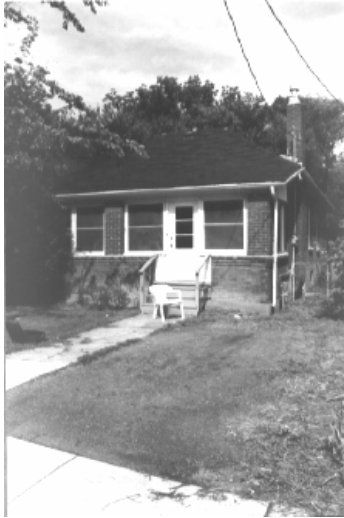
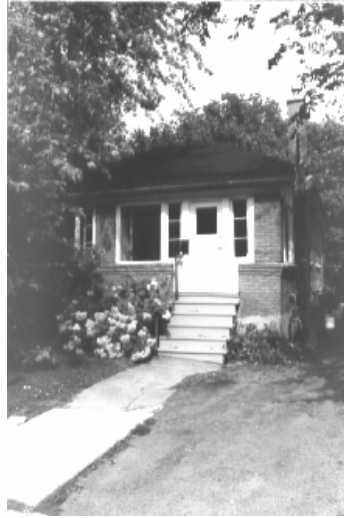
15 and 17 Albert are two of a series of four one-storey brick bungalows. Each has a full width front porch under the front plane of the hipped roof. The porch on 15 is open while on 17 it has been enclosed with screens. The buildings feature shallow arched openings and stone sills.

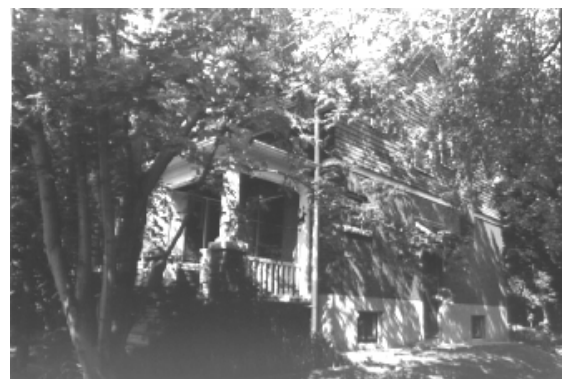
23 Albert Street is a 1 1/2 storey brick clad early twentieth century house with a full width enclosed porch and a hip gabled roof and dormers. It exhibits Arts and Crafts influences such as battered columns on brick piers and shallow arched openings with stone sills. The shingled side walls of the gable roof flair just below a raised plate to meet the brick clad first storey. The full width front

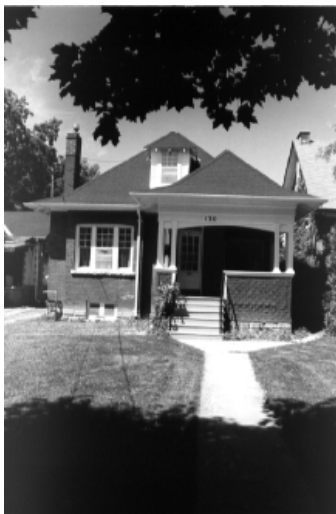
### **130 ALBERT ST. - THE TIROL HOUSE**

130 Albert is a one-and-a-half storey brick-clad bungalow with a flared hip roof and a small hipped roof dormer. From the right side of the front facade projects a porch with a similarly styled roof. In a much simplified way, Arts and Crafts elements emerge on this building, with square columns, shallow arched openings and exposed rafter tips. The porch has a solid balustrade clad in tin with a scalloped shingle pattern.

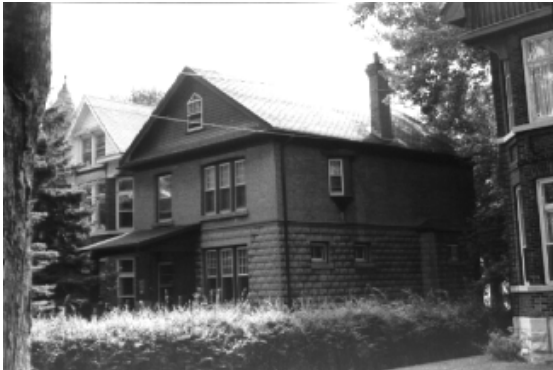
**148 ALBERT ST. - COGWELL HOUSE**

This is a two-and-a-half storey detached brown brick house which has some character. Originally a residence, it is now the Enrichment Studies and Elder Hostel Canada offices.

It successfully uses artificial stone with a thin concrete moulded cornice to delineate the first storey from the upper floors. The street side gable end is shingled with a flaring roof. A shed-roofed entry porch on the left side of the front facade follows the block-brick-wood progression of materials on the main house. The building's original owner was E. A. Cogwell.

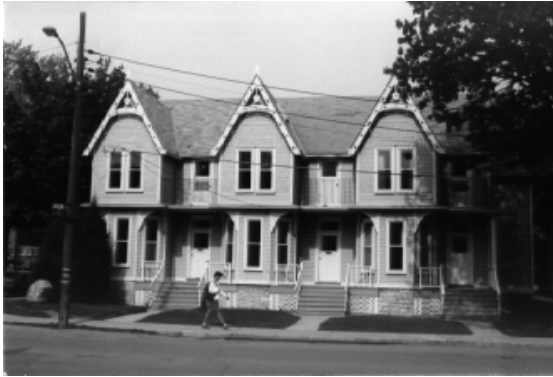
### **135-139 ALFRED ST**

135-139 Alfred Street were restored in the past fifteen years and, in 1992, were moved from their original site at the corner of Union and Alfred Streets. The houses are 2 1/2 storeys in height wood frame, with 6 bays, each alternating bay having steeply peaked gabled dormers atop 3-sided bay windows on the left side of each unit. The facades have good wooden detailing in the bargeboards, wall shingling and brackets over the window bays. No interior features were noted.

The building renovations following the move included new porches which copy those formerly existing, but the iron railings on the flat overhangs above the door suggest that there was once a more ornate two-storey porch on the buildings. The houses have been raised onto a new foundation which has been faced in salvaged local limestone. Other recent additions include aluminum storm windows, skylights, rear additions, as well as entrance steps and the foundation.

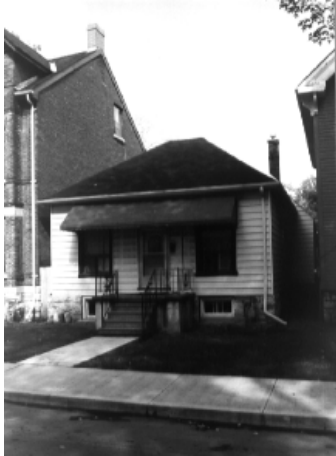
### **159 ALFRED ST. - SMALLBRIDGE HOUSE**

This is a small one-storey bungalow with a hipped roof. The limestone foundation, Victorian entry door and offset kitchen addition to the rear suggest, however, that this is the truncated incarnation of a much larger and better designed building. Now a heavy aluminum awning stretches the width of the three bays and a precast concrete step and stoop unit gives access to the front door. George Smallbridge is described in the Kingston Directory as residing in the house in 1889.

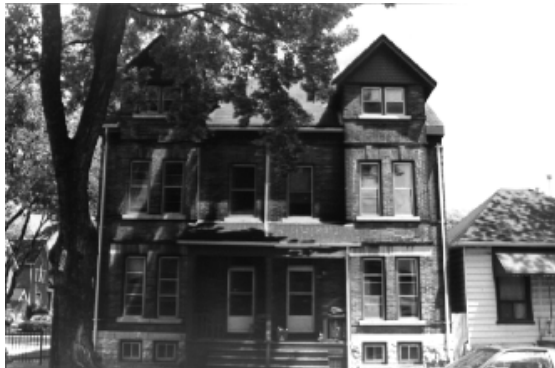
### **161-163 ALFRED ST. - WILSON / ANGLIN HOUSE**

The symmetrical facade, with recessed entrances and projecting pavilions, the brick and stone detailing and the prominent stone foundation are essential to the building's character. The street setback should be maintained.

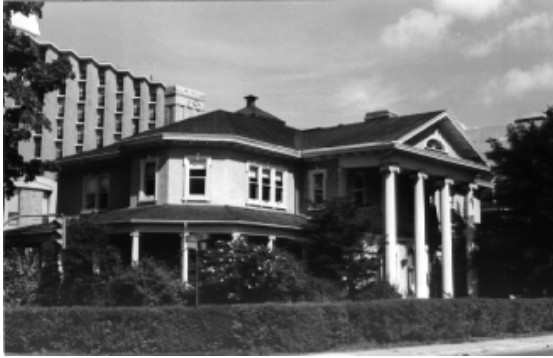
### **18 BARRIE ST. - MACKLEM HOUSE**

The building is in very good condition, with no apparent alterations from the original exterior materials. The landscape is very good, with mature trees, shrub and foundation plantings and a full hedge around the perimeter of the property. The site overlooks City Park, Richardson Beach and Lake Ontario. The building anchors the bottom end of the important Barrie Street streetscape and is a local landmark.

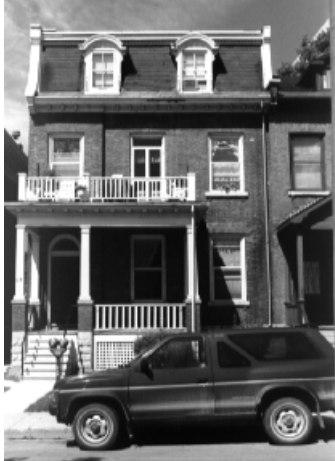
### **64 BARRIE ST. - DORAN HOUSE**

This is an elegant Second Empire two-and-a-half storey house which may have been intended to form part of a row. Three bays wide with a left side entry, the left bay projects one brick width from the building edge. A later flat-roofed porch now spans the left two bays and the balcony above has a centre bay walkout. A pair of ornately hooded units in the mansard roof sit above a simple cornice.

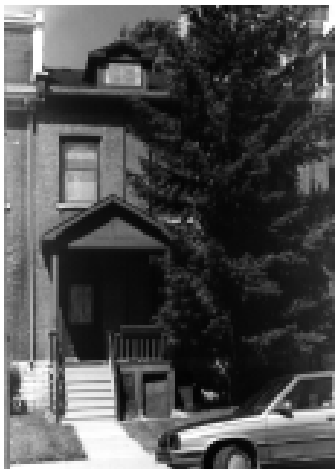
### **66 BARRIE ST.**

This house is identical to 64 Barrie St. but it has a shallow gable roof with two small dormers in it. The original porch has also been replaced but this time with a small gabled entry porch, which is not related to the second storey walkout.

In 1881 Ben Robinson, a labourer, was living at 66 Barrie St. Whether he was in this house or not is uncertain. In 1902 the house was vacant. It is possible that this was due to a fire, and that the roof is a replacement of the original mansard.

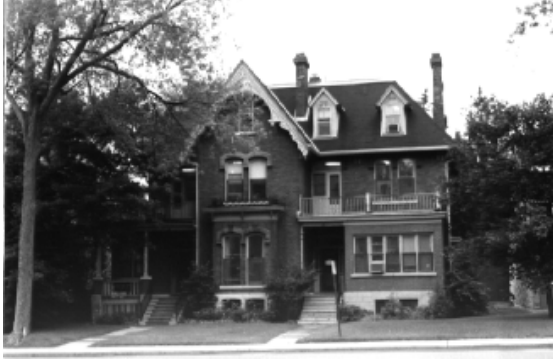
**82-84 BARRIE ST. - FLANAGAN / FORD HOUSE**

This pair of semi-detached brick houses was rated as Very Good because of its architectural detailing and use of wood, brick and stone, its Gothic Revival/Victorian Italianate style, all the work of a noted Kingston architect. It also maintains an important streetscape.

82-84 Barrie Street is a 2 1/2 storey pair of semi-detached houses, well proportioned, with many of its original features intact. Verandahs flank a central gabled pavilion which extends up to truncated hip roof, and wrap around the south side. To either side of the pavilion are entry doors with sidelights and arched transoms. Similar doors above lead to balconies over the porches. The house has a foundation of coursed ashlar limestone and, on the roof, pairs of gabled roof dormers centred in each of the four bays. Ornamentation includes stone labels over the paired arched top windows and ornate bargeboards on the gable ends. No interior features were noted.

The landscape has mature street trees, foundation plantings and lawn. The house maintains the street setback.

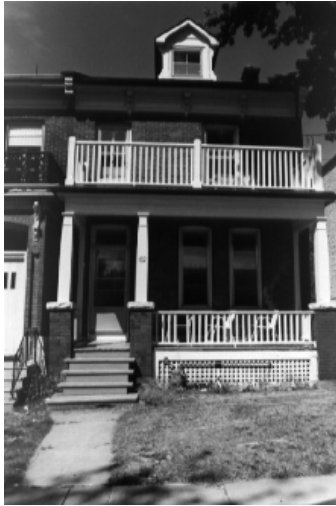
### **102 BARRIE ST. - THE HISCOCK HOUSE**

102 Barrie St. is a two-and-a-half storey red brick residence which is attached to 100 Barrie and copies its form and design. While many of the details have been replicated, their arrangement differs slightly. The roof dormer has been centred in the roof, and the ornate brackets in the eaves which match those on #100 have been spaced differently. 102 also has a full width porch that appears to date from the early 20th century.

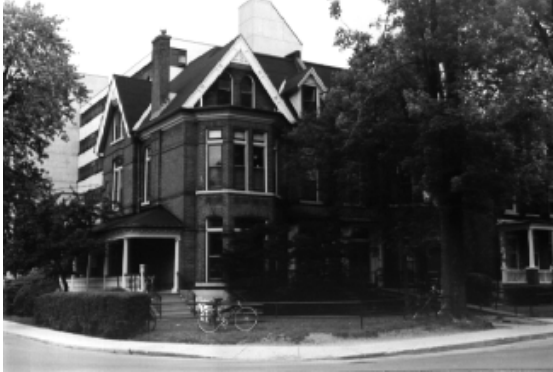
**162-164 BARRIE ST. - GRAD HOUSE**

The landscape consists of mature street trees, foundation plantings and hedges along the perimeter of the site. Some deciduous trees have been planted to replace former street trees. The house establishes the street setback for this block and anchors the corner with its use of bays on each street frontage.

The mansard roof, with elaborate firewalls, and the well-crafted balustrade on the entrance verandah are essential to this building's exterior character. The existing landscape is also important.

Recent alterations of aluminum storm windows and a metal fire escape are not sympathetic. Consideration should also be given to reopening the transom and second storey windows which have been filled in.

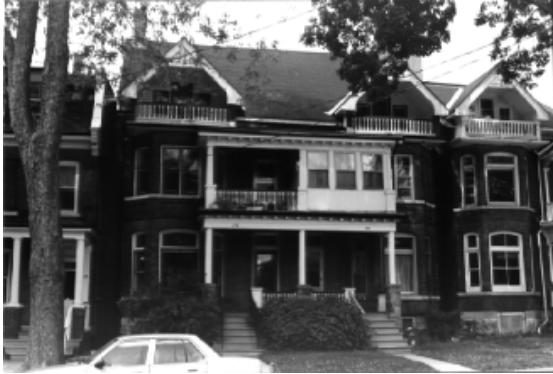
**172-174 BARRIE ST. - MOOERS HOUSE**

172-174 Barrie Street are 2 1/2 storey semi-detached brick houses. The two-storey angled window bays at each end rise to overhanging balustraded porches which are protected by gabled roofs. A two-storey porch over the main entrance is supported on cylindrical columns on "Boyd Block" piers and has a flat roof above onto which open doors from the second storey. A two-storey wing extends to the rear. Details include decorative bargeboards on the gable ends, dentilled cornices on the porch, stone sill courses under the bay windows and stained glass in the transom windows over the entrance doors. No interior features have been noted.

The landscape includes mature street trees, lawn and foundation plantings. The houses maintain the consistent setback of the houses on this block.

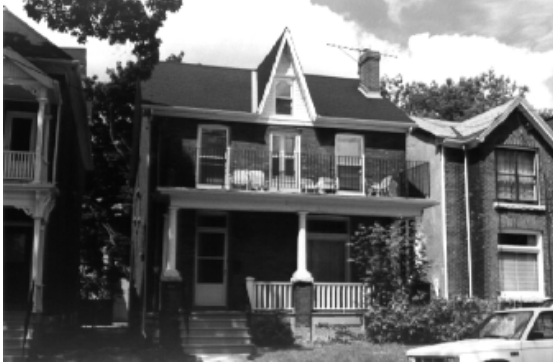
### **180 BARRIE ST. - MOREHAM HOUSE**

This is a two-and-a-half storey, red brick Victorian house with a steeply-pitched central gable. A full-width porch with a simple railing and Tuscan columns on brick piers rises to a balcony with modern railings. Note the arched window and decorative shingles in the centre gable.

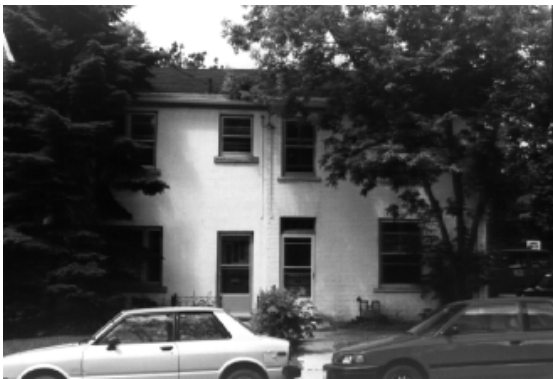
### **188-190 BARRIE ST. - CHADWICK/McGROGAN BUILDING**

This is a simple, rectangular, two-storey, brick-sided building with a central entrance and balanced window placement.

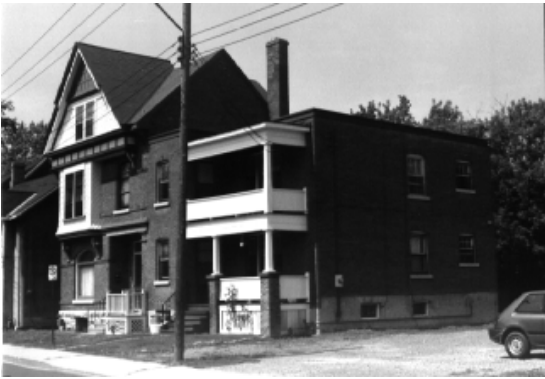
### **25 CLERGY ST. W. - O'DONNELL HOUSE**

This is a square brick two-storey duplex building. It has a flat roof and full width porches on each storey across the facade. The porches have solid railings and are supported by tapered square columns.

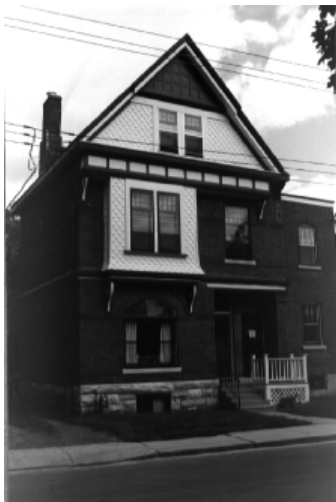
### **27 CLERGY ST. W. - CALVERT HOUSE**

woodwork entablature supported by a boxed oriel which, in turn, is supported by decorative brackets. No interior features were noted.

The high quality brickwork, rusticated stone base, fish scale wooden shingling of the oriel and gable ends, the multi-paned transom of the upper storey windows and the street setback are essential to this building's character. The building addition at #25 detracts from the character.

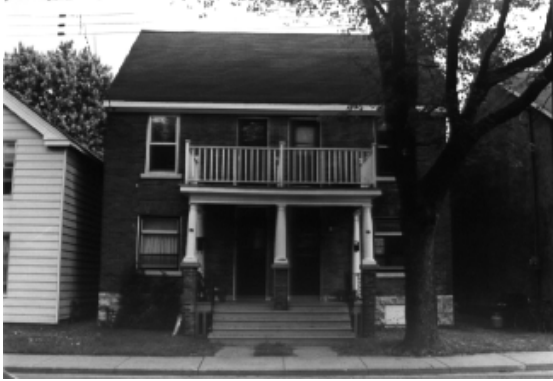
### **35-37 CLERGY ST. W. - WATTS/DOYLE HOUSE**

The four-bay semi-detached units mirror each other in this two-storey brick structure. Although forming only two units, the building could easily be part of a block of Victorian row-housing. There is a flat-roofed porch on top of which is a top verandah with a high square balustered railing. The porch structure has Tuscan columns on brick piers. Note the window sills and shallow arches at the openings.

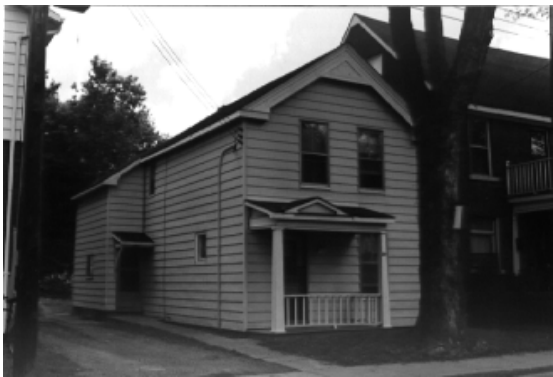
### **39 CLERGY ST. W. - DEAN HOUSE**

This simple vernacular two-storey frame building has vinyl cladding but retains a distinctive gable return and bargeboard. The small porch on the front gable portion echoes the character of the bargeboard.

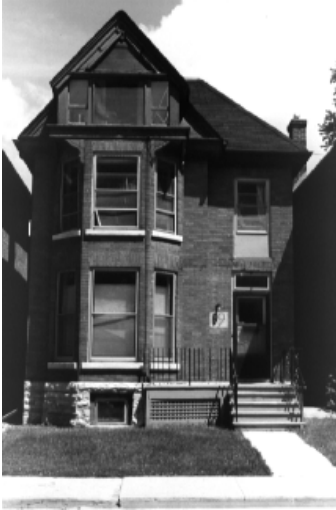
### **99 CLERGY ST. W. - BAILEY HOUSE**

This is a two-and-a-half storey hipped roofed brick building with a shallow projecting pavilion containing deep 3 sided, 2 storey bay windows. In the pavilion gable there is decorative woodwork and bargeboard. A small screened porch is carried by cantilevered corners. The right bay entrance has a door above suggesting an original two-storey porch, and the uncovered front stoop has a modern wrought iron railing.

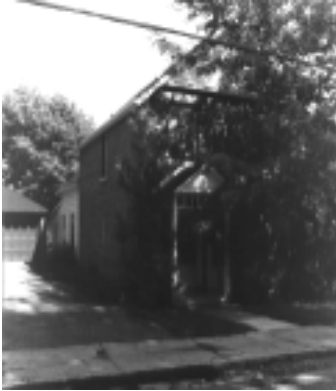
#### **137 COLLINGWOOD ST. - ROE HOUSE**

A two storey, red-brick, end-gabled house with a small gabled entry porch. The porch has turned columns and spindlework ornamentation. There is a square bay window at the front, and an unusual pent roof above the eaves line.

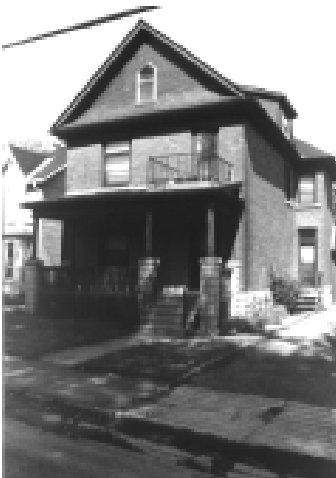
#### **141 COLLINGWOOD ST. - BUNT HOUSE**

This is a two-and-a-half storey, end-gabled, red-brick house with a full-width front porch. The porch has turned columns on concrete block piers. The pedimented front gable has a pent roof and is decorated by shingle work and a peaked window. There are shallow arches over the window and door openings. The house also has a brick rear addition in a similar design to the main structure.

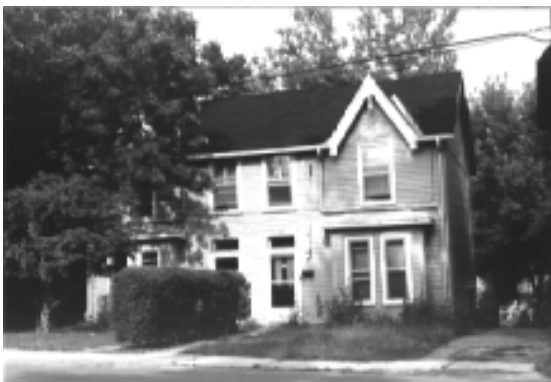
#### **143-145 COLLINGWOOD ST. - POWELL/AITKEN HOUSE**

The two-and-a-half-storey four bay wood frame house has cream-coloured aluminium siding and a red shingled roof. The 1st and 2nd bays are part of a projecting gable ell. A flat-roofed square bay with entry to the right has a shed-roofed porch with turned columns. There is a bay window in the north elevation.

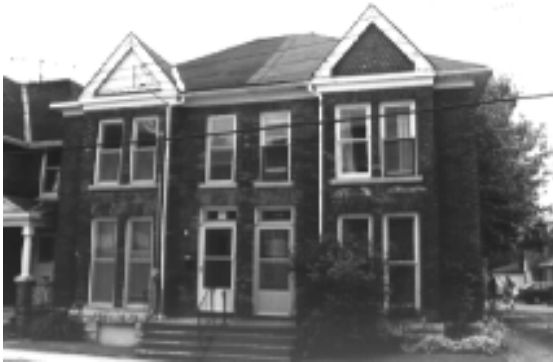
### **304-306 EARL ST. - BRIAN/SWINGWARD HOUSE**

This two-storey, hipped roof brick building has semi-detached units which mirror each other. Entrances are in the middle bays and the outer bays have slightly projecting gabled pavilions with paired windows on both floors. The gables have bargeboards and decorative shinglework.

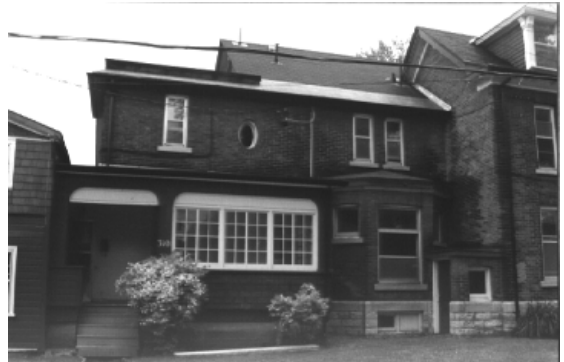
### 314 EARL ST.

This extension of an existing wing has a poor composition and use of materials. The structure is a 2 storey frame structure with vinyl cladding. It matches the form and massing of the wing of No. 194 University Avenue, and has a 2 bay facade with an entrance in the first bay. A large plate glass window flanks the entrance; above is an asymmetrically placed smaller window in the second storey. The gable end on the side elevation contains two single windows, the rear one having a metal fire escape leading from it. The rear elevation has three asymmetrically placed windows of various sizes, two in the second storey and one below. No interior features were noted.

The extent of alterations depends upon the date of construction but may include the cladding, windows, door and fire escape. The house, as part of the wing on Earl Street, helps establish the street line in this block and mirrors the massing of the house at the other end of the block (No. 324 Earl).

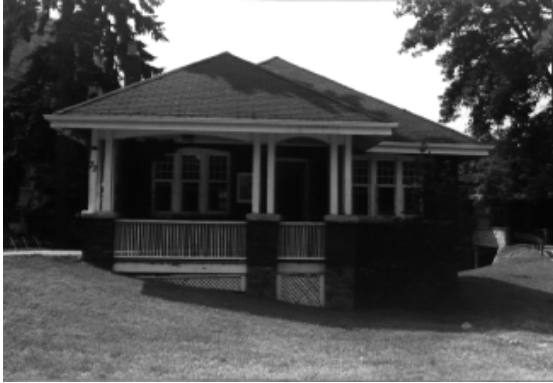
### **72 QUEEN'S CRES. - REID HOUSE**

The three-bay brick bungalow has a central entrance and a porch across the left two bays. The porch is carried by doubled and tripled square posts on brick piers. The roof is hipped with an additional hip over the porch.

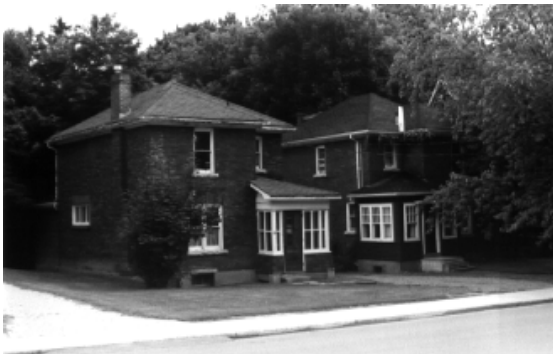
### **82 QUEEN'S CRES. - ALEXANDER HOUSE**

This is a modest two-storey four-square brick house with a notched front entry and enclosed verandah. Note the stone sills.

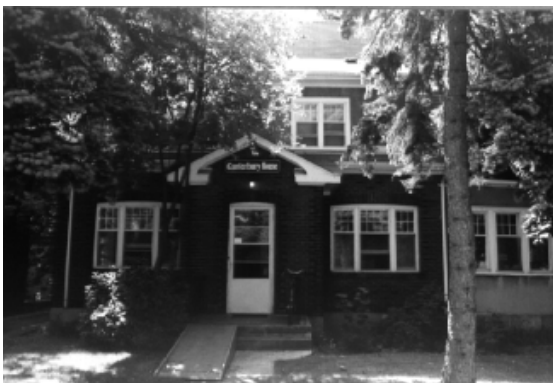
### **90 QUEEN'S CRES. - CANTERBURY HOUSE**

This is a two bay four-square brick house with two storeys and an entry porch in the left bay. The porch has an arched fascia and is supported by triple Tuscan columns on brick piers. The hipped roof has a central dormer with arched fascia. There are bay windows in the west side. The windows have stone sills and flat arches.

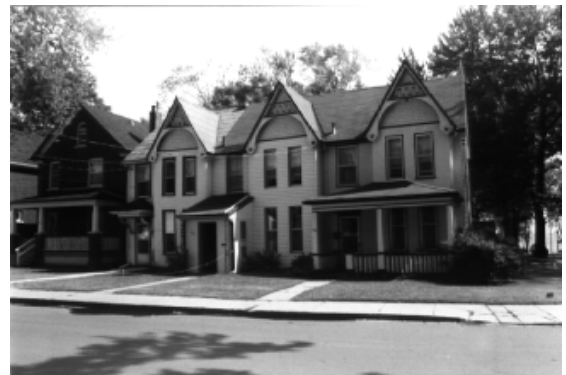
198-202 Stuart Street is a 2 storey (probably) wood frame triplex residential building with a side gable roof. The 6 bay facade has slightly projecting gabled pavilions in bays 2, 4 and 6, with pairs of narrow windows in each storey and gables extending above the eaves line above. Entrances in bays 1, 3 and 5 have transoms and windows in the second storey above. Each entrance has a different

canopy: bay 1 has a hipped roofed hood supported by brackets, bay 3 a fully enclosed shed roofed porch, and bays 5 and 6 have a full-width hipped roof porch supported by tapered wooden columns on a concrete stoop with a wooden balustrade. 2 storey extensions to the rear of each unit have shed roofed additions. Detailing includes decorative shingles, spindlework and bargeboards in the gable ends. No interior features were noted.

Alterations include vinyl siding, aluminum storm windows and changes to the entry porches. The landscape consists of lawn and foundation plantings and the house occupies an important streetcorner within a significant heritage grouping.

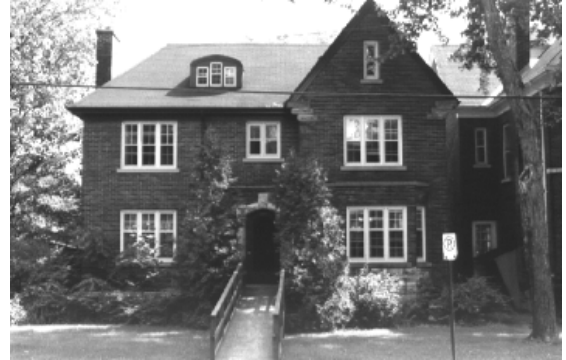
**186 UNION ST**

This is a two-and-a-half storey, red brick Victorian house has an entrance in the right bay that has a neo-Georgian surround. The left bay is slightly projected with two storey bay windows and is topped with a gabled pavilion that projects slightly over the bay. There are decorative shingles in the gabled pavilion. A flat-roofed garage has been added.

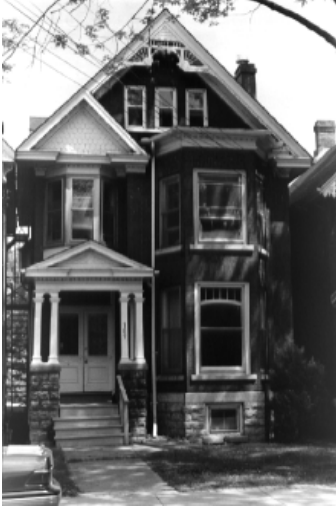
**189 UNIVERSITY AVE. - SUTHERLAND HOUSE**

The elements of Newlands' design, especially the asymmetrical composition, the rusticated base and stone sills, the two storey bay with bracketed cornice, the projecting bay above the paired entrance doors, the shingling, bracketed cornice and bargeboards in the gables, the spindlework and triple window in the main gable, and the curved muntins in the main first floor window are essential to the building's character.

Reinstatement of the bargeboarding and replacement of the porch (to match the same renovations to #186) would improve this property.

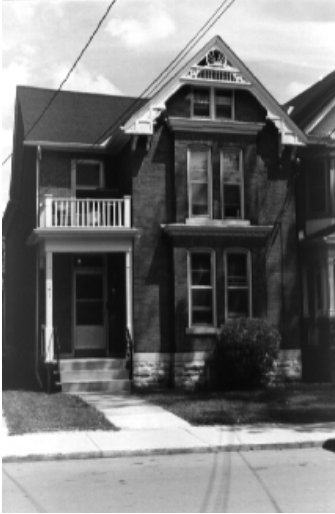
**191 UNIVERSITY AVE. - GAW HOUSE**

Alterations include aluminum storm windows, a basement window in the second bay filled in with a vent, and the possible replacement of the original porch. Landscape features include one foundation planting and lawn. The house is part of an important heritage grouping.

The asymmetrical composition, the projecting pavilion in the main bay, with its paired round-arched windows and bracketed cornice, the bargeboard and spindlework in the main gable, the rusticated base and stone sills are essential to the building's character.

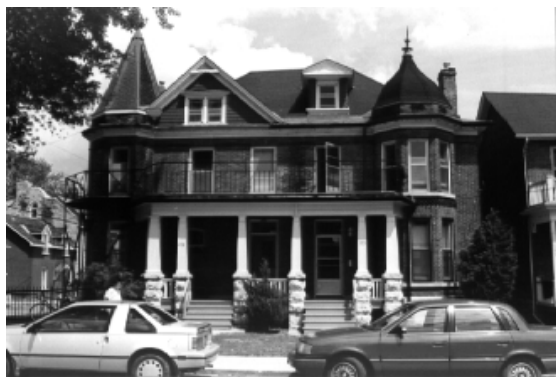
**193-195 UNIVERSITY AVE. - DONNELLY HOUSE**

Bay 2 of the main facade has small stained glass window high in the first storey with a standard window above and a paired window in the end gable which links bays 1 and 3. Bay 4 has a gabled dormer in the roof above and bay 5 has an angled bay which rises to a tower with three windows per storey, with common sills. This tower is set in from the corner and is capped with a bell-shaped roof and a pinnacle. The rear additions to this building are inventoried under #310 Earl Street. Details include decorative brick panels just below the roofline and windows on both towers, dentilled cornices, stone sills, pellet moulding in the wall gable and decorative side wall shingles and a sunburst design in the pediment of the roof dormer. No interior features were noted.

Alterations include aluminum storm windows and the exterior fire escape. Landscape features include mature street trees, lawn and foundation plantings. The house establishes the street setback for this block and anchors the street corner.

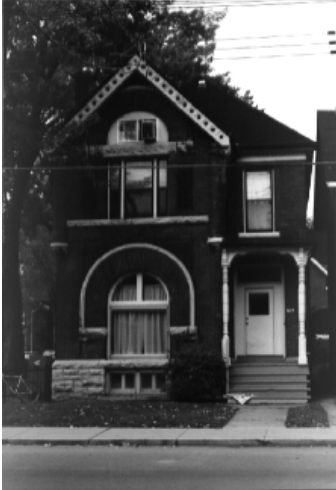
### **196 UNIVERSITY AVE. - JENKINS HOUSE**

Details include limestone string courses separating the first and second storeys, heavy stone sills, decorative brick and stone arches around the first floor windows, terra cotta panels flanking the second storey window in bay 1, decorative barge board in the gable end, cylindrical brick and stone buttresses on the edges of the second storey, and stone brackets on the chimney breast. No interior features were noted.

Alterations include aluminum storm windows, infilling of the gable end window, and replacement windows on rear fire exits. Landscape features include mature street trees, lawn and foundation plantings. The house anchors the street corner and establishes the street setback for this block.

The late Victorian Romanesque style, asymmetrical composition, the transomed entrance with porch and turned columns, the rusticated stone base and rusticated sills, the round-arched main

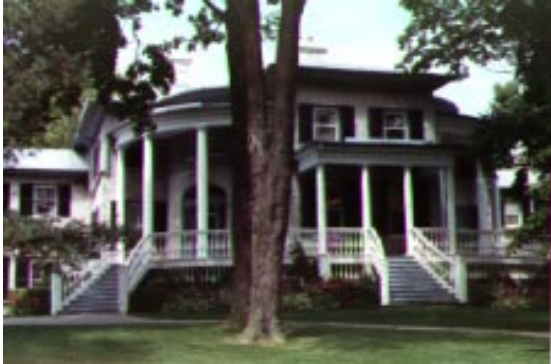
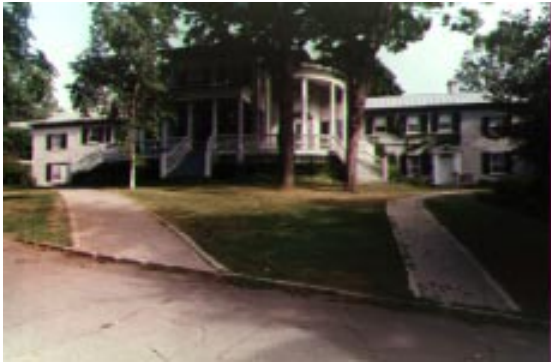
## **I-1 Summerhill**

Summerhill is a large two storey limestone detached villa with a hipped, standing seam metal roof. It has a central block with a T-shaped plan, the re-entrant angles of which are filled in by quadrants. Flanking the central block and set well back are matching two storey wings. The central block is set on a high foundation, surrounded by a light well which provides light and access to the semi-basement storey. The flanking wings are set at ground level.

The central block has a projecting two storey pavilion with two shuttered windows on each floor and windows on each side. The flanking quadrants have entranceways in the main floor. On the second storey there is a segmental arched opening with a triple window over a common sill. Details in this area include radiating voussoirs over the entrance fan lights with a sunburst pattern. Sidelights with a curvilinear design above a fielded panel are set between reeded pilasters which rise to wide moulded architraves. The slightly curved main doors have a central bead and fielded panels, some replaced by glass.

Alterations have been made in 1867 (interior centre), 1870 (exterior wings), 1888 (exterior centre), 1918 (interior overall), 1951 (interior west wing), 1961 (interior east wing), and 1982-83 (exterior renovation and restoration of centre). These most recent alterations have restored many features of the earliest development phases, and the house has been well maintained throughout its life. No interior features were noted. Landscape features include the Summerhill Park landscape (described in the Landscape section), mature trees, lawns, perennial beds and shrubs. The building is a campus and City landmark and establishes the character of Summerhill Park.

The architectural and historical character of this building is defined by its use of Kingston limestone and the symmetry, dignity and scale of its composition. Though the work of several architects, the house is an excellent early example of a large Kingston villa, showing American Federal influences and such typical villa features as large columns on the porticoes. The detailing of the entrance stairways, verandahs and doorways is excellent and essential. The roof design, materials and chimneys are important. Summerhill's continued use as the Principal's official residence and the mature landscape setting, overlooking the Lake, are also essential characteristics. This building has sufficient merit for its main facade to be preserved in its entirety.

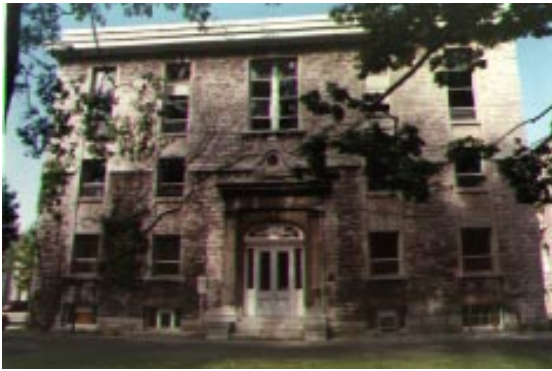
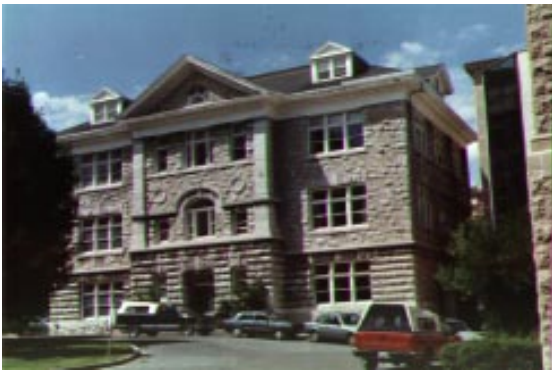
**I-2 Old Medical Building**

This building is rated as Excellent because of the surviving elements of its original Georgian-influenced composition, an example of the work of a prominent local architect, with strong historical associations as the first permanent building erected by the University and has been in almost continuous use by the Medical faculty. It established limestone as the characteristic material for the University, forming the boundary of the first quadrangle.

The Old Medical Building is a 3 storey limestone institutional building with a flat roof. It is designed in the Georgian style. The five bay facade of the main block has a central entrance with double doors, sidelights and a segmental arched fanlight framed by stone pilasters which support a plain frieze with moulded cornices. The bays flanking the entrance have a flat arched single window (metal, without window mullions) in each storey, and there is a double window over the entrance. The plain ashlar string course at the second storey level is interrupted by vertical panels which contain the windows. The south side of the building has two of the vertical panels and two original tall window openings, one now blank. The north face of the building has three vertical panels. A large wing extends on the west side, set back from the edges of the main block. Windows are the original transomed type, three per floor. A single storey flat-roofed addition obscures the first floor windows on this face. Details include a datestone in a moulded stone enframement above the main door and a wide white cornice edging the flat roof. No interior features were noted.

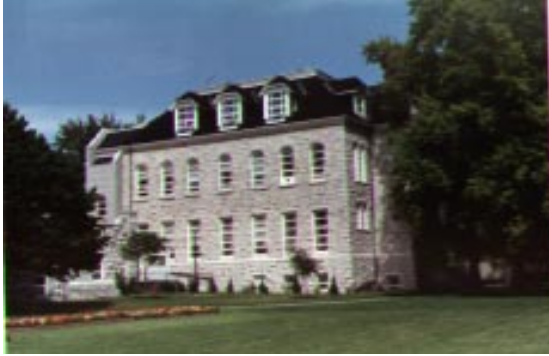
## **I-5 Carruthers Hall (Science Hall)**

The west side of the building has seven windows per storey and the east side eight, in each case square-headed on the first storey and round-headed in the second. Above these are similar dormers to those in the main facade, three per side, and one in the rear elevation. The east elevation has a gable-roofed projection from the lowest level providing an entranceway to the semi-basement. It is flanked by square windows. The rear of the building has irregular fenestration with two round-arched windows under the gable peak. No interior features were noted. Details include billet moulding on the main cornice and simple moulding along the perimeter of the flat roof atop the truncated hip main roof.

The symmetrical composition, rusticated stone cladding, hierarchy of square-headed, round-headed and dormer windows, and the entranceway with its round-arched transom, flanking windows and stone steps, are all essential to its character.

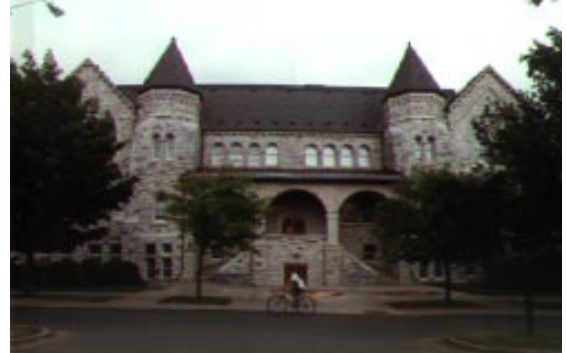
This building is rated as Excellent because of its architectural composition of towers, arched entrance and corbelling. It is an excellent example of the Romanesque style, by prominent architects and remains largely unaltered. It is also a turn-of-the-century building with important historical associations, and establishes an important heritage grouping in Lower University Avenue.

Ontario Hall is a 3 storey rusticated limestone institutional building with a modified gable roof. The main University Avenue facade is symmetrical with flanking gable-roofed engaged towers and gabled pavilions. The central entranceway is three bays wide and is probably the largest of any University building. Low stone walls curve from the sidewalk up the inner side of the twin curved stairways to the first floor entrance. Within the curve of these low walls at ground level and set into the base storey is a later entrance below the broad arch. Flanking this ground level door are square pillars which support the three main round-headed arches of the entry porch. The porch has a sloping roof. The entranceway has a large double door with a segmentally arched window over, flanked by a pair of round-arched windows. Other square-headed windows are set in the curve of the stairs. Above the porch roof are two sets of four round-headed windows set between engaged columns. A dentilled cornice supports the front slope of the main roof.

Interior features have been largely obscured by later alterations. Alterations to the exterior are minimal and include the replacement of some of the original slate roof with asphalt shingles.

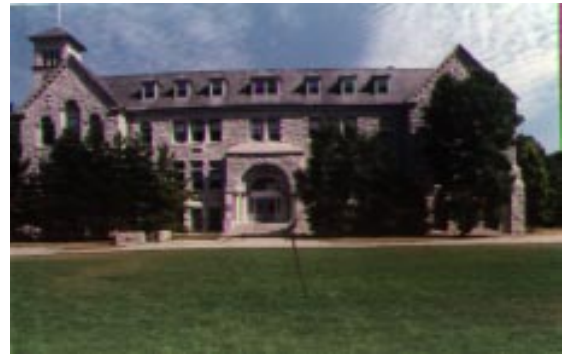
This building is rated as Very Good because it is a well-proportioned building designed by prominent architects and has important historical associations as a gift from the City. It contributes to an important heritage grouping and has been retained virtually intact.

Kingston Hall is a three storey building with an attic storey under a side gable roof. It is constructed of rusticated Kingston limestone in a style that is an eclectic mix of Romanesque and Victorian elements. The main southern facade is completely symmetrical with five main sections comprised of a central entranceway, flanking four bay sections of the main block, and three bay projecting gabled pavilions at each end. The main entrance is set in a two storey, hip-roofed projection. The double doors with side lights and a large fan light are set under compound round arches supported by ashlar columns with capitals. Above the entrance are two windows in the third storey and a double window, hip-roofed dormer in the roof. The flanking sections contain sets of three windows per storey, with a single window per floor in the outermost bays. In these flanking sections the first and third storey windows are square-headed and the second floor windows are square-transomed. There are three dormers in the roof above each of these sections. The gabled projections have one and a half storey buttresses. The first storey windows are square-headed, the second storey windows are square-transomed and the third storey windows are round-headed, with a tall central one flanked by two shorter ones, and with ashlar columns supporting the round arches. A dentilled cornice follows the roof around the building at the roof edge.

No interior features have been noted. Alterations include minor replacements to window units. The building forms part of an important heritage grouping with Theological Hall and Summerhill.

The symmetrical composition, eclectic Romanesque Revival style, rusticated limestone cladding, projecting gable-roofed entranceway with arched surround, fanlight and sidelights, paired and triple windows, single and paired dormers, and the corbelled eaves, round-arched and pilastered window surrounds, and corner buttresses in the flanking gable ends, are all essential to its character.

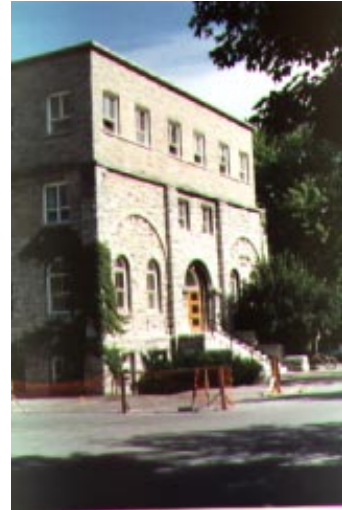
Jackson Hall is a 3 storey rusticated limestone building with a flat roof. The main facade is divided into three sections by pilasters which rise from the edges of the wide stone stairway to the string course above the second storey. The main entranceway has double doors with a fanlight above and is flanked by short pilasters to the springing of the arch. Above this are two square-headed windows. Flanking the main entrance are two sections with large, slightly recessed blank arches containing two round-headed windows in the first storey. There are no second storey windows in these flanking sections. Above the second storey string course is a third storey addition with a simple cornice and six windows, paired with a common sill. The raised basement of the building has two square-headed windows in each of the flanking sections. No interior features were noted.

Alterations include the removal of the original gabled roof and attendant architectural detail and their replacement with a flat-roofed third storey. The limestone used in the third storey is of a different colour to the local limestone of the original building and is not compatible.

Jackson Hall was built in 1906 to designs by two Queen's Engineering professors, Kirkpatrick and Macphail. It was built to house the gymnasium and other recreation facilities on campus and was known as the "Old Gym" for many years. From 1930, the building housed the Department of Mechanical Engineering and a Department of Hydraulics laboratory. The new third storey was added in 1959. The building currently (1995) holds the Department of Engineering and shops for the University staff tradespeople. Jackson Hall was named in honour of Arthur Jackson, professor of Engineering Drawing.

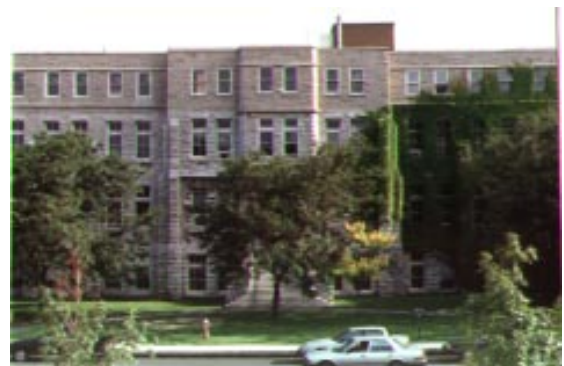
Gordon Hall is a 3 storey masonry building with a full height basement. It is clad in Kingston limestone with a top storey addition clad in Queenston limestone. The style is simplified Collegiate Gothic. The fenestration and proportions of this building are not well developed and the addition of a fourth storey (in a different type of stone) further detracts from its appearance. The main facade has a central projecting pavilion of 6 bays flanked by

symmetrical wings of 6 bays each. The raised basement has an ashlar string course above, while pairs of windows are located between buttresses in the two floors above. An ashlar string course above these buttresses defines the top storey, and a double ashlar string course indicates the parapet along the roof edge. The central projection has buttressed corners and two windows on either side of a further projection which contains the main entrance. Stone stairs rise between flared low stone walls to a large double-door, fan-lighted entrance set inside a round arch. Flanking square pilasters rise to a simple entablature and above it are two windows in each floor. All windows in the original building have flat arches and transom windows; those in the fourth floor are flat-arched without transoms.

The east and west faces of the building each have a central buttressed projection with two windows on the first and second floors. This projection is flanked by sections with single windows on each floor. The south face of the building is partially obscured by the Annex and continues the fenestration pattern, with the exception of a Gothic-arched and flat-arched triple window in the stairwells over two projecting stone entranceways. These entrances have gable ends with an ashlar cornice and wooden double doors with a fanlight in a stone arch above. Details include the carved lettering over the main entrance and the door surrounds (stonework and fenestration). No interior features were noted.

The attached rear Annex, now linking Gordon Hall to the Frost Wing, appears to have been constructed soon after World War II. It is a four storey flat-roofed extension of Gordon Hall, clad in Queenston limestone, and using the same compositional and stylistic elements. The Annex clumsily overlaps the rear projecting entrances of Gordon Hall. The 12 bay main facade on the west side has a 9 bay pavilion with a projecting entrance in the fourth bay. Ashlar band courses above the first, third and fourth storeys tie the composition together. Pairs of wooden sash, flat-transomed windows with ashlar sills are located in each bay. Ashlar cladding in the second storey above the main entrance engages the second storey window pair in this bay and the third storey sill. The projecting main entrance has a Gothic-arched doorway with a carved stone surround. Details include bronze lamps flanking the doorway, carved stone plaques above the doorway and in the ashlar cladding above the doorway. No interior features were noted. The Annex began the infill process which eventually removed the Memorial Quadrangle.

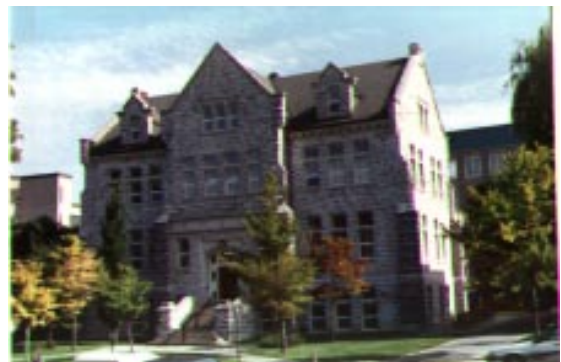
Flanking the central pavilion are three square-transomed windows on each storey and a dentilled cornice under the front edge of the gable roof. Above the cornice in each flanking section are single

stone-fronted, gabled dormers containing single square-headed windows. These dormers and the main pavilion gable end are parapetted. The east and west faces are parapetted gable ends containing four square-transomed windows in the basement storey, the same in the first storey, two with dripstone moulds, and the same in the second storey. The two square-headed windows in the gable ends have a dripstone mould. Additions cover the south face of the original building. No interior features were noted. Details include the building name carved in the stone course over the entrance.

Alterations include extensions erected in 1930 and 1961 on the south face of the building. These additions include limestone cladding and retain the limestone buttresses of the original building. The extensions have a flat roof. Recent repointing of the main building has been poorly done. All the original windows appear to have been replaced. The building was one of the first University buildings to face onto Union Street and helped to establish the street edge and setback. The more recent rear additions encroached on the original Memorial Quadrangle.

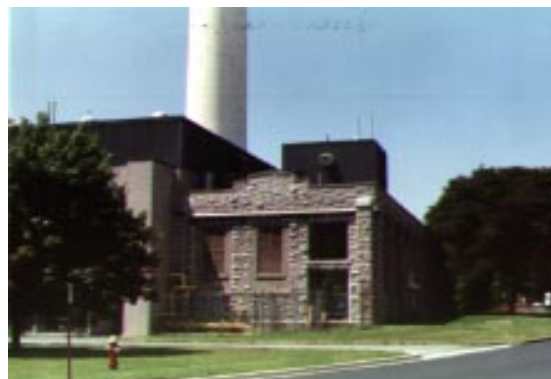
This building is rated as Excellent because it is a well designed example of a service building, the work of two prominent architects, and one of the first examples of a structural steel building on campus. It has historical associations through the Queen's professor who designed the steam distribution system, and it establishes a University presence on the waterfront.

The Central Heating Plant is a 1 storey structural steel building clad in limestone, with a flat roof. The north facade on King Street has three bays under a dentilled cornice and flanked by buttresses. The central bay is topped with a slightly raised parapet. The west face has 9 bays divided by buttresses and linked together by the continuation of the dentilled cornice. Entranceways in bays 3 and 7 are contained within slightly projecting shallow pedimented pavilions, each with a double door and flanking low stone walls. Above each entry is a small square-headed window. Each bay contains a large square-headed composite window with metal muntins. No interior features were noted.

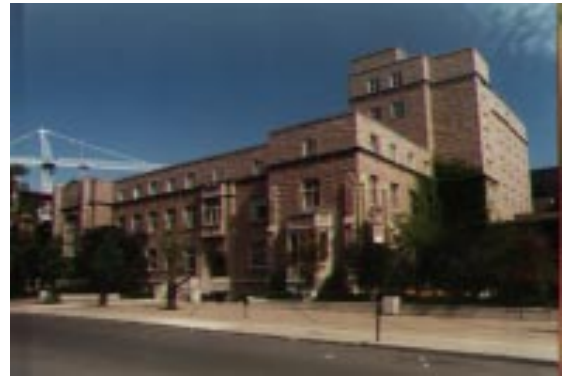
Flanking this central section on the east is a projection with buttresses at each corner rising two storeys. In the centre of this section is a projecting bay topped by a high parapet. Three stained

glass windows fill each face in the bay (housing the Memorial Room); above the bay is a double flat-arched window and a smaller window of the same type in the upper parapet. The eastern gable end has four bays, with two storey buttresses flanking the first bay and at the edge of the fourth bay, where the six storey addition is attached. Windows and cladding on this gable and the addition are the same type as those on the main facade.

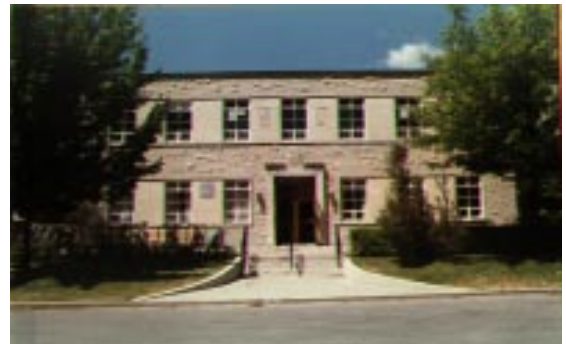
Clark Hall is built of Queenston limestone, used in ashlar on the front facade and rusticated on the south side of the building. The windows are an industrial metal sash with window surrounds of projecting dressed limestone.

There are interesting bas-relief panels between the second-storey windows and over the entryways. They feature motifs from the applied sciences, such as a suspension bridge and a surveyor's transit. Above the southern entry door there is a carved meandering pattern of vegetation. The name 'Clark Hall' is chiselled in raised letters above the main entrance. The university coat of arms is located above the doorway and the motif of a hydro-electric dam and an industrial complex are in bas-relief above.

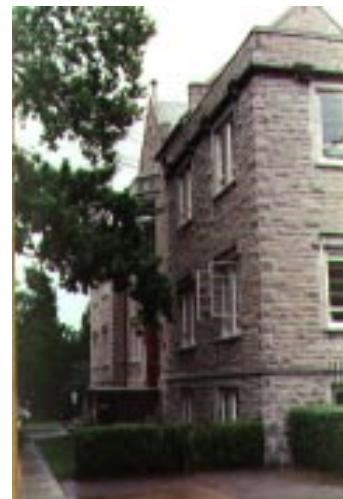
Built for the University administration, Richardson Hall was designed by David Shennan from Montreal. It is a late Collegiate Gothic building, done in a very accomplished manner, with carved foliage on the cornice line below the parapet. The windows, which are metal sash painted white, are surrounded by well-detailed limestone labels above and limestone sills below. The oak entry door with a shallow limestone Gothic arch bears the inscription ‘Richardson Hall’. An oriel window is located above the arch. Some of the upper windows are of leaded glass, with white-painted wooden mullions. The front entry steps are a dark granite.

The interior of Richardson Hall features Travertine marble flooring and has clear anodized aluminum railings in the staircase. Rose-coloured marble is used as trim around doorways, and for

baseboards on the ground floor and main stair. Where the Travertine marble stops, there is terrazzo flooring, followed by vinyl composite tile flooring.
