Queen's University  
Heritage Study

# TABLE OF CONTENTS

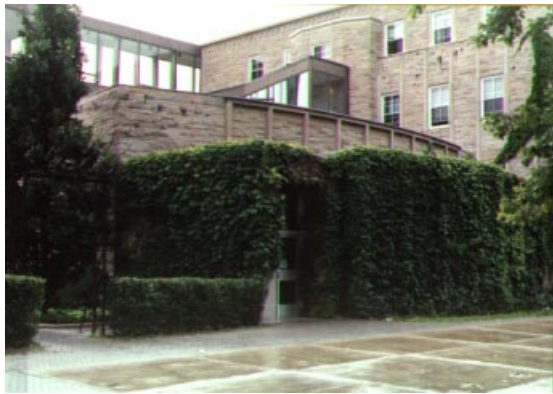
Alterations include a steel and glass addition on the southwest face of Dunning Hall and replacement window units.

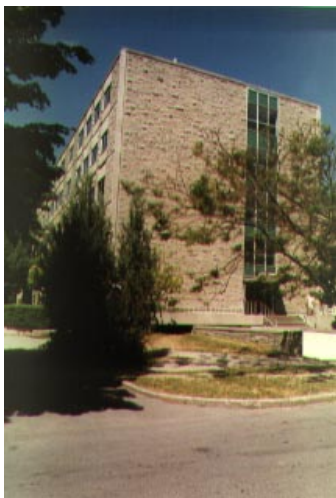
### **I-38 The Frost Wing**

The Frost Wing was designed by Barott, Marshall, Merrett & Barott for Chemistry. This is a straightforward, Modern building that was originally three storeys. The current five storey structure is a rectangular block of alternating vertical panels of limestone cladding and windows separated by concrete panels. Horizontal string courses separate the storeys.

Queenston limestone is the principal cladding material. The windows are of aluminum or stainless steel with a very slight tint.

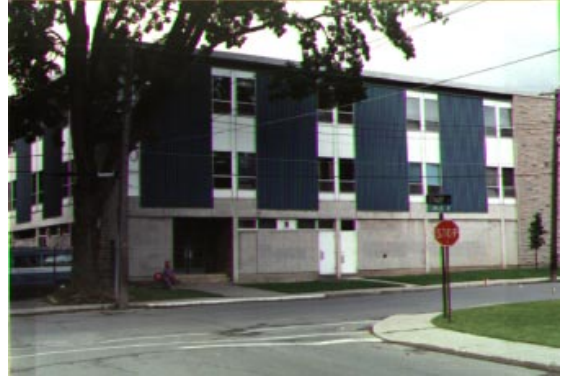
### **I-56 St. Lawrence Building**

This Modern building detracts from the streetscape. It has some Queenston limestone in its facade, however, the introduction of ridged blue metal panelling and aluminum windows with white panels between is an ill-resolved use of materials. The building has a clear anodized aluminum parapet flashing.

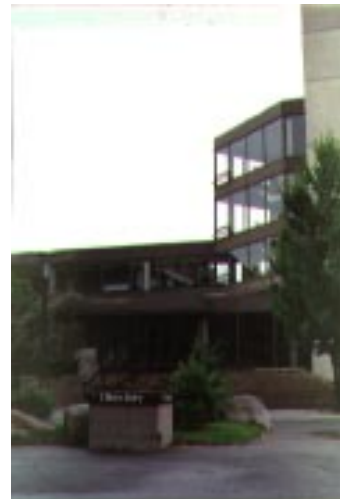
## I-59 - Mackintosh-Corry Hall

Mackintosh-Corry Hall is a 3 to 5 storey concrete and glass Modern institutional building with a flat roof. The main entrance is on the southeast corner of the building, with secondary entrances on the other building faces. The main entranceway is reached by angled flights of concrete steps and consists of glass and aluminum entrance doors and flanking glazing under a flat canopy, set forward and at an angle from a full height glazed pavilion with horizontal bands of anodized aluminum at the base of each storey.

The main building has 4 storey sections flanking a central skylit internal pedestrian “street”. The exterior walls are of poured concrete with deeply recessed horizontal windows under a flat roof. The interior walkway consists of vinyl composite flooring, painted drywall, and untreated concrete columns.

There do not appear to have been any alterations. The building is a linked complex in the interior of the block west of University Avenue and has its access from mid-block laneways and pedestrian routes.

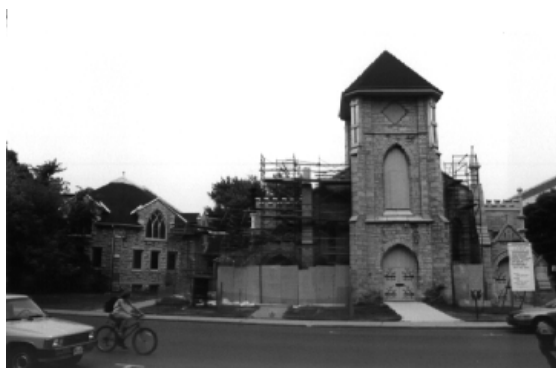
### **91 ARCH ST - ST JAMES ANGLICAN CHURCH**

The buildings have been progressively renovated over time, sympathetically so in each case. Major renovations currently underway (a complete replacement of the roof and tower) appear to be a restoration of the original fabric and do not detract from the heritage character.

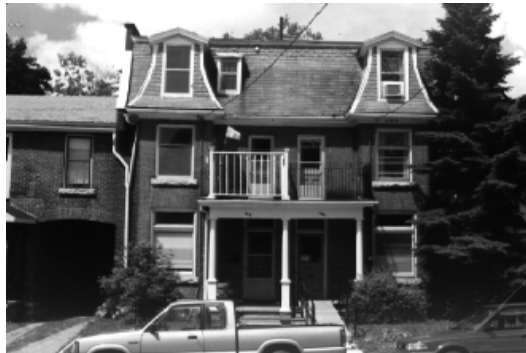
**184-186 BARRIE ST. - LOYNES/DE L'ARMITAGE HOUSE**

184-186 Barrie is a 2 1/2 storey, semi-detached brick house. Its facade is composed of four bays, the outermost bays projecting slightly and being topped by mansard shaped dormers with low gabled roofs. The central entrances are enclosed by a porch with a flat roof above onto which open doors from the second storey. A two storey addition extends to the rear. Details include turned columns on pedestals supporting the porch. No interior features were noted.

Alterations include aluminum windows, mismatched railings on the porch balcony, and a dormer window added to #184. The building is not in good repair.

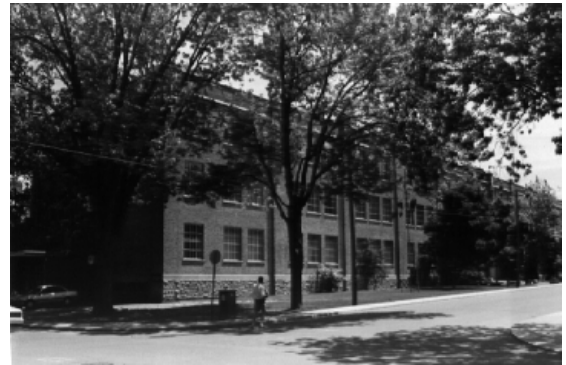
Kingston Collegiate and Vocational Institute is a much altered 3 storey brick high school. Stylistically it has elements of Collegiate Gothic. The main entrance is in the central bay of the 12 bay Frontenac Street facade, with an auxiliary entrance in the 11th bay. It is slightly recessed into a limestone surround. The building elevations are multi-bayed, with each bay defined by full height stone and brick pilasters. Each bay has three large multi-paned steel framed windows per floor. Details include four oak doors in the main entrance, with glazing under a multi-light transom containing Gothic tracery, and Gothic arch details in limestone along the parapets on each elevation. The building interior has a noteworthy central staircase.

A large brick and concrete wing was added to the north elevation in 1931; otherwise, the building is relatively unaltered. The building is a prominent landmark yet is well integrated into an established residential streetscape. It forms part of a large block which includes a heritage grouping consisting of a single family residence and the former Victoria Public School.
