Site **St. Mary's Of the lake Hospital**

Report Title **Vibration Monitor Locations**

Drawing Title **Site Map**

**Subject:** Vibration Monitoring Summary – February 19 to March 4, 2021  
**Project:** St. Mary's of the Lake Renovations  
**Client:** Queens University  
**Ref No:** 02101810.000

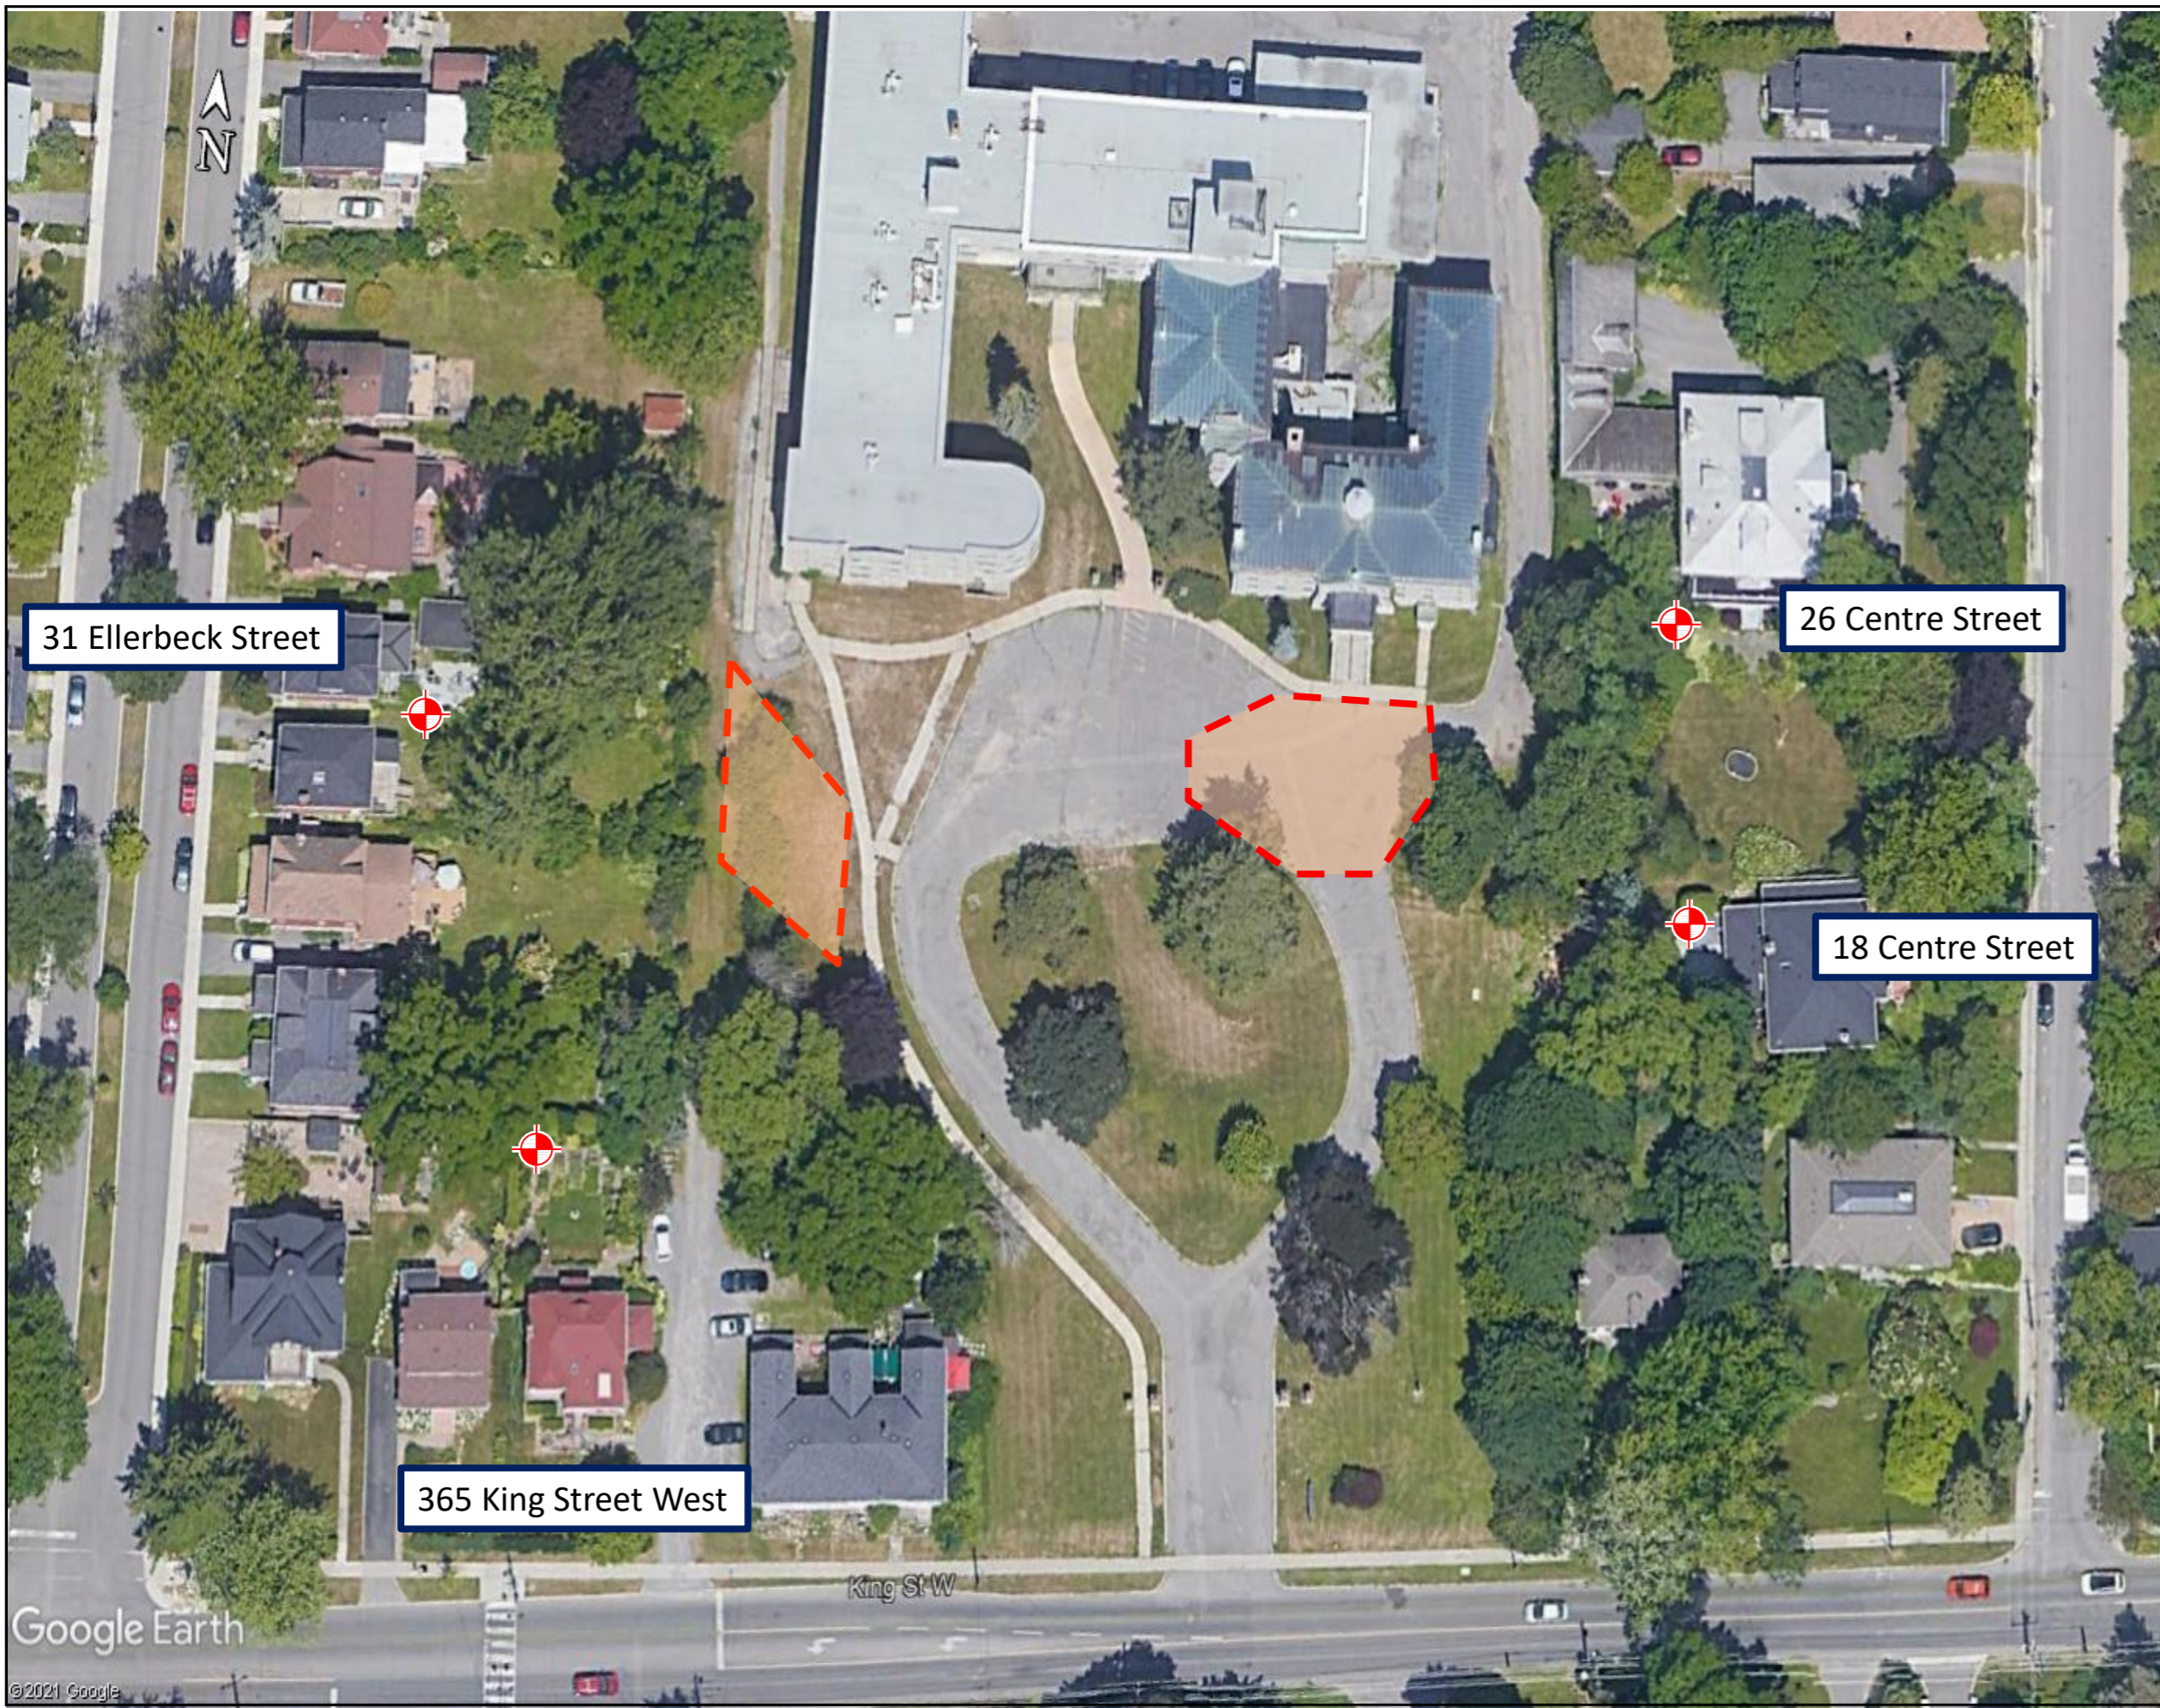
Figure No2	<b>1</b>
------------	----------

- Legend**
- Approximate Location of Construction Activities
  - ⊕ Approximate Location of Vibration Monitor

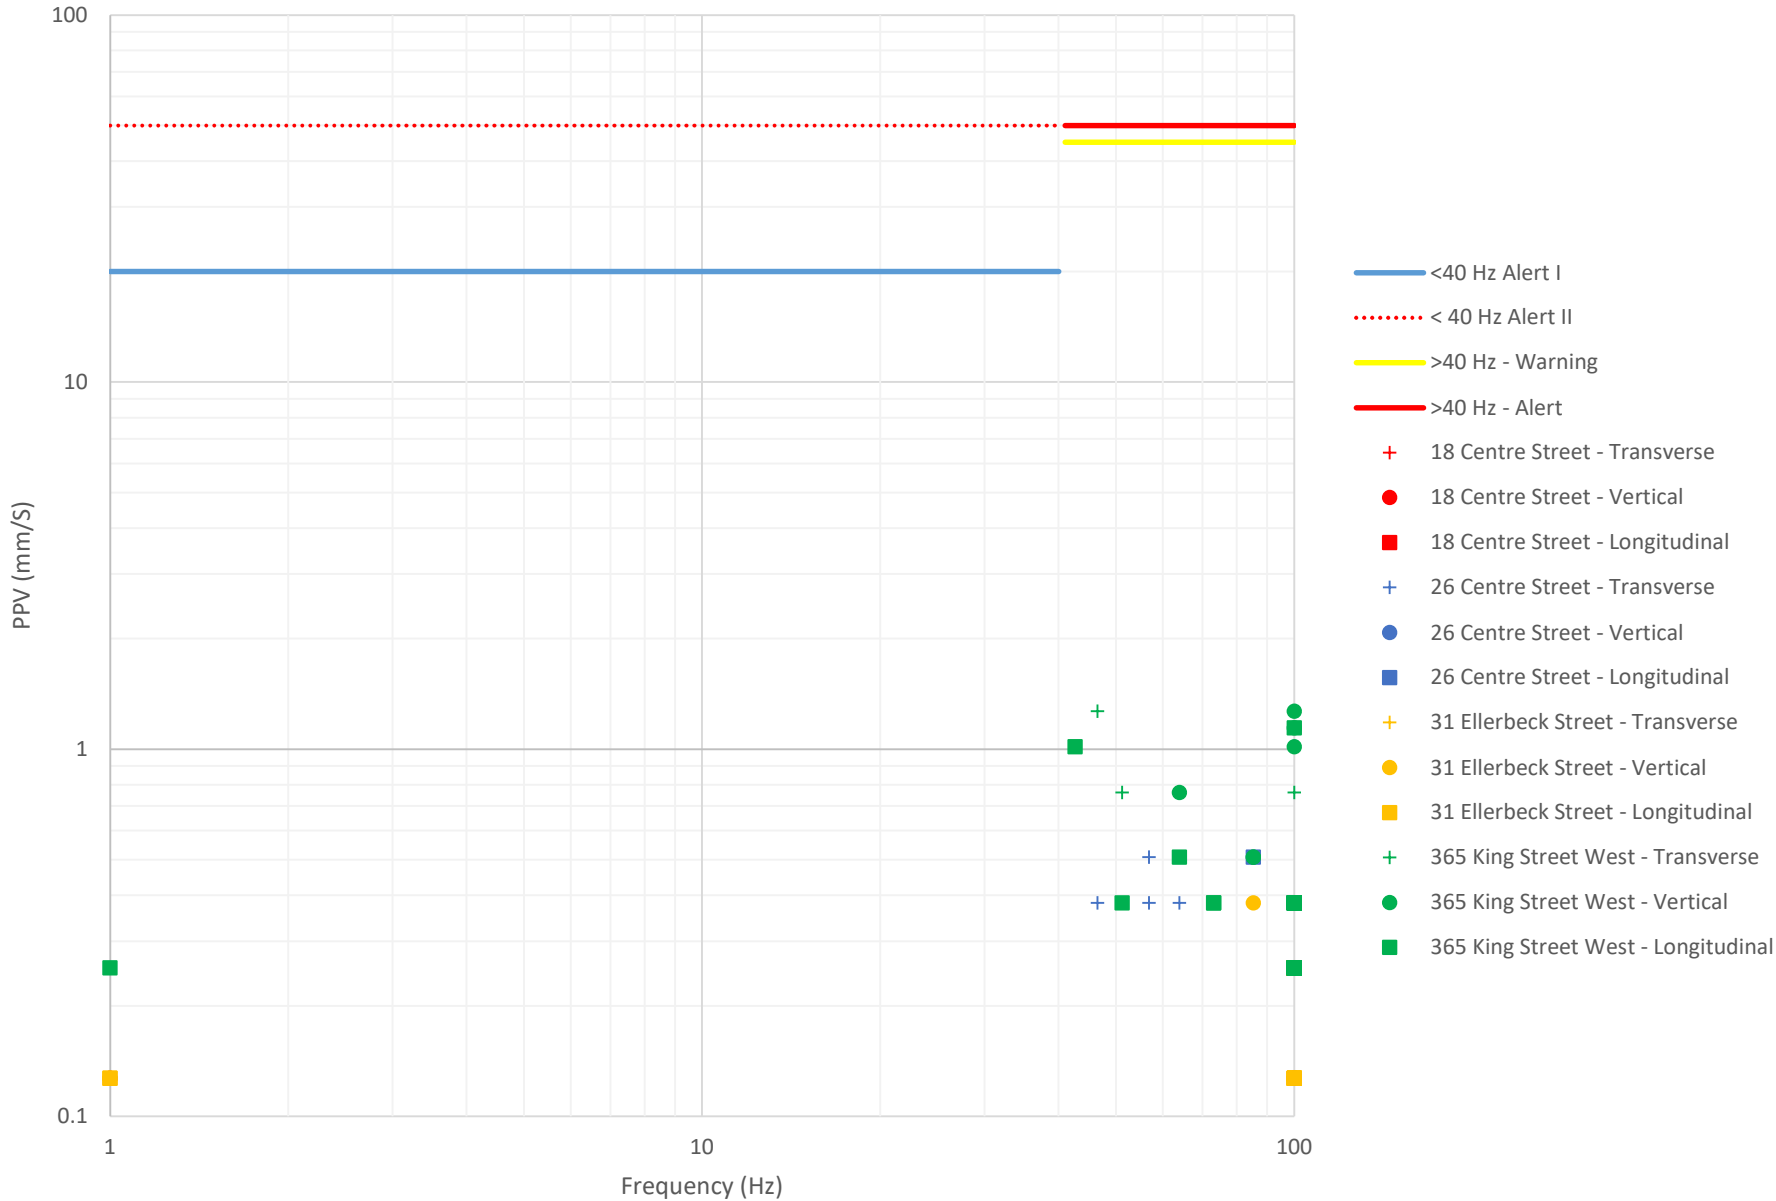
Queens - PPV vs Hz Vibration Data

Seismograph Location	Date of Installation	Maximum Peak Particle Velocity (PPV) [mm/s]	Date of Maximum Vibration Trigger
18 Centre Street	February 19, 2021	0.254	February 19, 2021
26 Centre Street	February 19, 2021	0.508	February 28, 2021
31 Ellerbeck Street	February 19, 2021	0.381	February 24, 2021
365 King Street West	February 19, 2021	1.143	February 22, 2021
