Subject: Vibration Monitoring Report – March 26th to April 1st, 2021
St. Mary's of the Lake Hospital Renovations
Kingston, ON

DST File No.: 02101810.000

Monitoring Locations

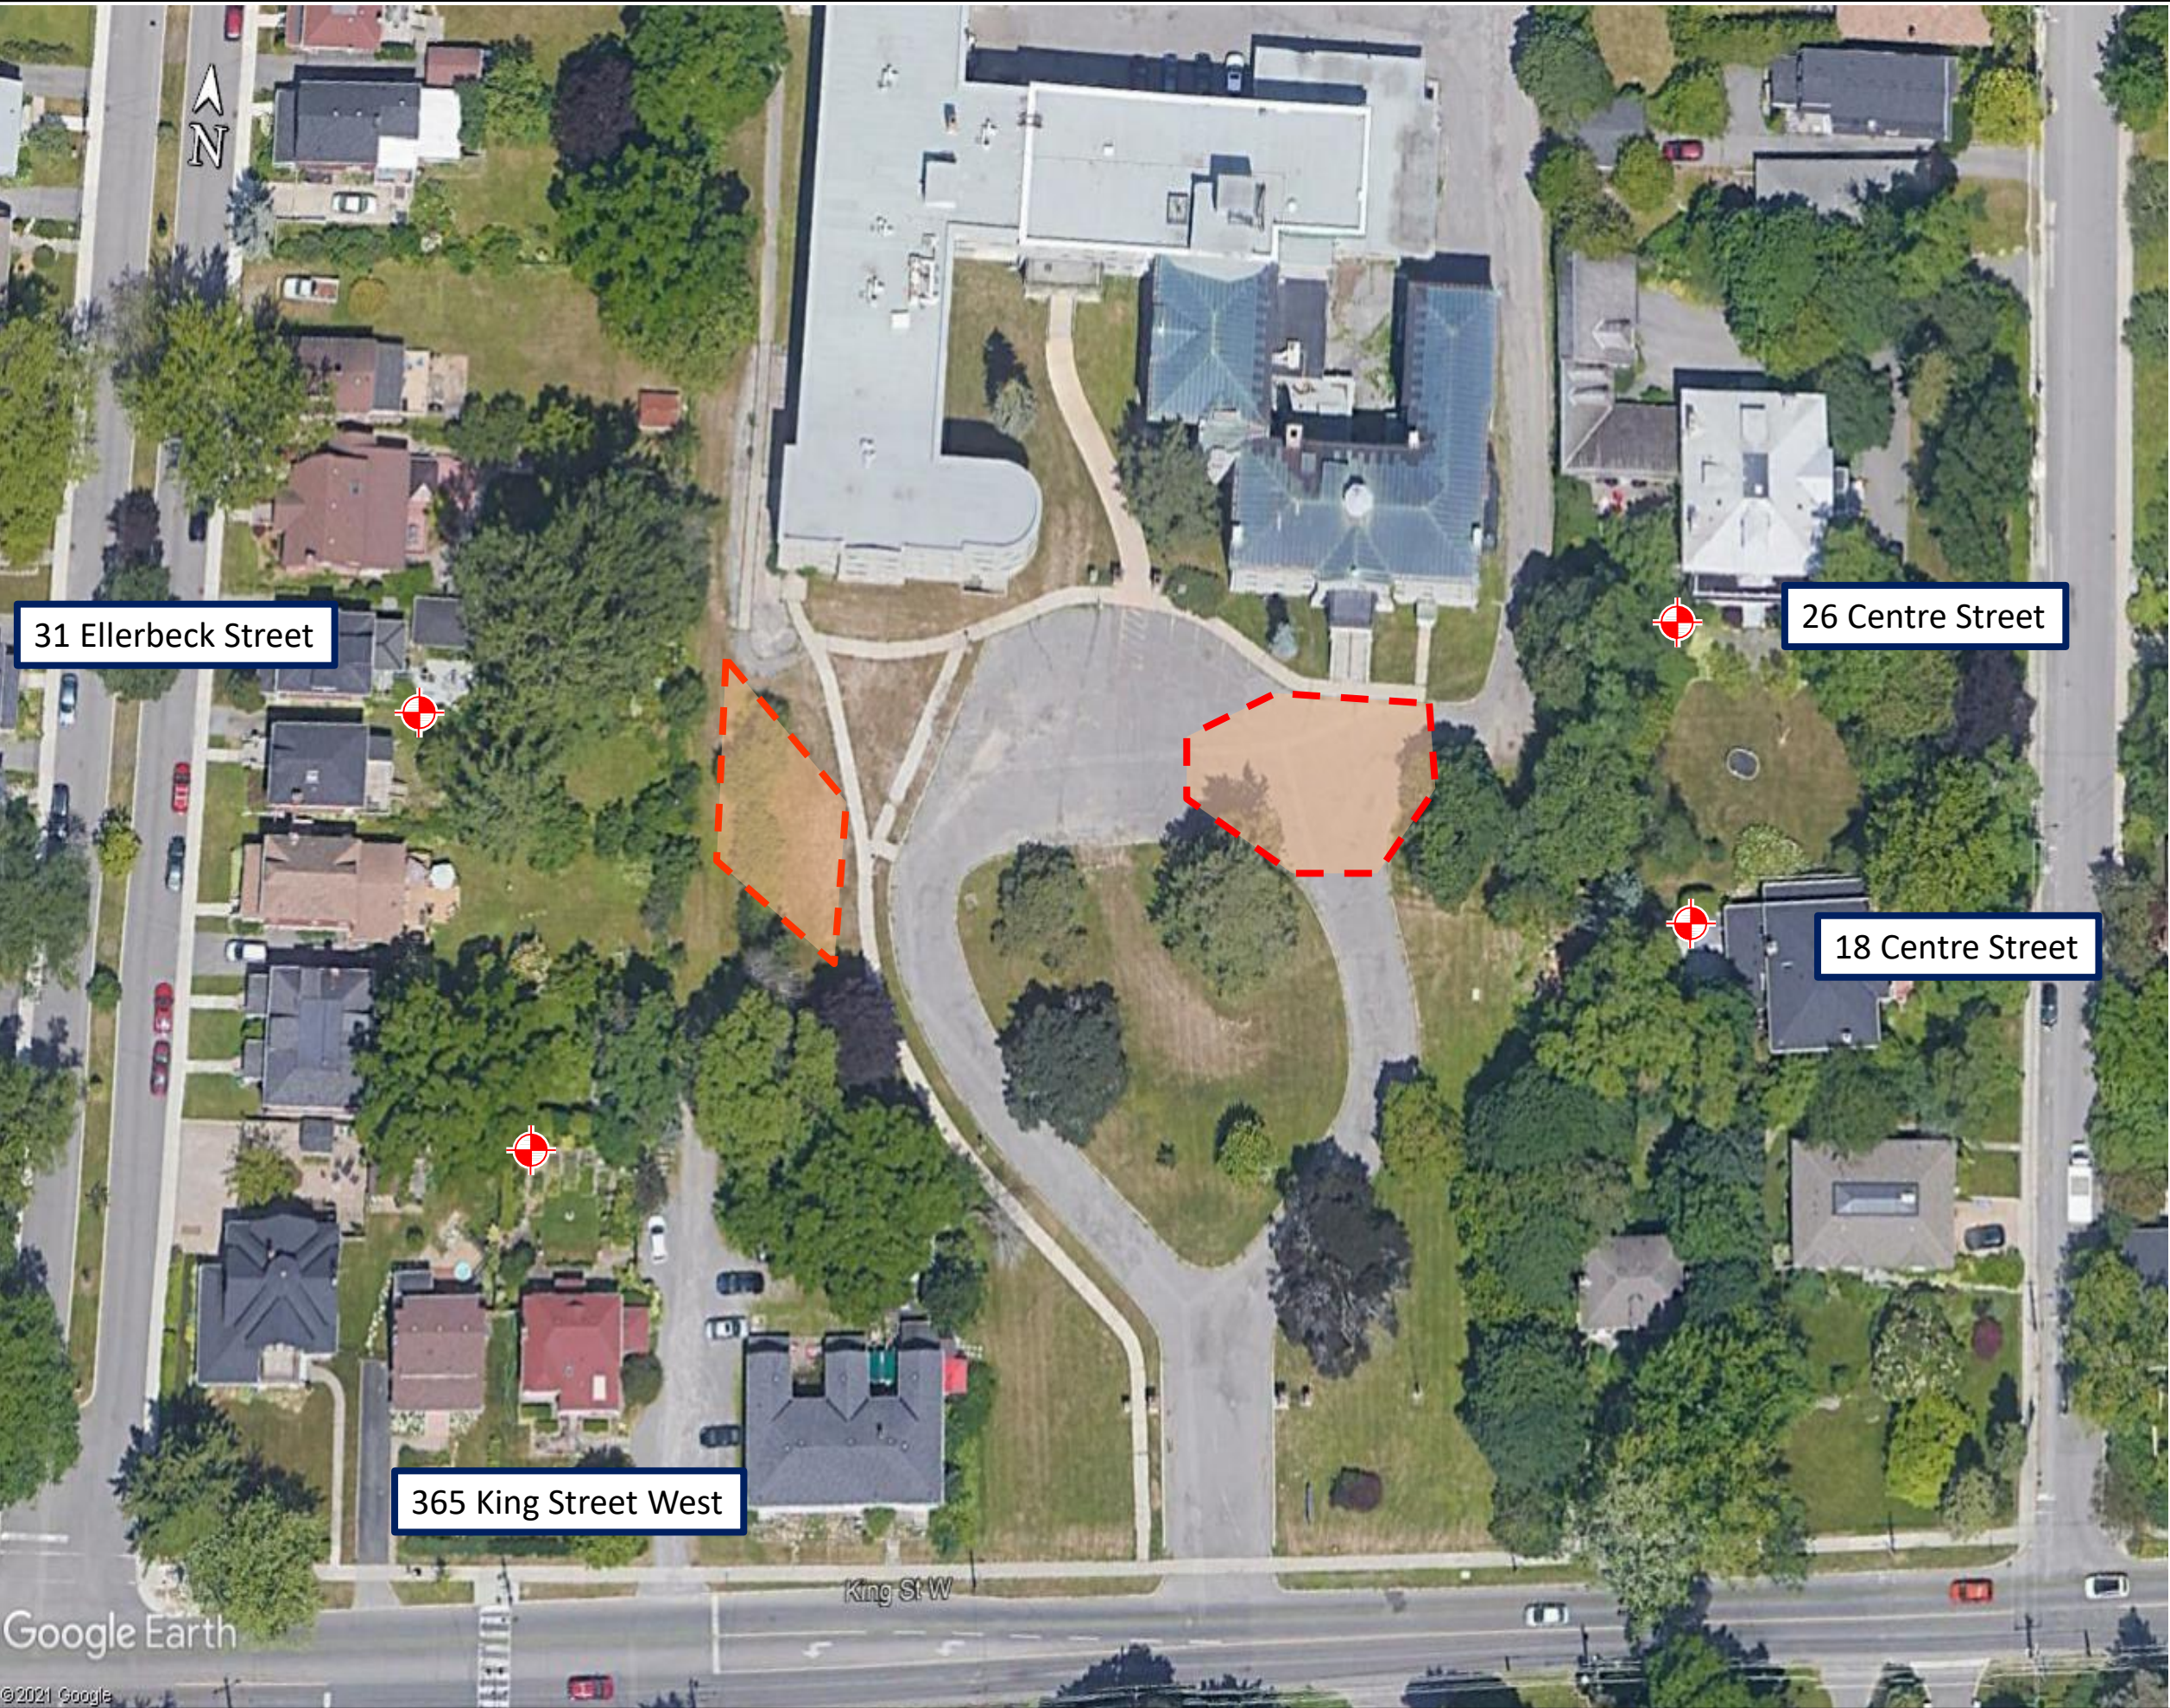
A total of four (4) vibration monitors were installed on February 18, 2021 at the following locations:

- 18 Centre Street;
- 26 Centre Street;
- 31 Ellerbeck Street; and
- 365 King Street West.

Please refer to the site map "Figure 1: Monitoring Locations" attached in Appendix A to overview the monitors' locations.
