March 26, 2021

**Subject: Vibration Monitoring Report – March 19 to March 25, 2021**  
**St. Mary's of the Lake Hospital Renovations**  
**Kingston, ON**

**DST File No.: 02101810.000**

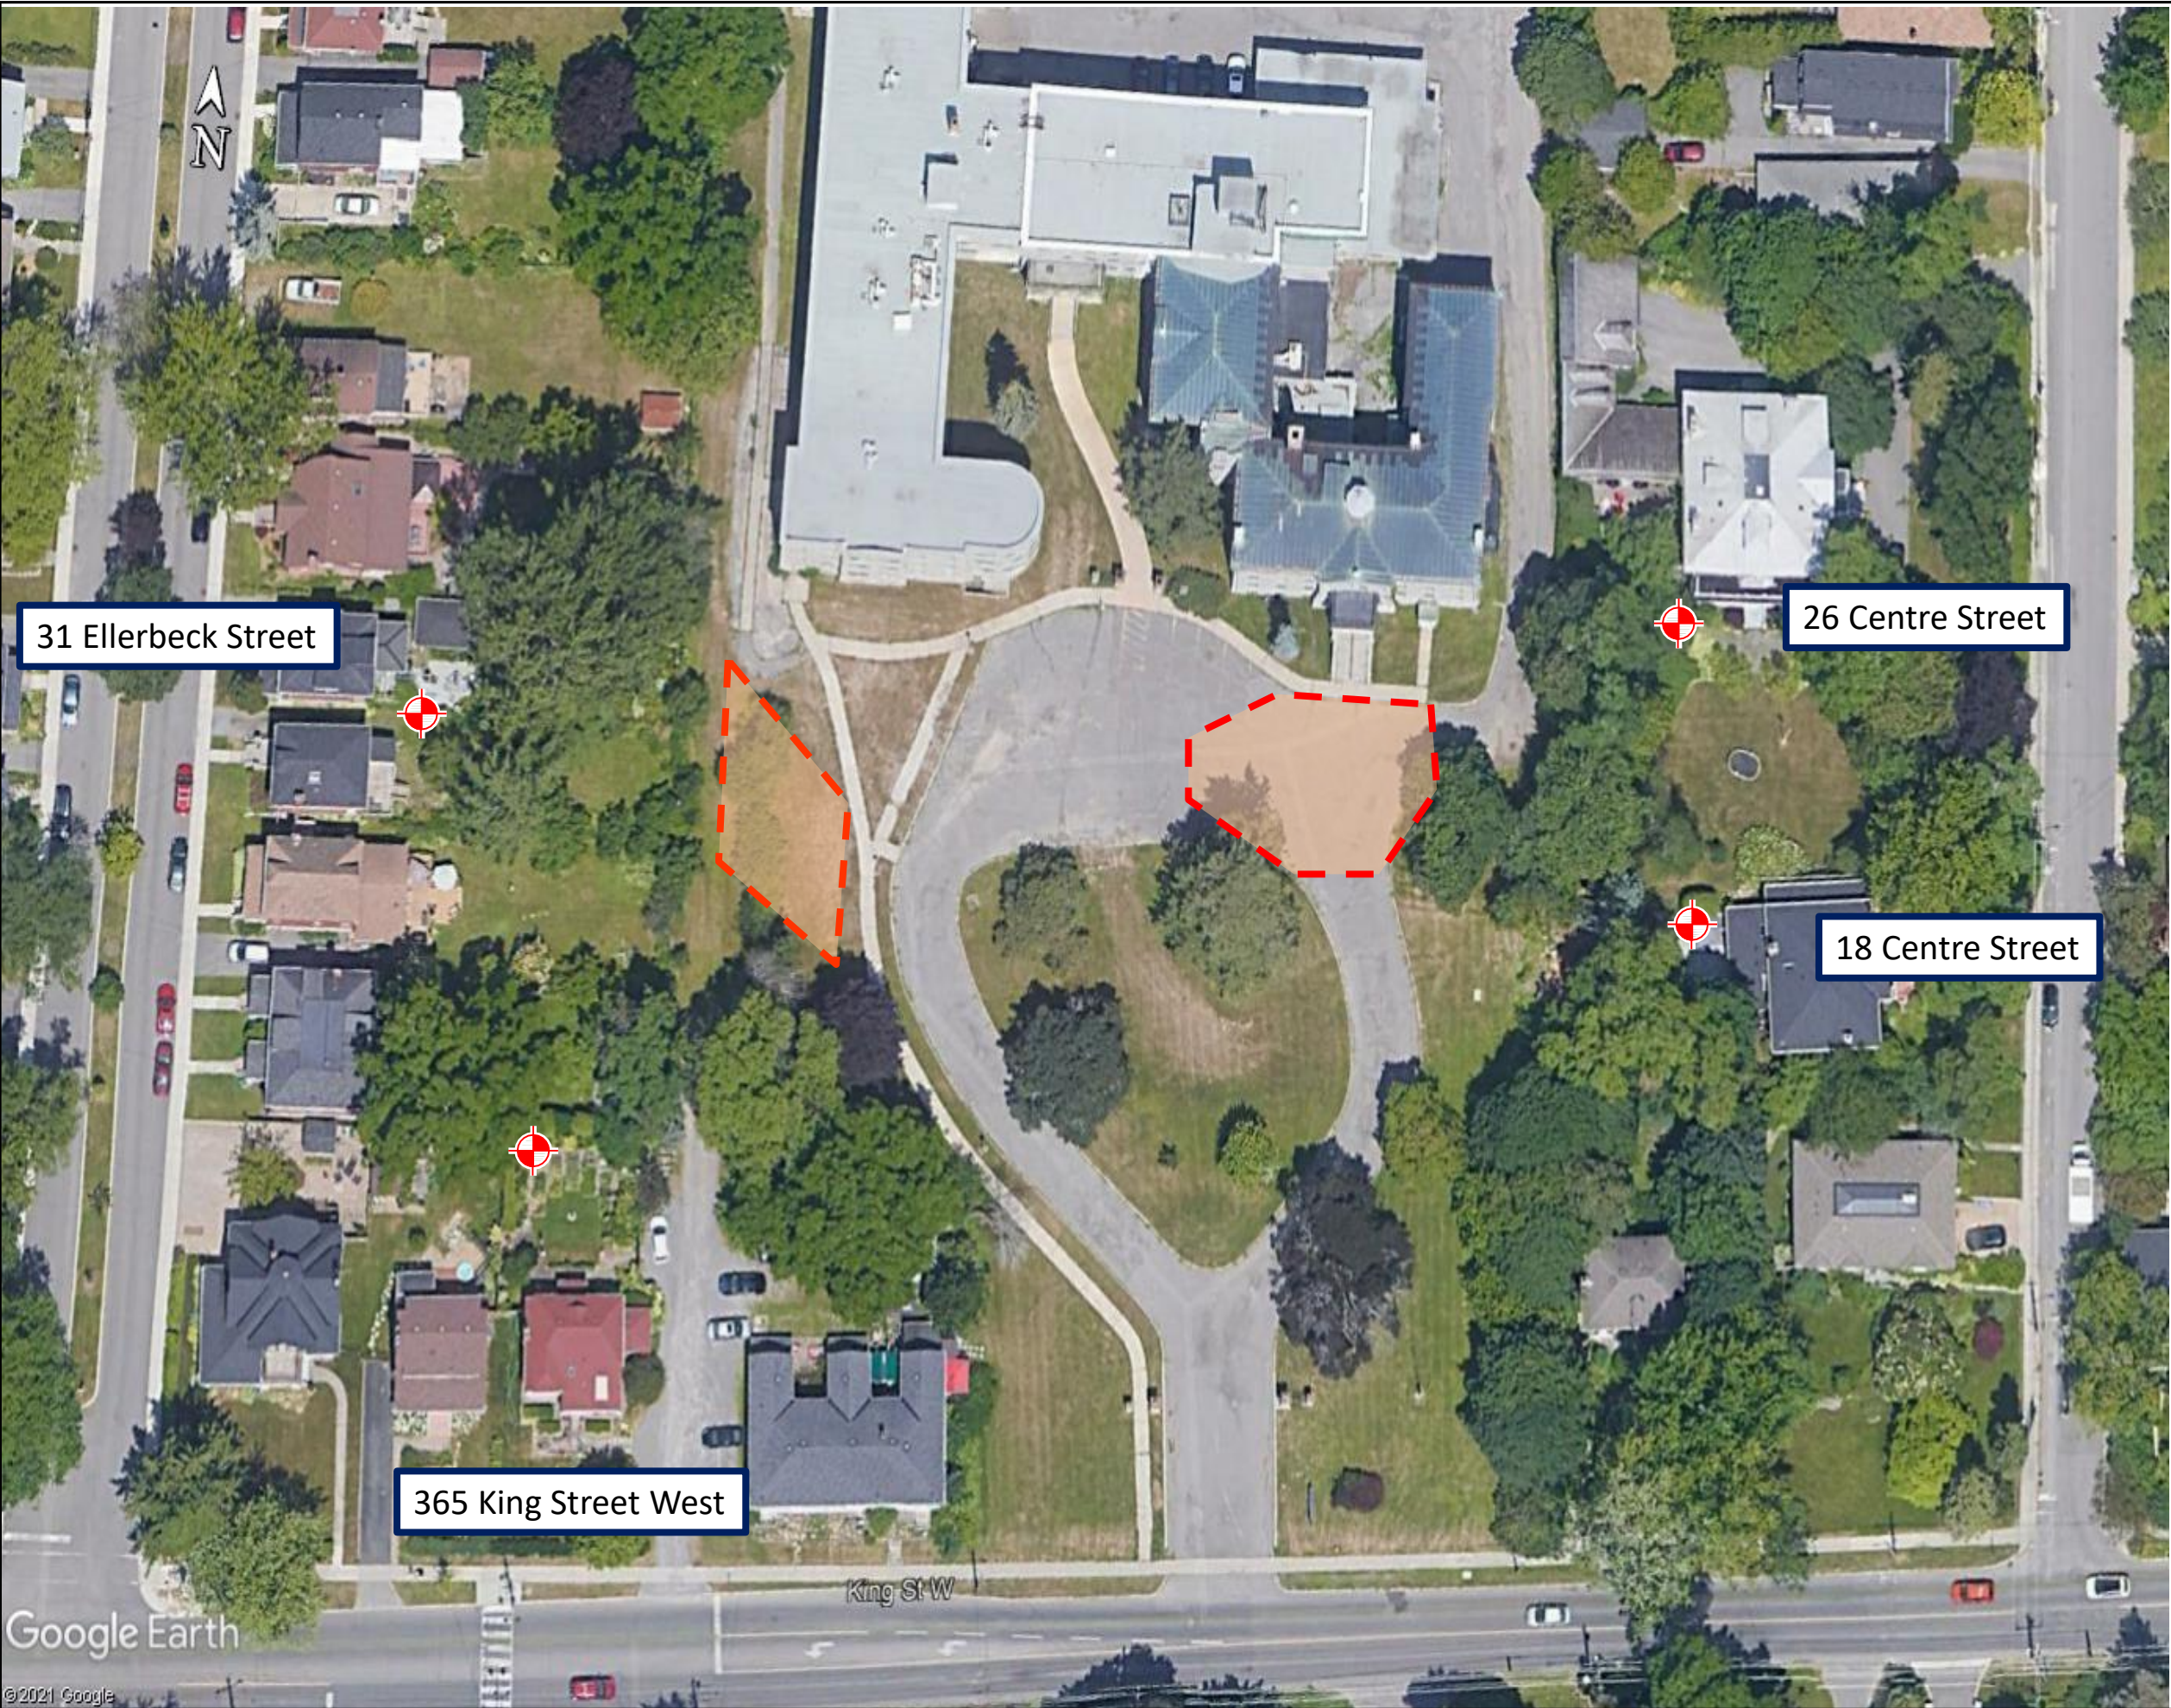
| Figure No2 | | 1 | |

A total of four (4) vibration monitors were installed on February 18, 2021 at the following locations:

- 18 Centre Street;
- 26 Centre Street;
- 31 Ellerbeck Street; and
- 365 King Street West.

Please refer to the site map "Figure 1: Monitoring Locations" attached in Appendix A to overview the monitors' locations.

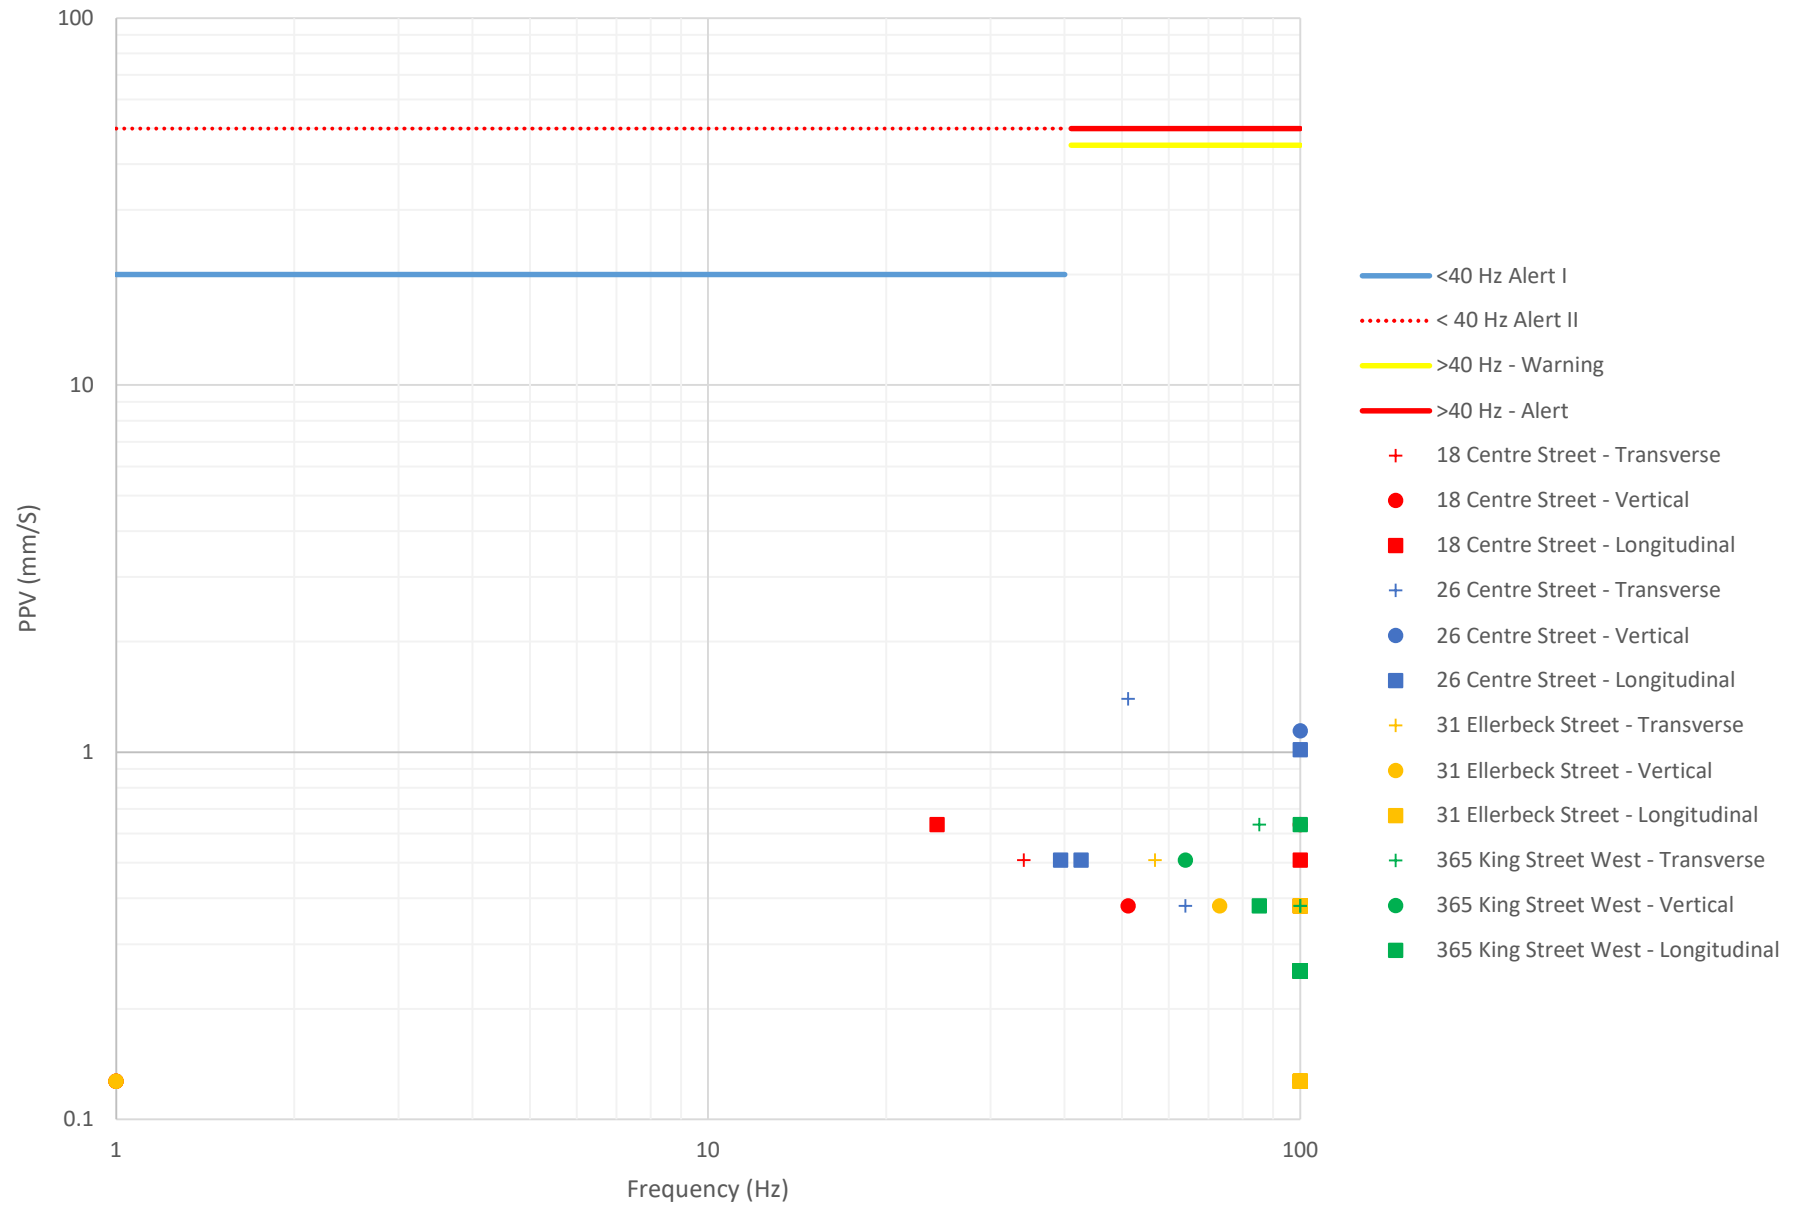
## Queens - PPV vs Hz Vibration Data

Based on the recorded data review between March 19 to March 25, 2021, all vibrations were below the allowable limits outlined in Table 1 attached in Appendix B. The highest vibration level of 1.397 mm/s with a frequency of 51.20 Hz was recorded at 26 Centre Street on March 24, 2021.
